Our Ref: 406.05730.00012

***RE: PRELIMINARY BAT ROOST ASSESSMENT (PRA) OF BUILDINGS OFF LLANTHONY ROAD, GLOUCESTER***

In July 2017, SLR Consulting Limited (SLR) was appointed by Amey to complete a Preliminary Bat Roost Assessment (PRA) of a large multi-use office and warehouse building to the west of Llanthony Road, Gloucester, GL2 5JH (UK Grid Reference: SO 82256 18043).

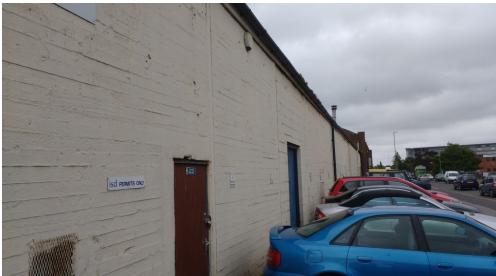
<p><b>External Description</b></p> <p>The multi-use office and warehouse building has a range of construction styles due to the building having been extended at least once during its lifetime. It dates from the 1940's/1950's.</p>

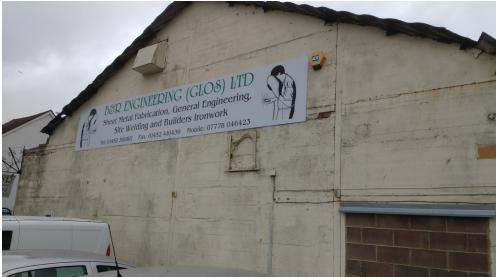
<p>The majority of the building is constructed from single skin breeze block walls with a row of five metal framed roof pitches covered with corrugated concrete/asbestos sheets. There are a number of windows at regular points. The building is mostly in reasonable condition, however, certain areas are dilapidated and support small features potentially suitable for individual or small numbers of roosting bats. This part of the building is divided up into many smaller individual units. Most of the units are in active use and house small manufacturing and engineering businesses which produce light, noise, odour and vibration.</p>

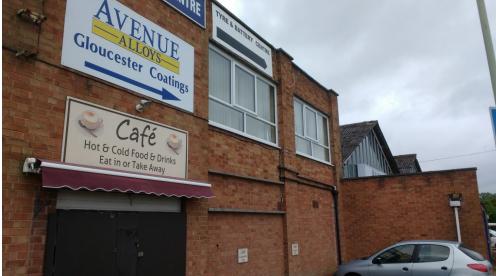
<p>The original part of the building has cavity walls constructed from red brick, with a small section of flat roof and a metal framed pitched roof covered with corrugated concrete sheets. There is a single, large enclosed roof void within this part of the building, which is accessible from the offices below. This section of the building contains offices and a bathroom showroom.</p>

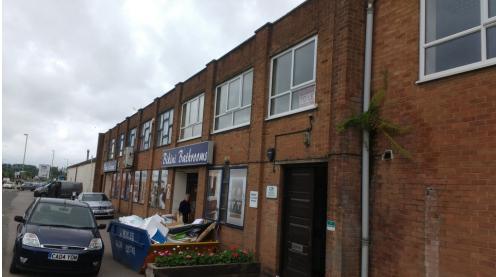
<p>There are a number of small potential bat roost features and/or entry and exits points on each of the four elevations of the building and these are detailed below.</p> <p>The southern elevation of the building has localised gaps in the brickwork and masonry, small gaps between the wall top and roof-covering, gaps around a blocked window frame, gaps under the end ridge tiles, and small gaps behind a wooden board.</p> <p>The eastern elevations have a partially open soffit box, gaps behind the facia boards, gaps between the corrugated roof panel, and small weep holes above the</p>

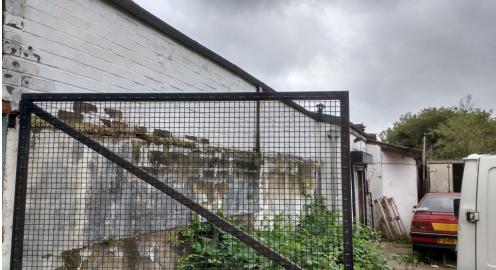
<p>window frames.</p> <p>The northern elevation has a gap at the roofline beneath a capping stone on the flat roof, gaps behind the fascia board above the windows, small gaps under lead flashing, and gaps under the end ridge tiles.</p> <p>The western elevation has gaps under roofing felt on the flat roof, small gaps behind the fascia board and in the brickwork, and gaps between the wall top and roof covering.</p>

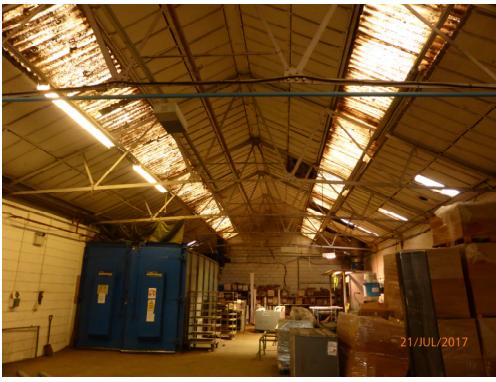
<p><b>Internal Description</b></p> <p>No evidence of bat activity was found within the enclosed roof void within the building. The void was noted to be particularly draughty (due to gaps between the single skin of corrugated roof sheets) and have dense accumulations of cobwebs. A window or vent opened into the roof void allowing light ingress into the void. It is anticipated, due to the single-skin roof covering and abundance of gaps that the void suffers from wide fluctuations of temperature. Rats have been known to be present within the roof void in the past, and evidence of bird presence (feathers) was noted in the void.</p> <p>There are no other accessible roof voids within the building and the majority of the remainder of the building is open to the roof. In these parts of the building the single-skin of corrugated roofing sheets are lined internally with rectangular boards suspended from the metal roof frame. In many places these lining boards are beginning to decay leaving open gaps and in other places the boards have fallen out completely.</p> <p>As stated the majority of the building is in active use, and is thus subject to significant noise and light levels.</p>
