PRINCIPAL INSPECTION

Lydbrook Rail Bridge B976

21st – 24th March 2016

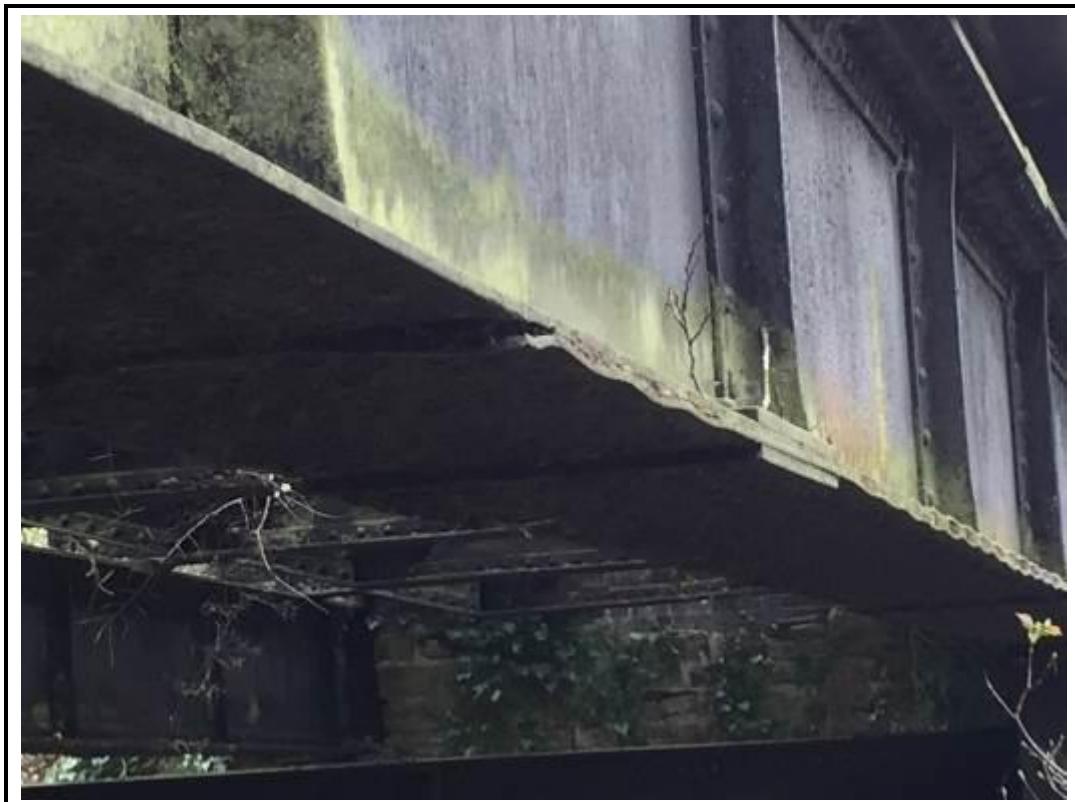
Corrosion and rust jacking is present between plates along the bottom flange ([Photo 5](#)) and in uprights at stiffener plates ([Photo 6](#)). This will be placing the rivets under increased axial stresses and could lead to them failing.

Photo 5. View of rust jacking to MGE bottom flange

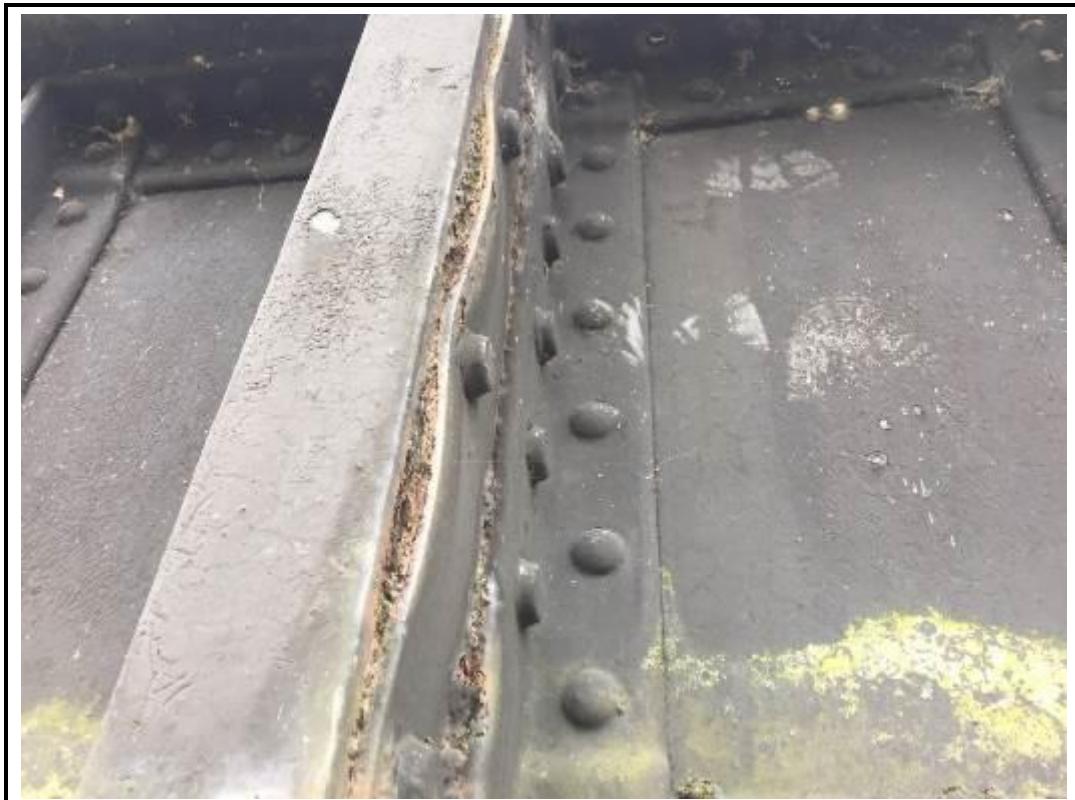
Photo 6. View of rust jacking to MGE upright stiffener plate

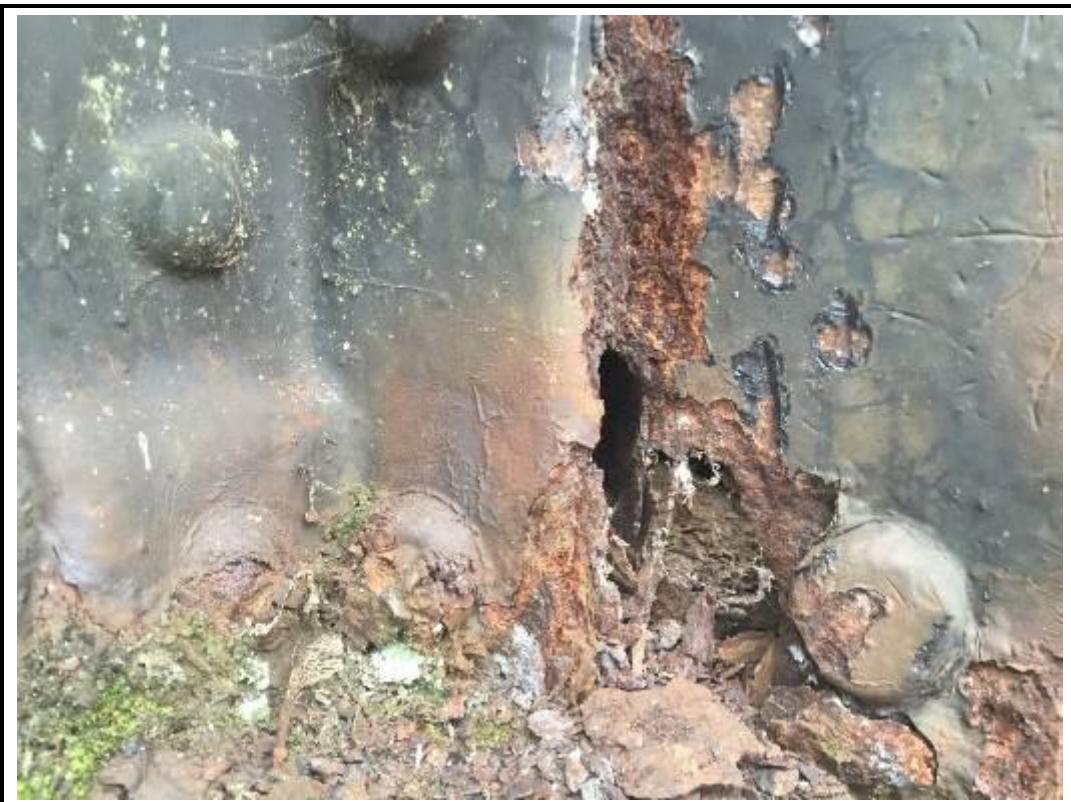
Minor areas of loss of section were noted in the gusset stiffeners ([Photo 7](#)).

Photo 7. View of loss of section to gusset stiffener in MGE.

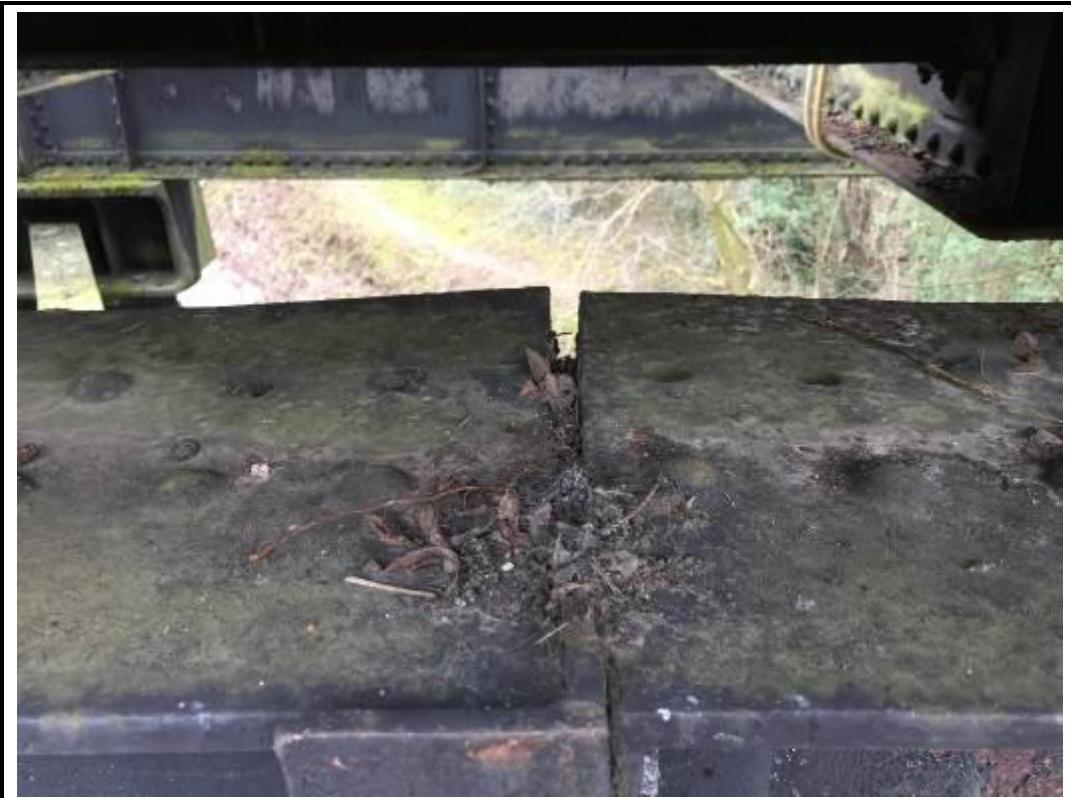
Slight distortion was noted at the majority of joins along with missing rivets at these locations ([Photo 8](#)). Top flanges appear distorted upwards by up to 30mm.

Photo 8. View of distortion and missing rivets, top flange, MGE joins.

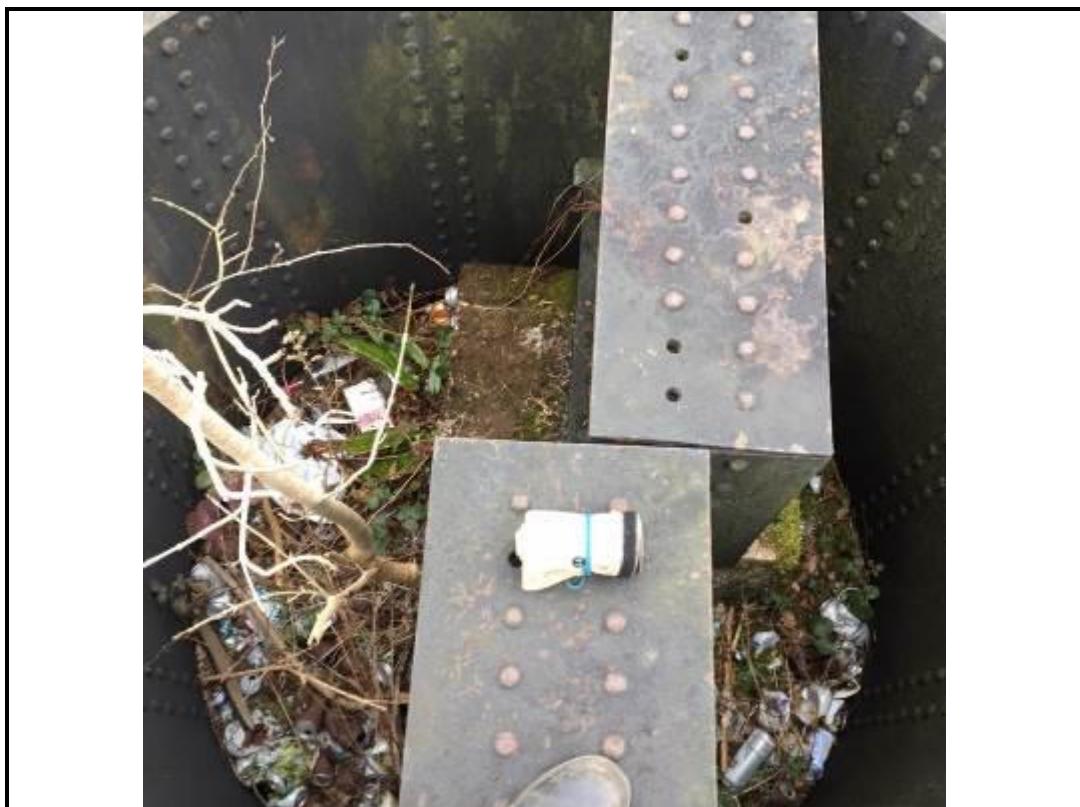
An offset of 250mm was noted within the upside pier 4 caisson where the MGE girders meet. This is thought to be a construction feature rather than a defect. ([Photo 9](#))

Photo 9. View of offset between two main girders, Pier 4 Upside Caisson.

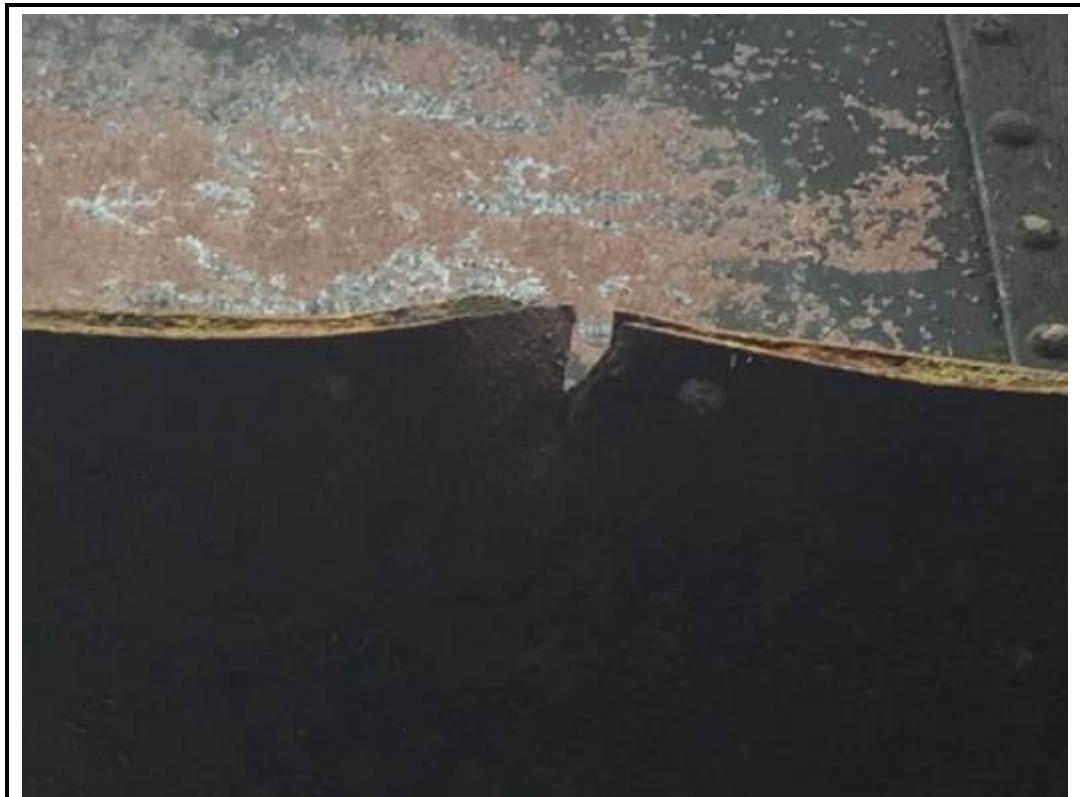
Impact damage was noted to the downside beam at the low mileage end above the vehicle track ([Photo 10](#)).

Photo 10. View of impact damage to downside beam, low mileage end.

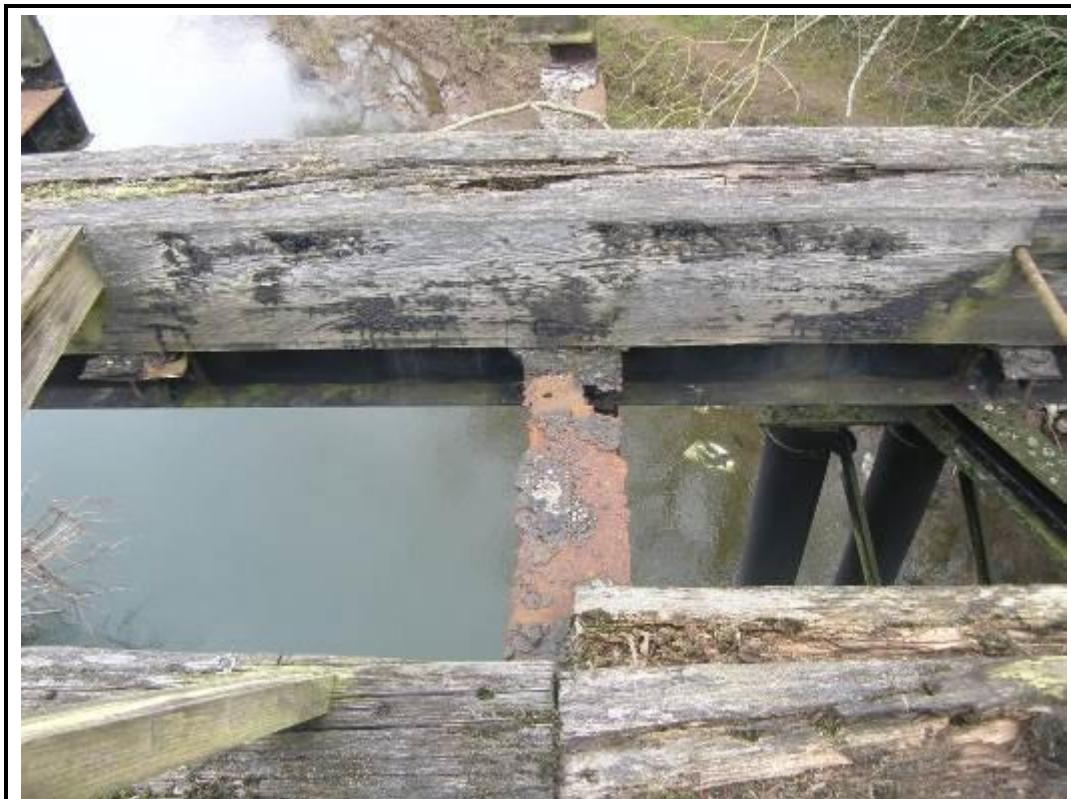
Loss of section was noted throughout the top flanges with an estimated 35% loss to over half of the beams ([Photo 11](#)). The worst affected areas are below the walkway timbers. In places the timber decking is supported directly on the web of the beams. This is particularly bad where the path steps out over the caissons ([Photo 12](#)).

Photo 11. View of general loss of section to transverse beams top flange.

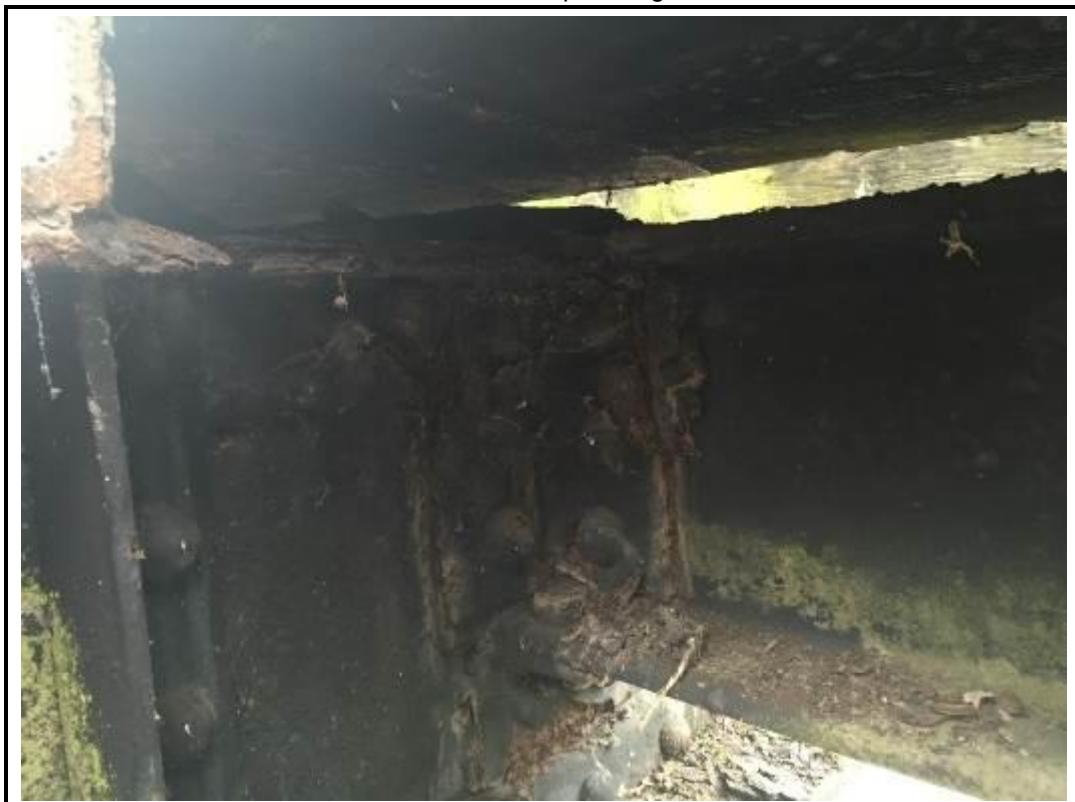
The longitudinal beams (constructed from rolled steel) which support the timber baulks are in fair condition ([Photo 16](#)). There are some isolated areas of loss of section to the top flanges where packing pieces between the beam and timber baulk used to be ([Photo 17](#)). Some of the connections to the transverse beams are badly corroded ([Photo 18](#)).

Photo 18. View of longitudinal beam corroded connection to transverse girder.

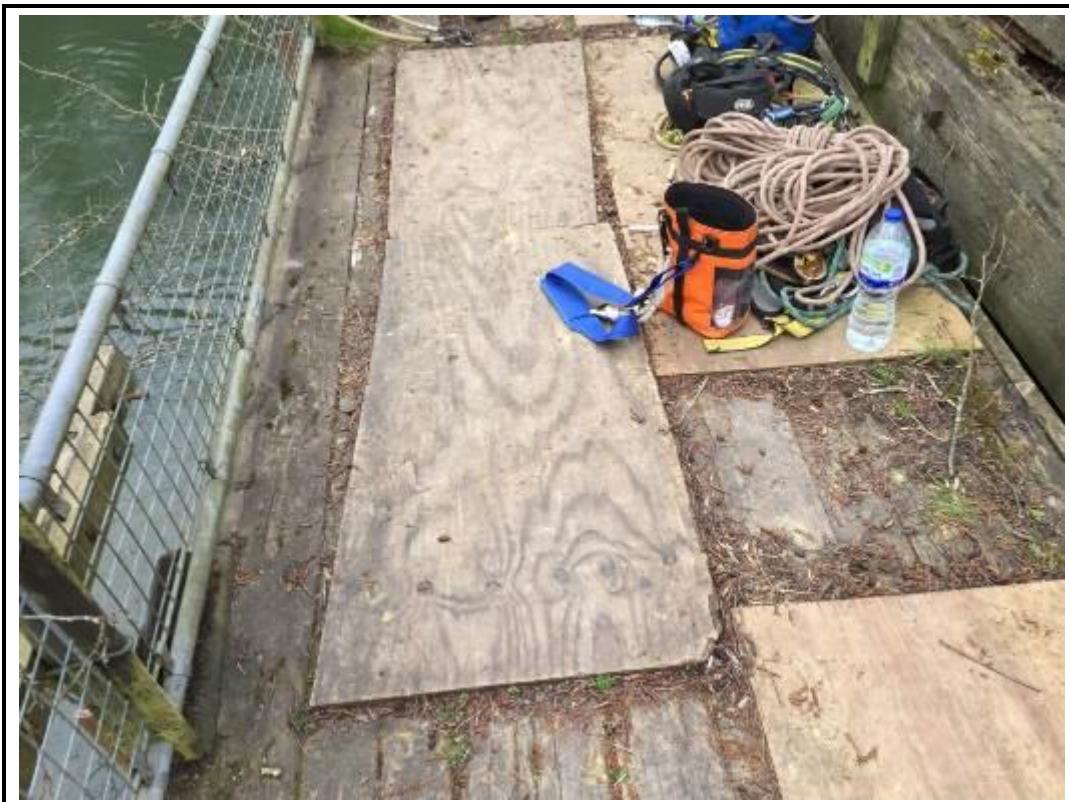
The timber walkway planks are in poor condition ([Photo 26](#)). There are several areas of plywood repairs ([Photo 27](#)) that cover collapsed timbers beneath ([Photo 28](#)). There are 4no missing or removed planks due to being rotten and no longer secured to the top flange of the transverse beams ([Photo 29 + 30](#)). The worst affected areas are at the high and low mileage ends. **These missing planks should be repaired before the walkway is re-opened.**

Photo 27. View of plywood repairs to walkway.

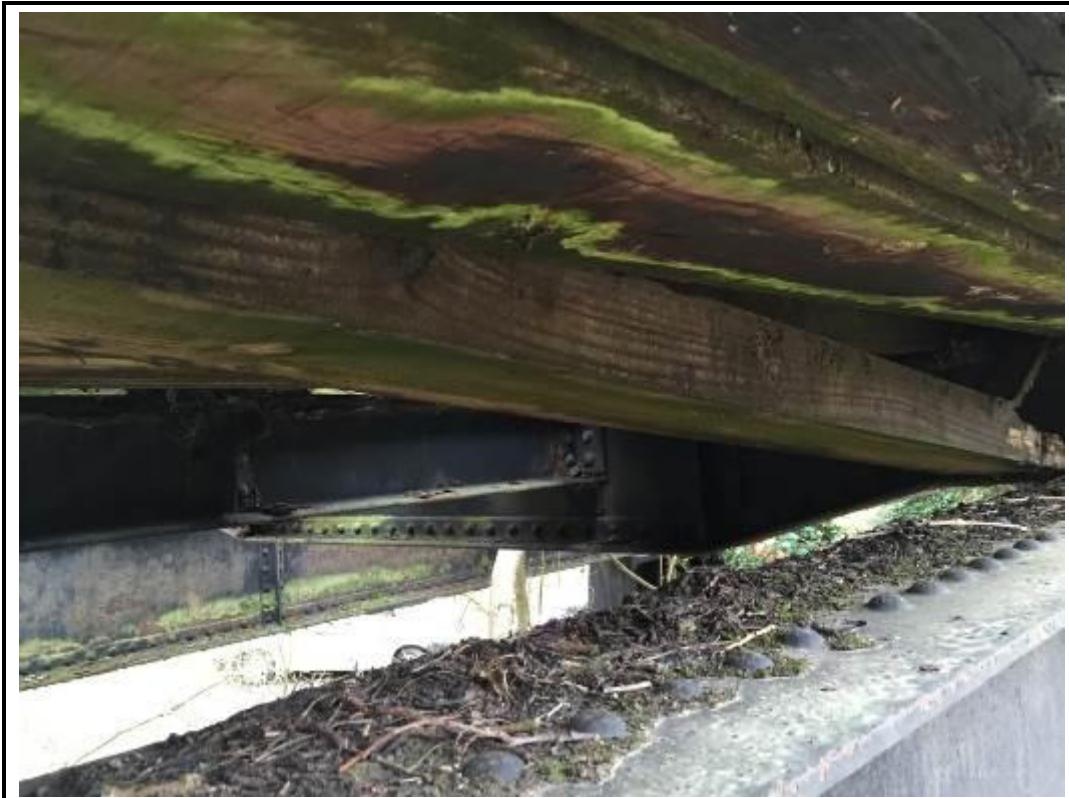
Photo 28. View of collapsed walkway timber.

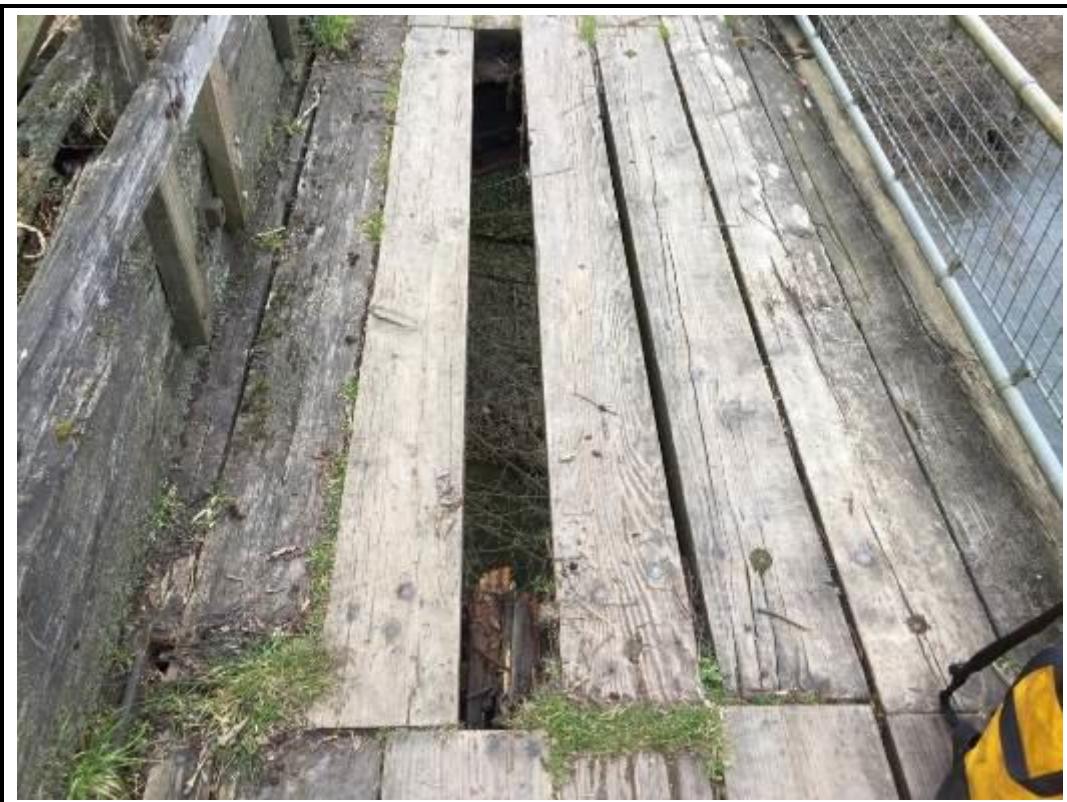
Photo 29. View of missing walkway timber at centre.

The walkway should be repaired and made safe as soon as possible as it is an amenity for both local inhabitants as well as tourists and enables good access to the footpaths on both sides of the river.
	It would be advisable to carry out targeted repairs to the worst cross girders in order to maximise the benefit of the walkway in terms of ongoing maintenance.
	The substructure is in relatively fair condition given the reduced loading currently experienced in comparison to the original loading requirement.
	A diving examination is advised in order to assess the existence of any scour underwater.

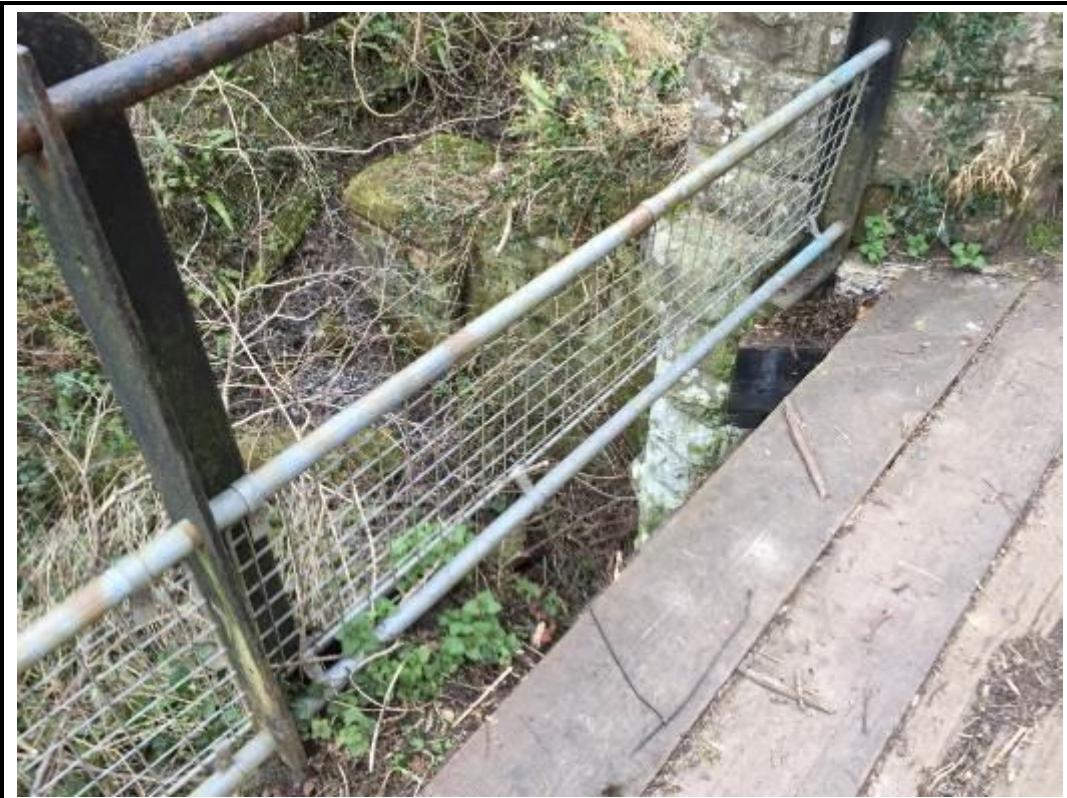
Photo 30. View of view of missing walkway timber at high mileage end.

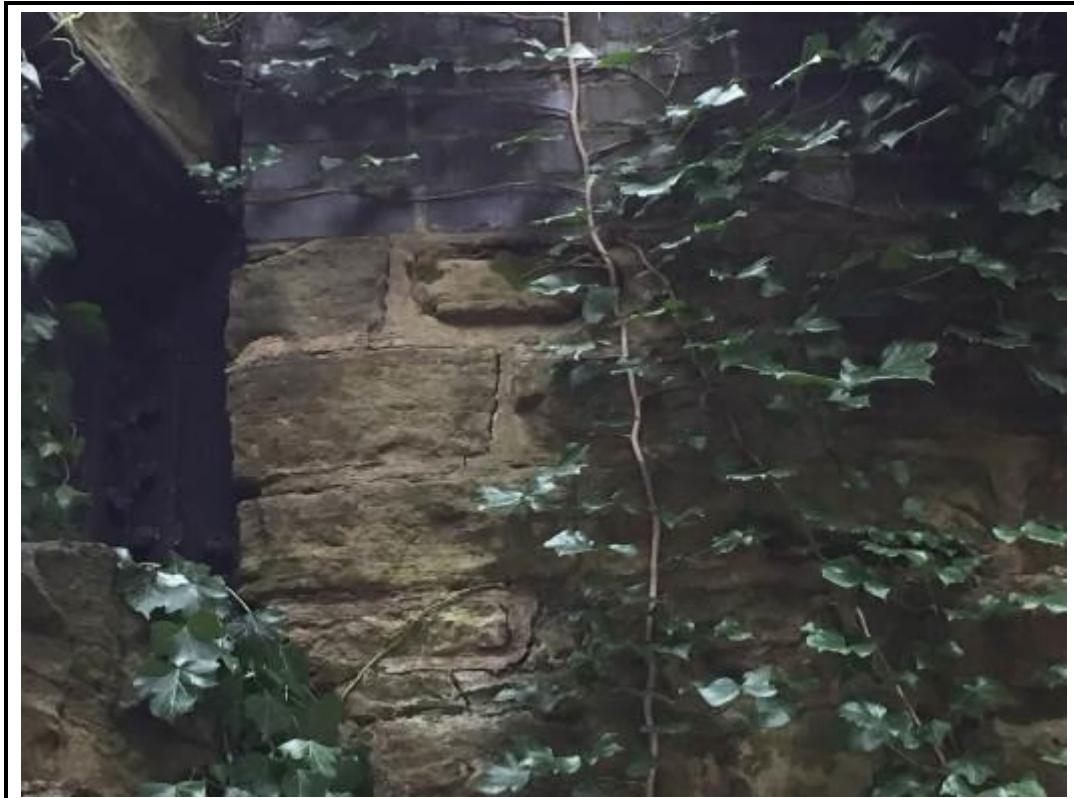
Vertical step fracture adjacent upside main girder, 0.5m L, open 5mm max ([Photo 32](#)).

Photo 32. View of vertical step fracture to low mileage abutment.

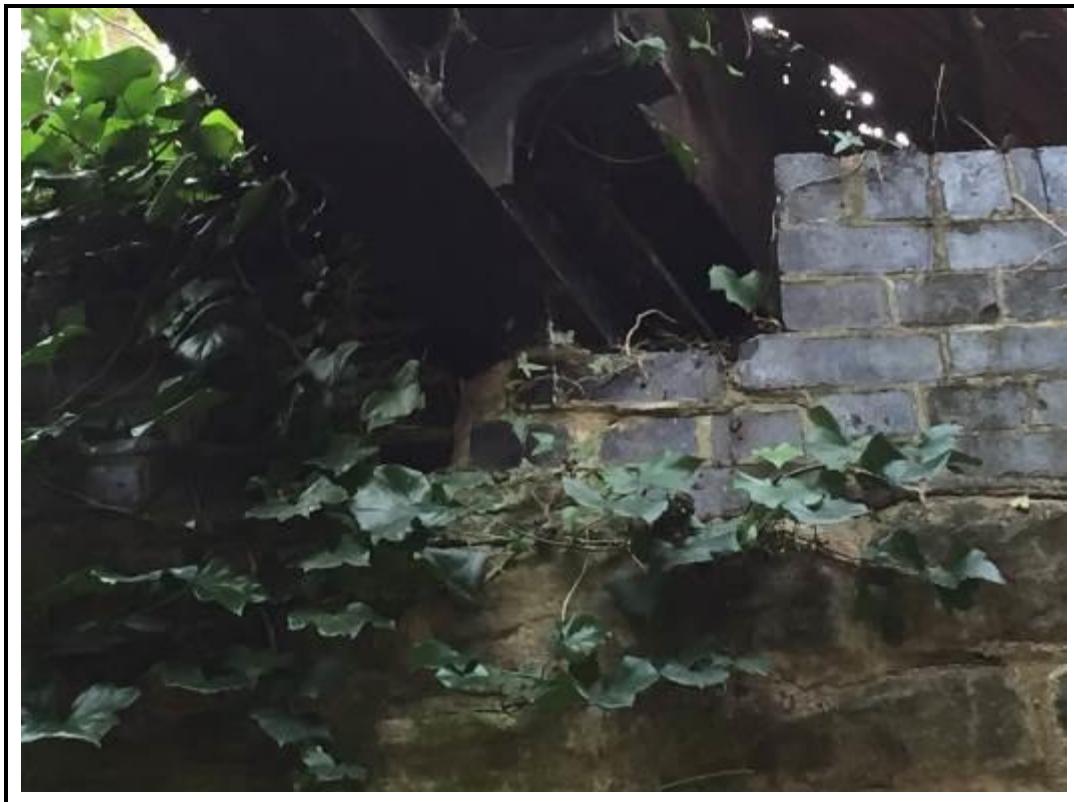
Vertical fracture through brick section below upside main girder, 0.2m L, open 4mm. The brickwork to the downside is displaced forward by 80mm ([Photo 33](#)).

Photo 33. View of vertical fracture and displacement to low mileage abutment.

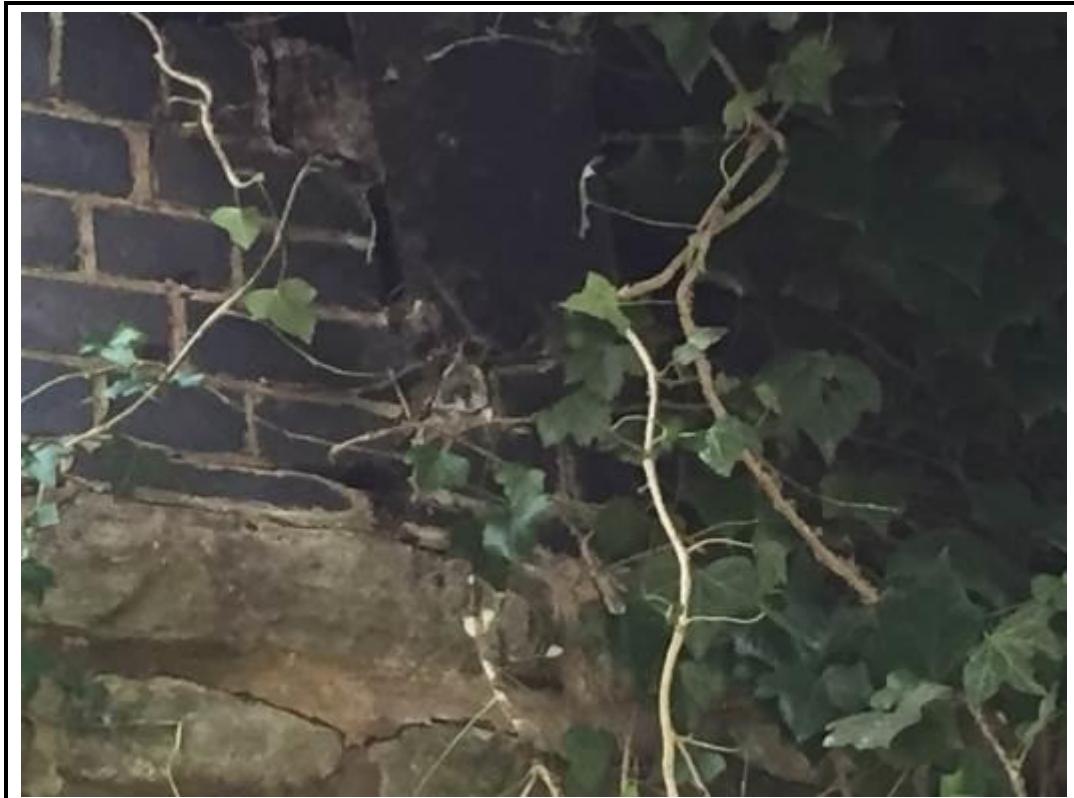
Vertical fracture through brick section below downside main girder, 0.2m L, open 3mm ([Photo 34](#)).

Photo 34. View of vertical fracture to low mileage abutment.

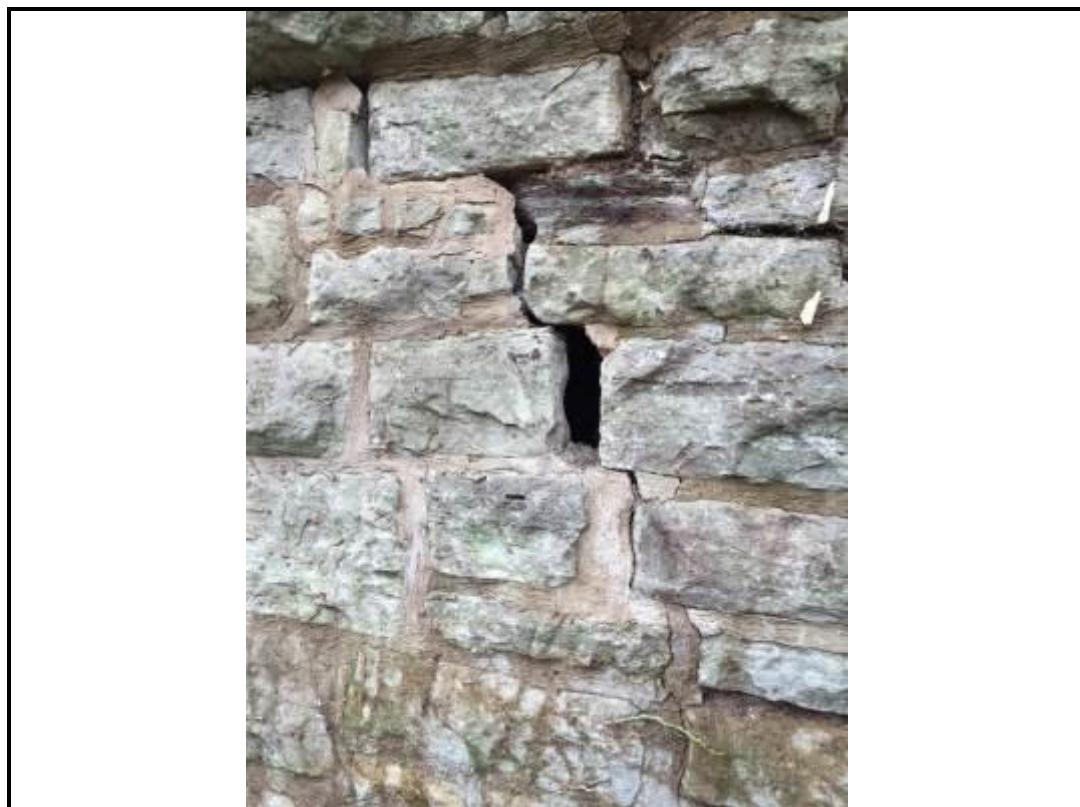
Vertical step fracture located in downside return. 3m up from ground level, 1.2m L open up to 70mm max and runs to full depth ([Photo 35](#)).

Photo 35. View of vertical step fracture to LM ABT downside return.

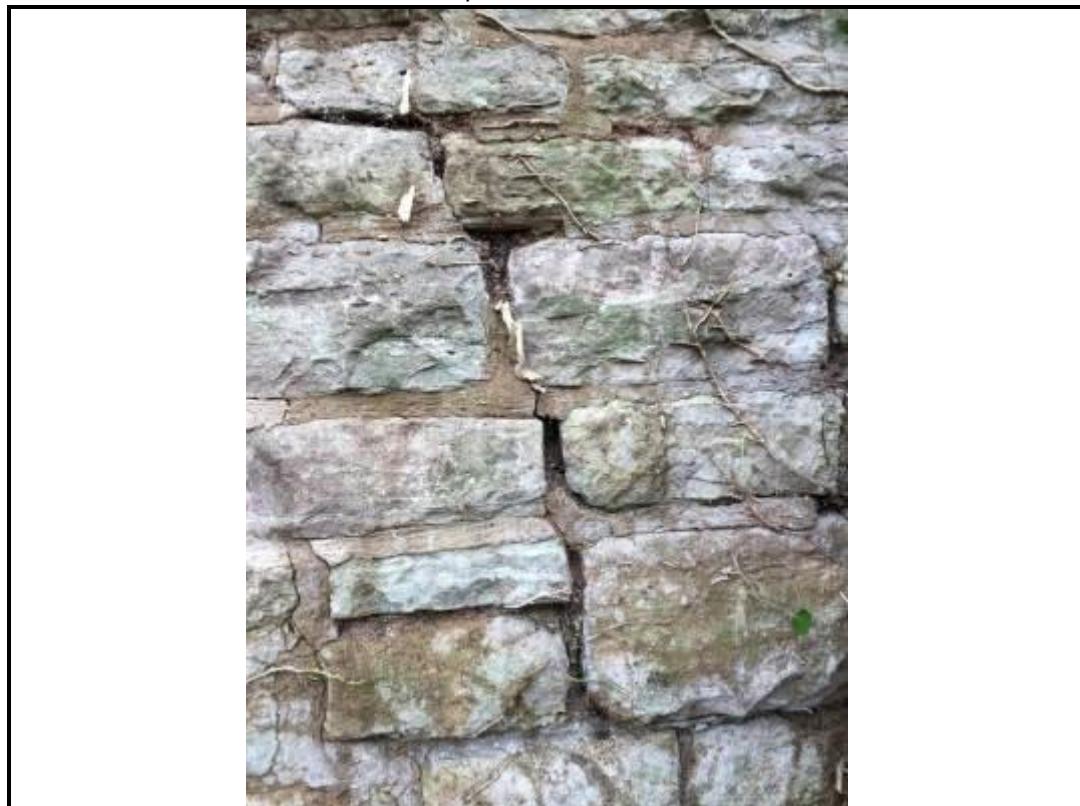
Vertical fracture located in downside return, 800mm L open 1-5mm ([Photo 36](#)).

Photo 36. View of vertical fracture to LM ABT downside return

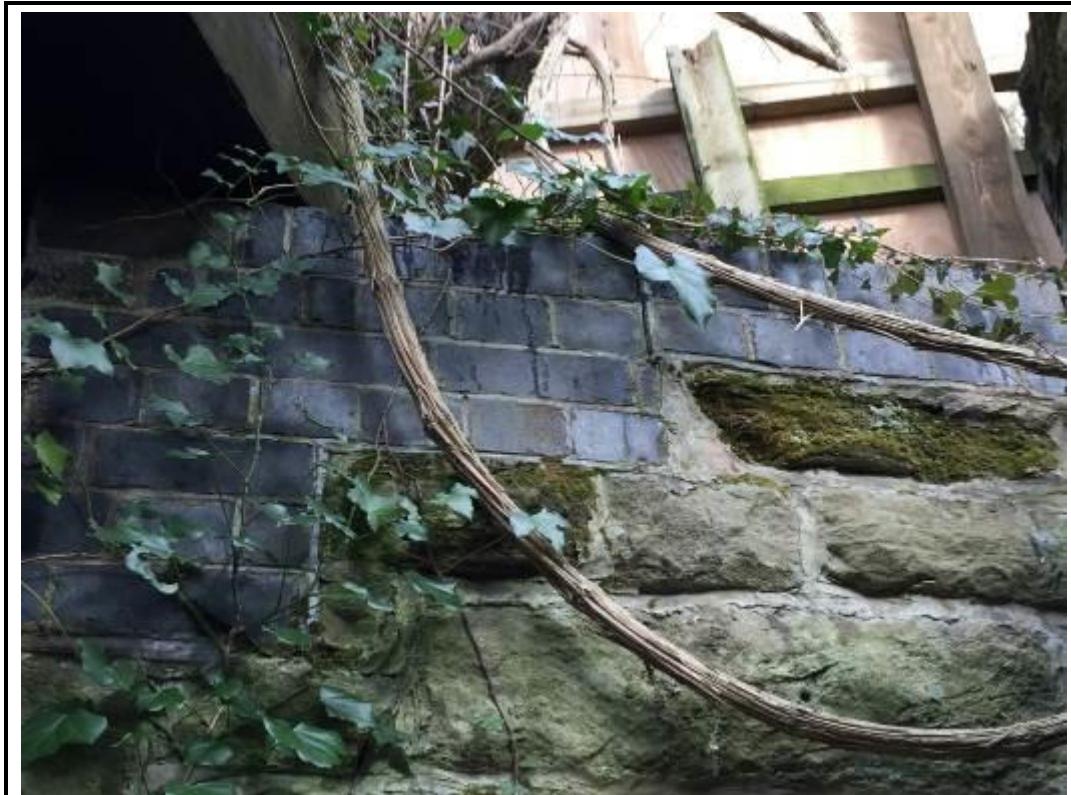
Brick top section is loose to hammer at the downside end; effecting 5no units.
Vertical fracture in brick section, 1.2m from upside. 200mm L open 6mm ([Photo 38](#)).
Vertical fracture 3m from upside, 200mm L open 5mm ([Photo 39](#))
Vertical fracture below downside main girder, 250mm L open 3mm ([Photo 40](#))

Photo 38. View of vertical fracture to high mileage abutment.

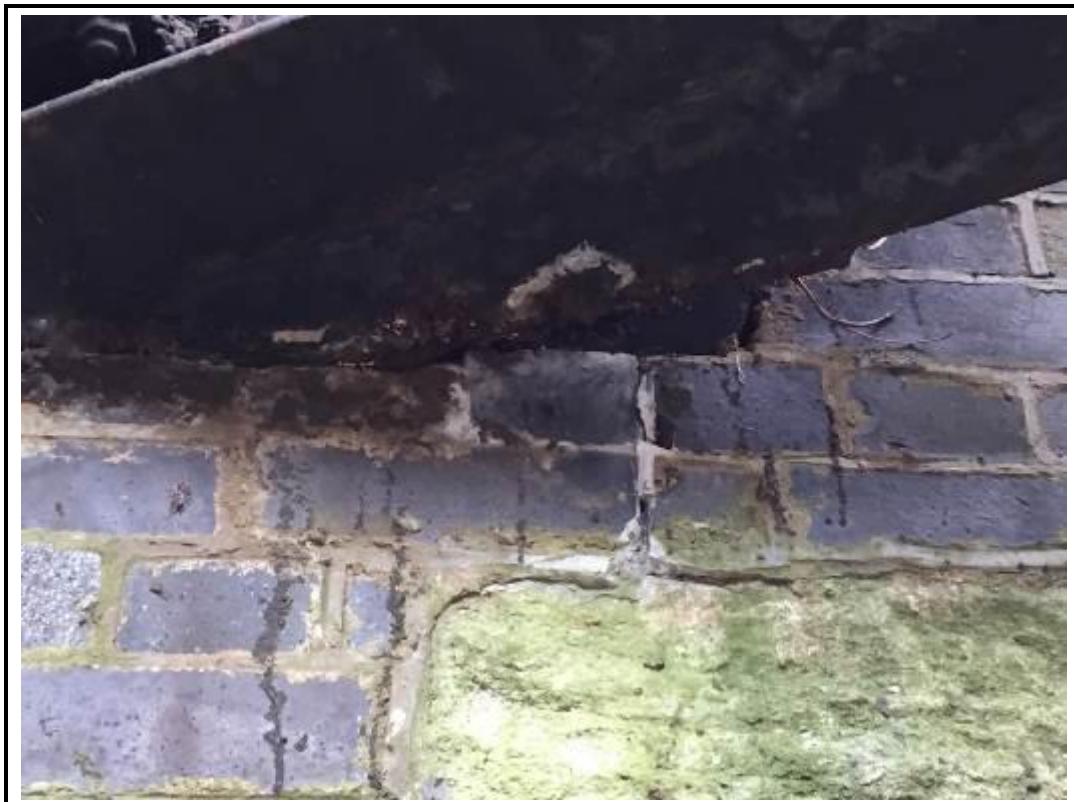
Photo 39. View of vertical fracture to high mileage abutment.

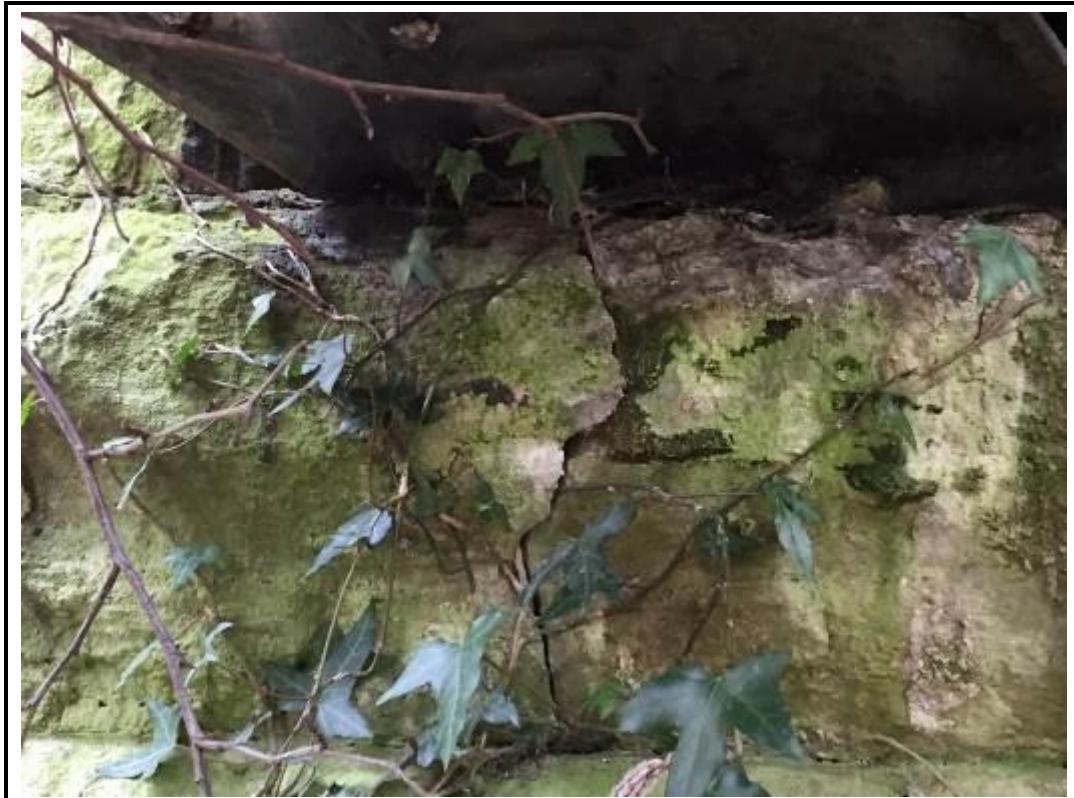
Photo 40. View of vertical fracture to high mileage abutment.

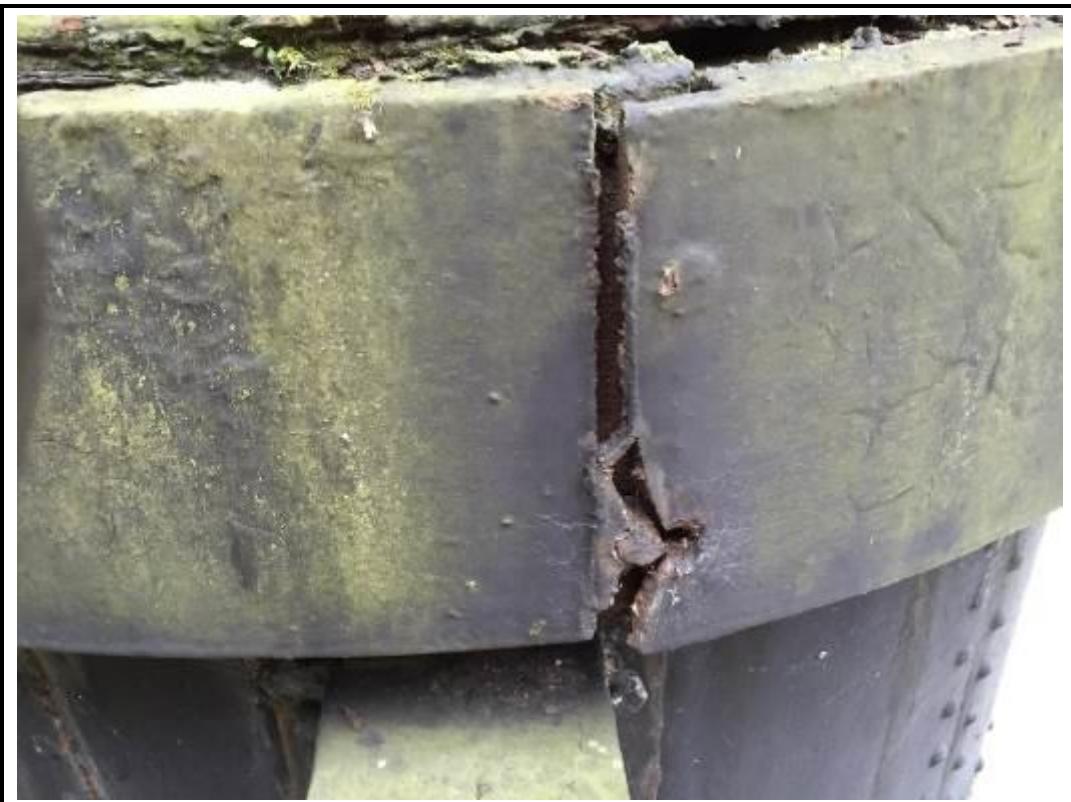
Both Pier 4 columns have fracturing with slight displacement to the decorative banding near the top to full depth on both the internal and external faces ([Photo 43](#)). The pier 5 upside column has hairline fracturing around the collar bolts ([Photo 44](#)).

Photo 43. View of fracturing to decorative banding on caissons.

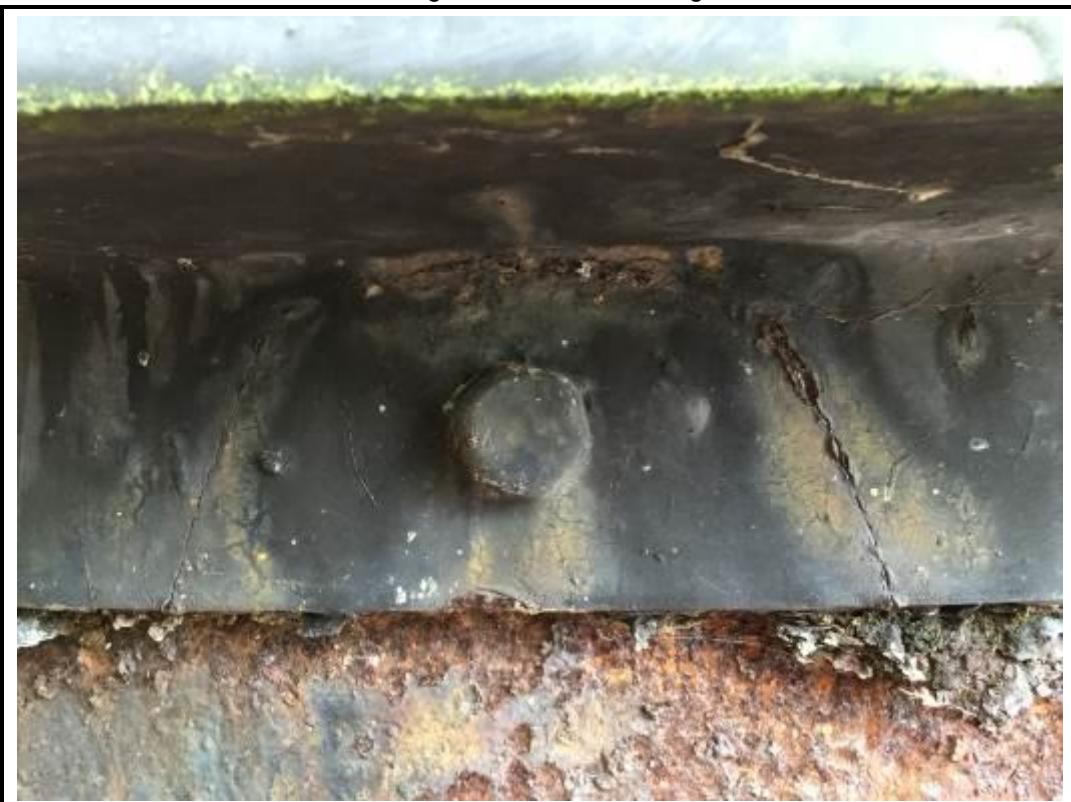
Photo 44. View of fracturing to pier 5 caisson decorative banding.

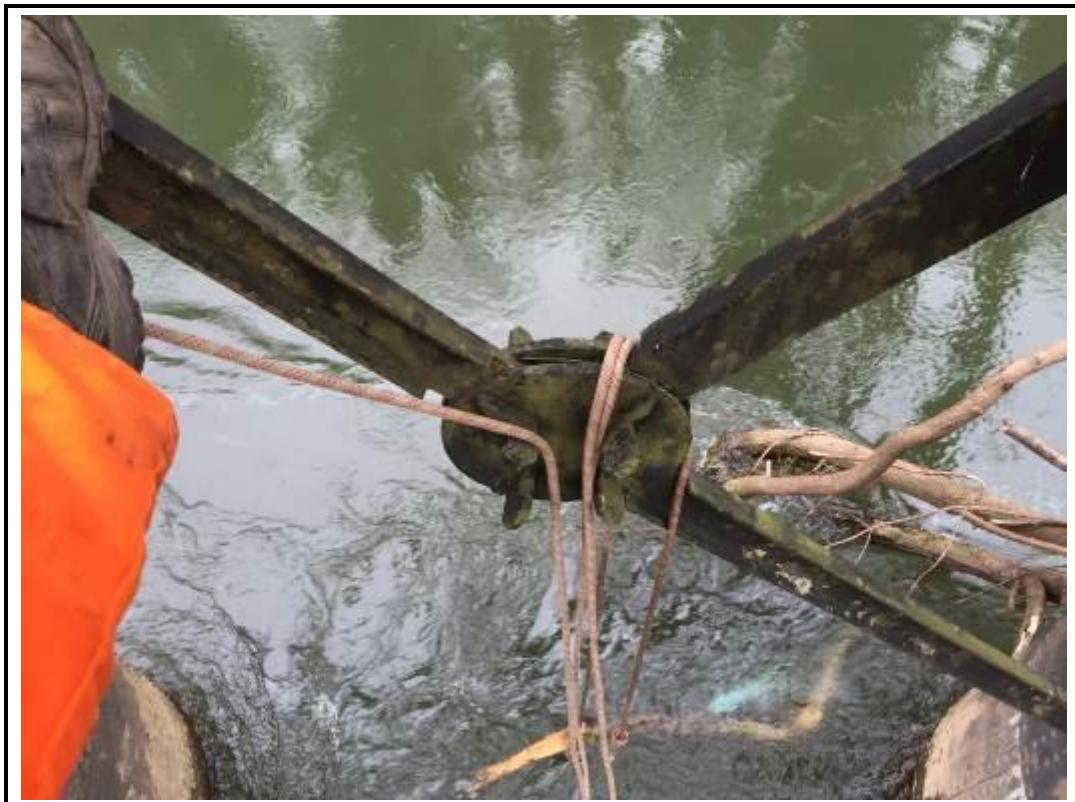
Cross bracing between the columns on each pier was missing the lower downside beam ([Photo 45](#)). On the upside of pier 4 the top connector has a missing bolt and is very loose ([Photo 46](#)).

Photo 45. View of cross bracing between piers with missing lower tie.

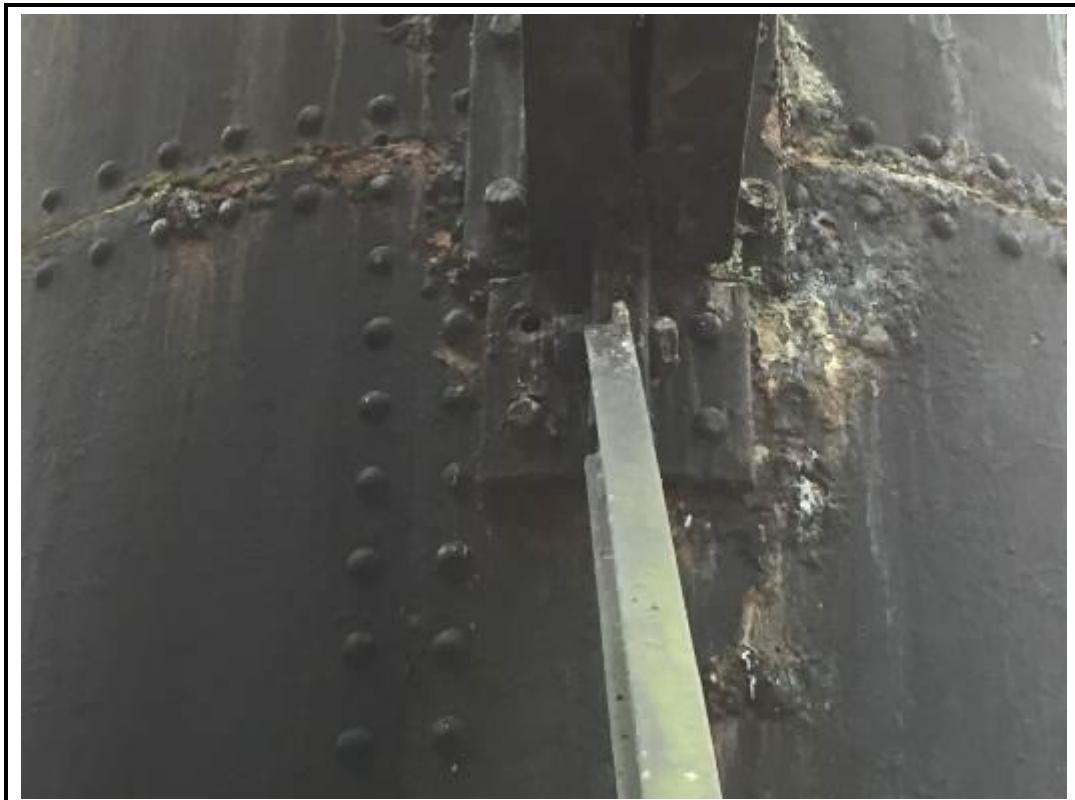
Photo 46. View of loose connector plate with missing bolt.

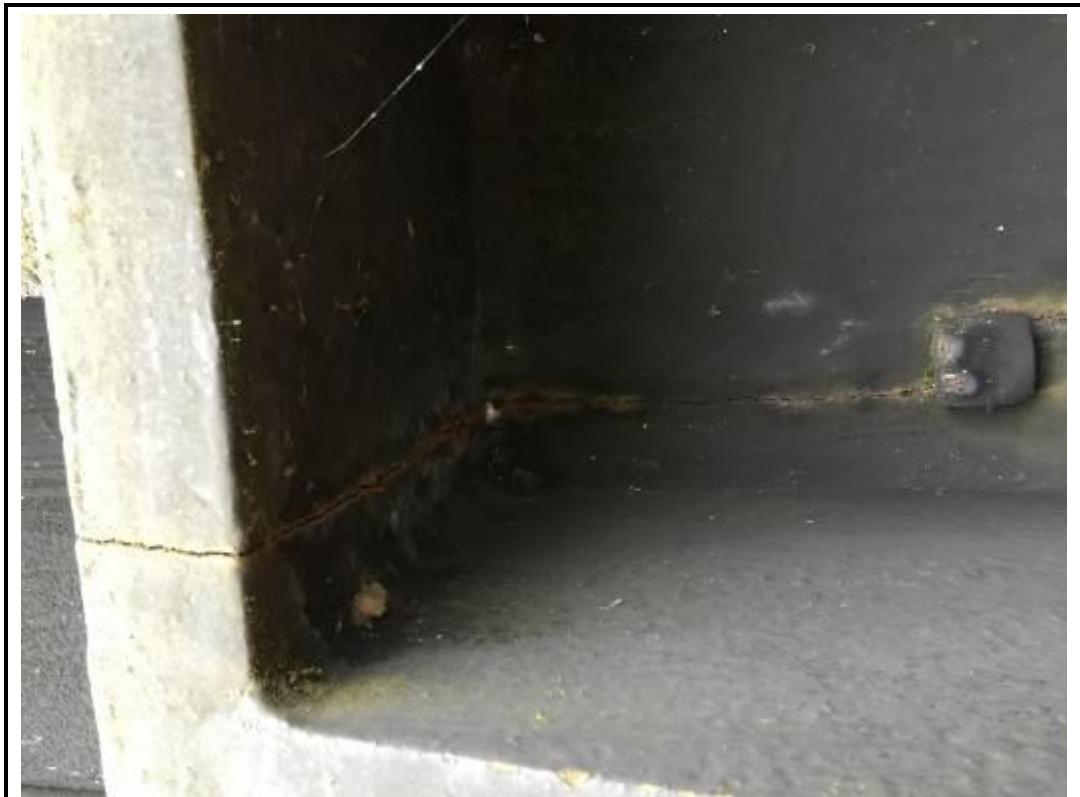
A fracture was noted through the pier 3 downside box open up to 2mm ([Photo 48](#)).

Photo 48. View of fracture through pier 3 downside box.
