PRINCIPAL INSPECTION

Lydbrook Rail Bridge B976

21st – 24th March 2016

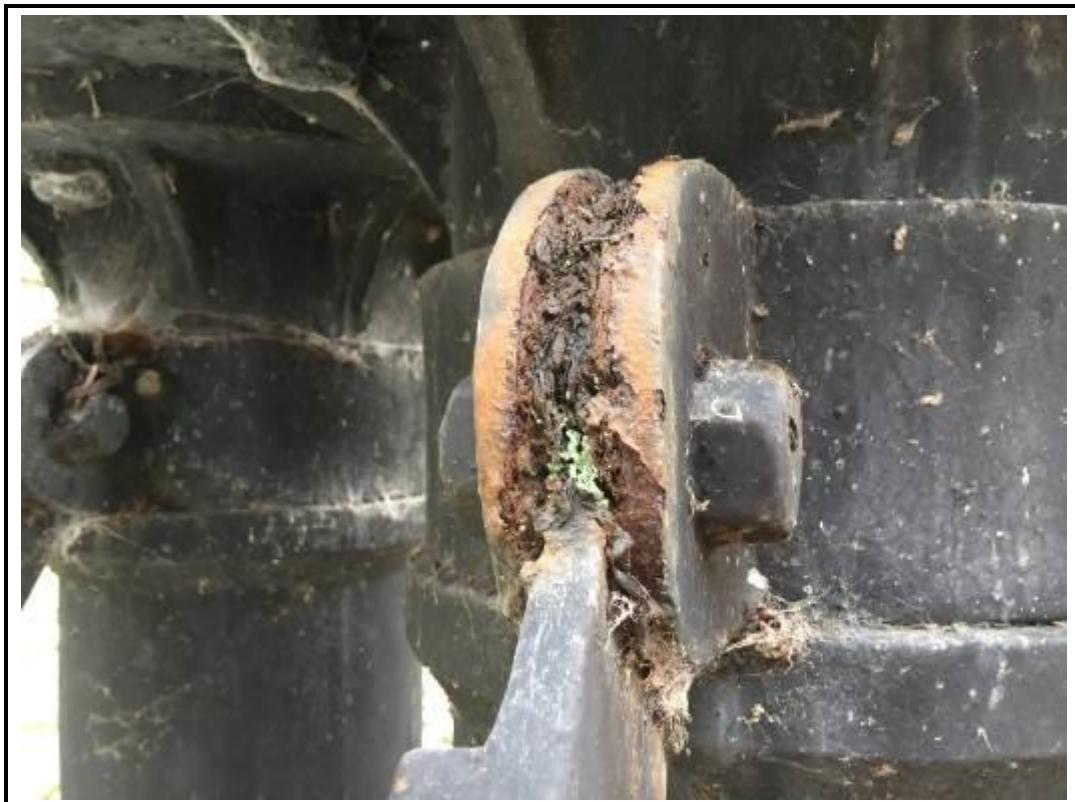
Lamination and corrosion was found to the majority of bracing connections ([Photo 49](#)).

Photo 49. View of typical condition of pier cross bracing connections.

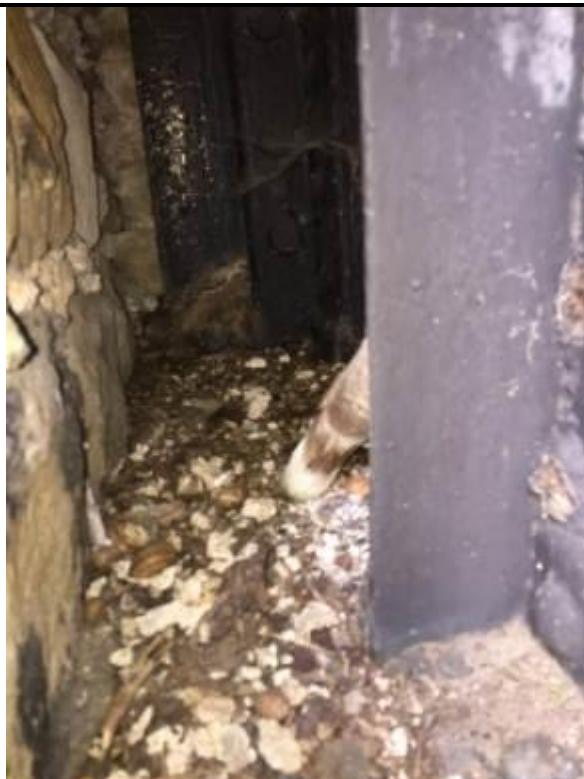
As mentioned in section 4.9 there are fractures in the abutments below the main beams at both ends. The bearing shelves are in good condition apart from amassing minor amounts of debris ([Photo 50](#)).

Photo 50. View of typical condition of bearing shelves.

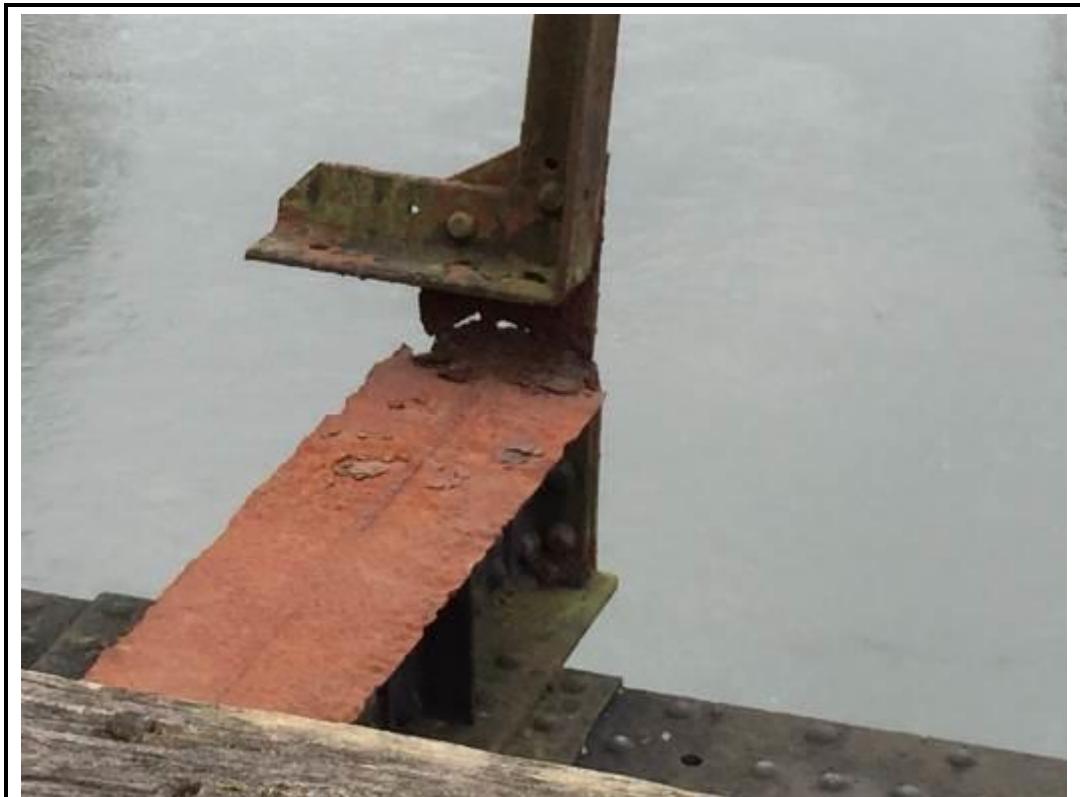
The upside handrail is in poor condition. The high mileage third was removed during the examination as it was collapsing over a footpath ([Photo 53](#)). The remaining section is suffering from severe corrosion and loss of section to the brackets that hold the uprights to the main girder ([Photo 54](#)). The support brackets from the LM end to pier 3 have collapsed and deformed causing the handrail to fall into the bridge ([Photo 55](#)).

Photo 54. View of corrosion and LOS to base of handrail uprights.

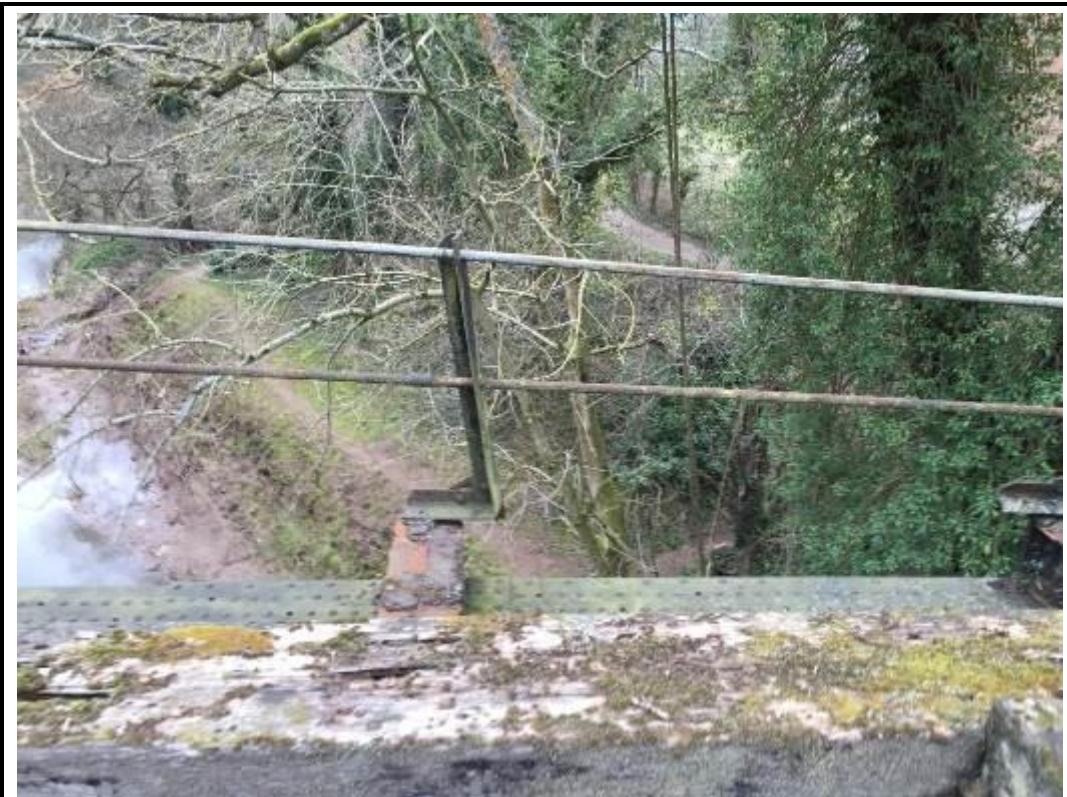
Photo 55. View of collapsed upright brackets on US handrail.

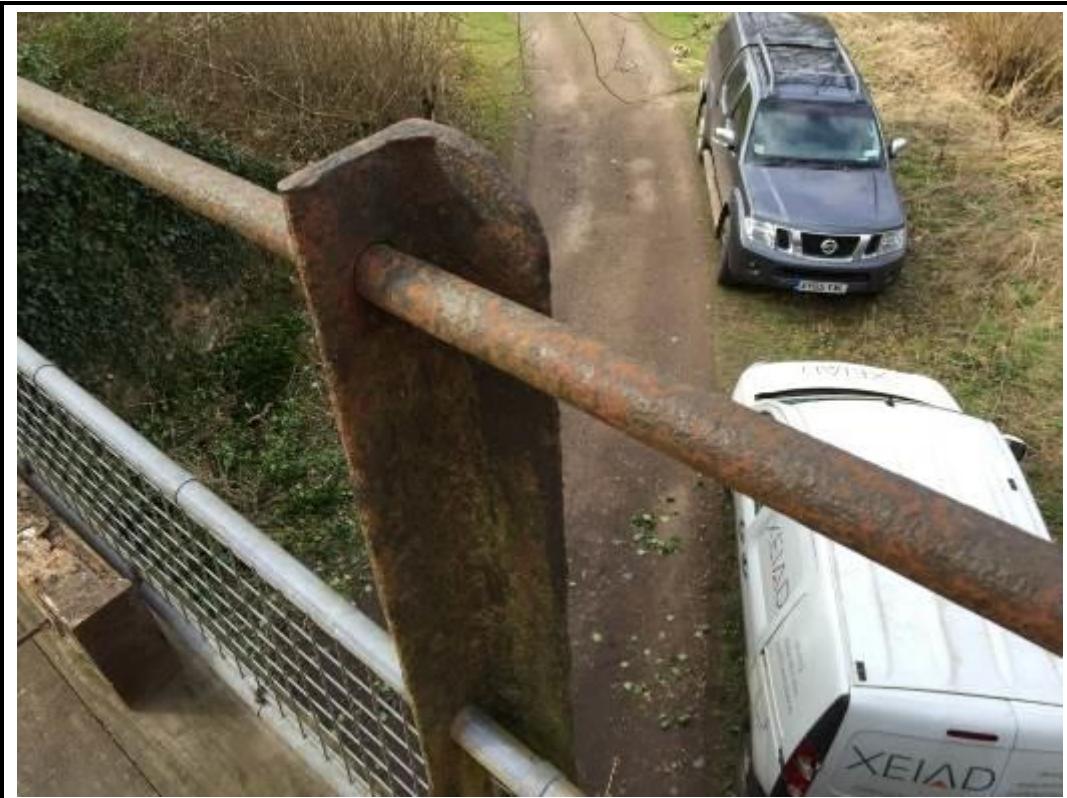
The downside handrail show paint loss throughout allowing corrosion and pitting to 2mm depth ([Photo 56](#)). There is a small section of deformed galvanised mesh with a missing bracket above pier 4 ([Photo 57](#)).

Photo 56. View of corrosion and pitting to downside handrail.

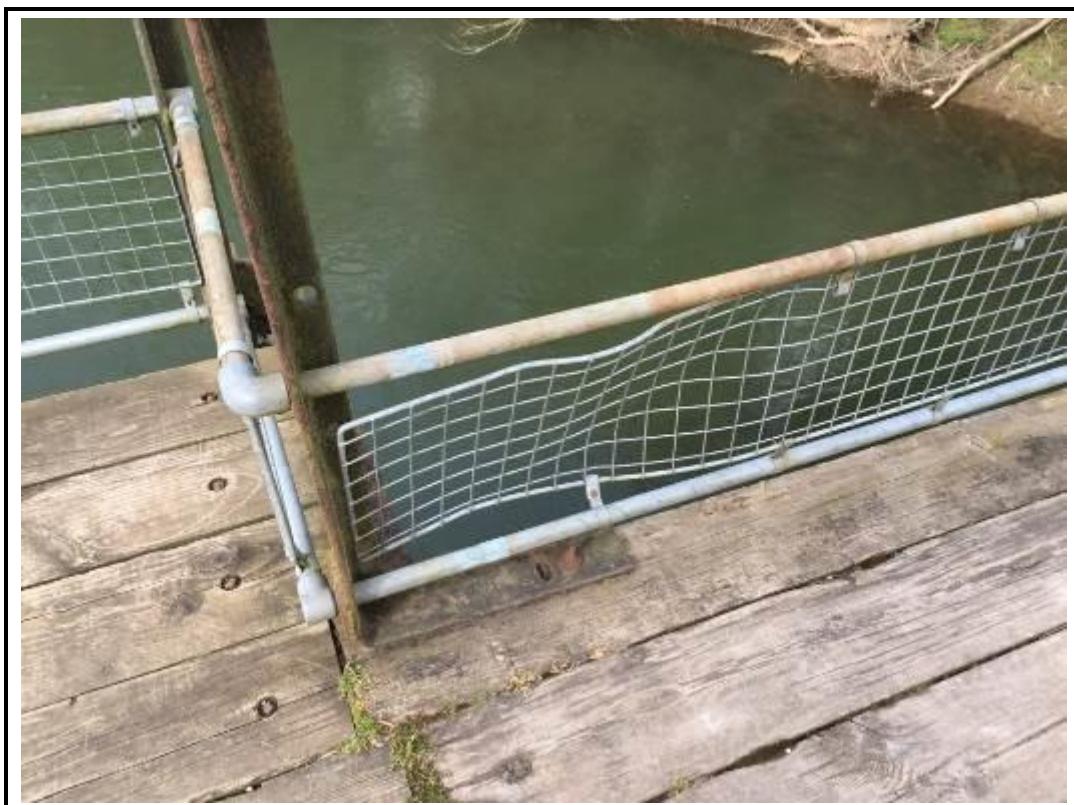
Photo 57. View of deformed galvanised mesh to downside handrail.

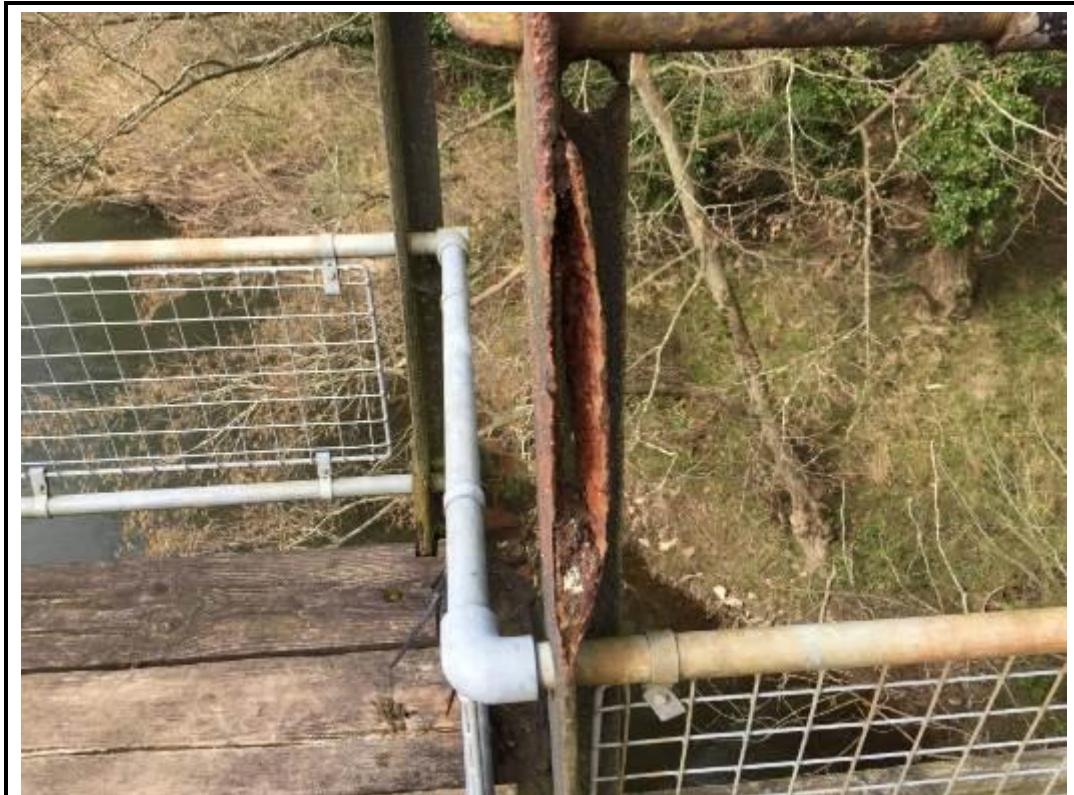
Rust jacking is also present on some of the uprights, the worst affected is situated above pier 5 ([Photo 58](#)).

Photo 58. View of rust jacking to downside handrail upright.

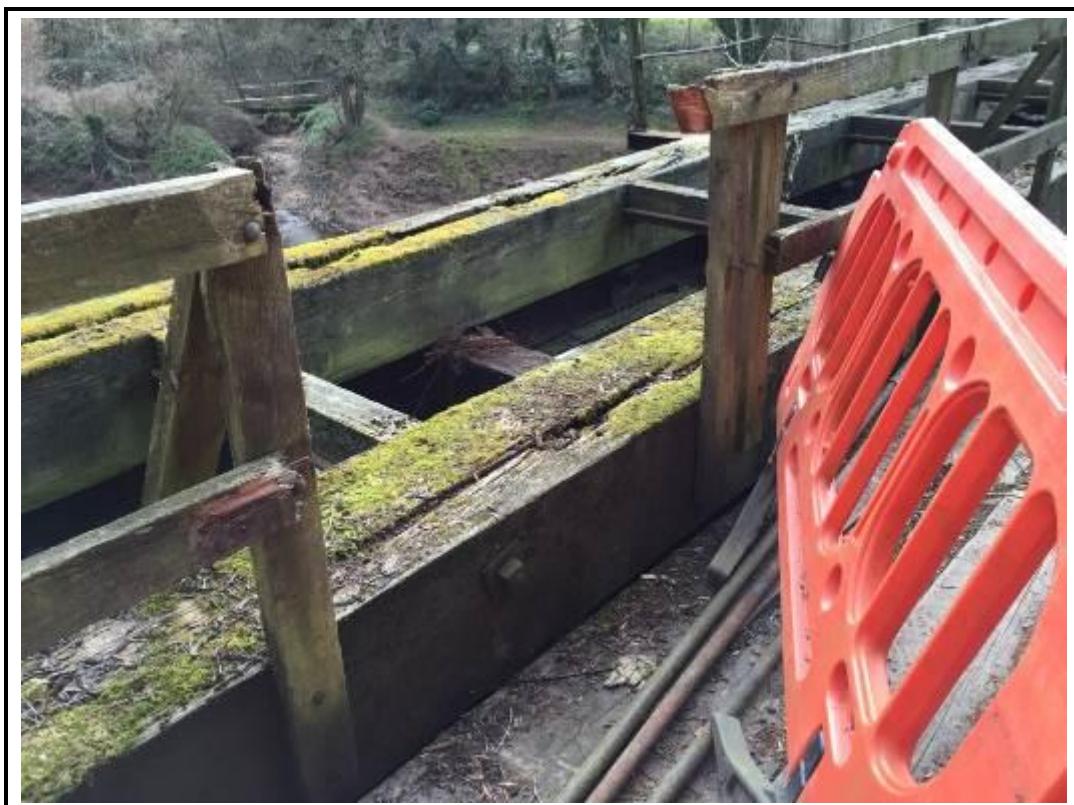
There is a missing section above pier 6 ([Photo 63](#)).

Photo 63. View of missing section to timber handrail.

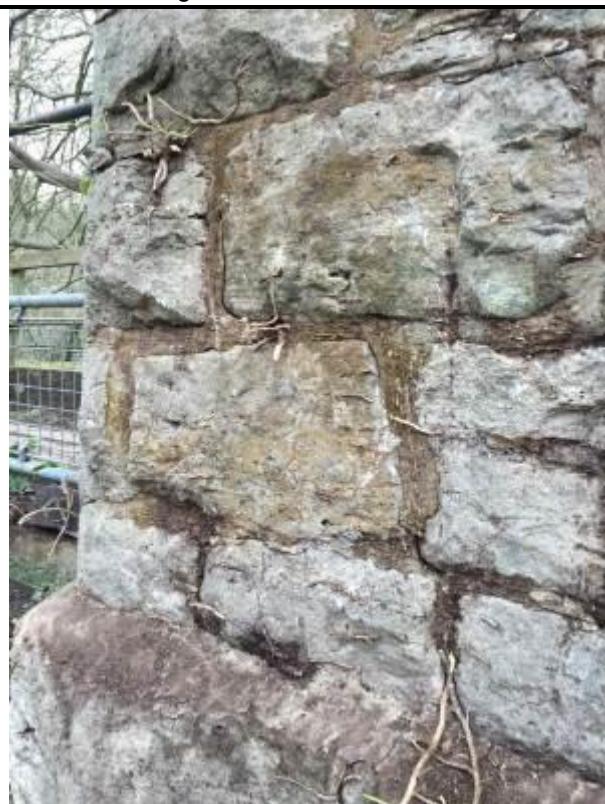
Diagonal step fracture 700mm form high mileage end, 1.2m L open 1-3mm ([Photo 64](#)).

Photo 64. View of fracture to low mileage downside parapet.

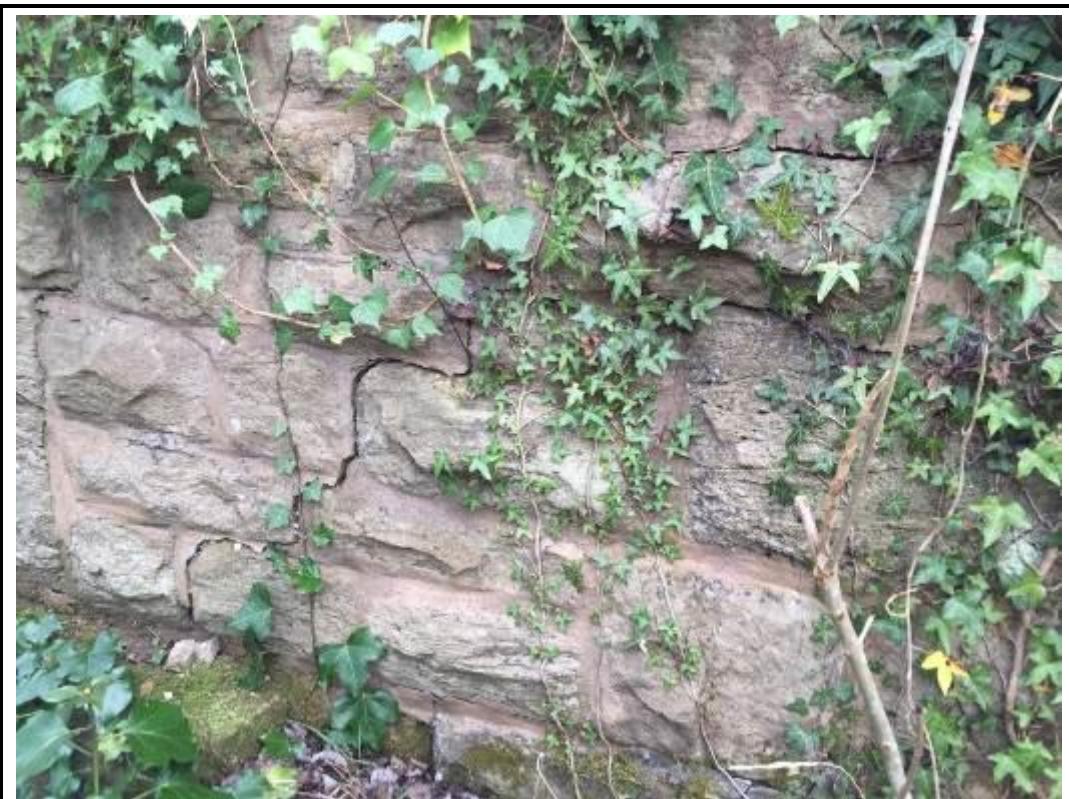
Diagonal step fracture at centre, 2.5m L open 10mm ([Photo 65](#)).

Photo 65. View of fracture to low mileage upside parapet.

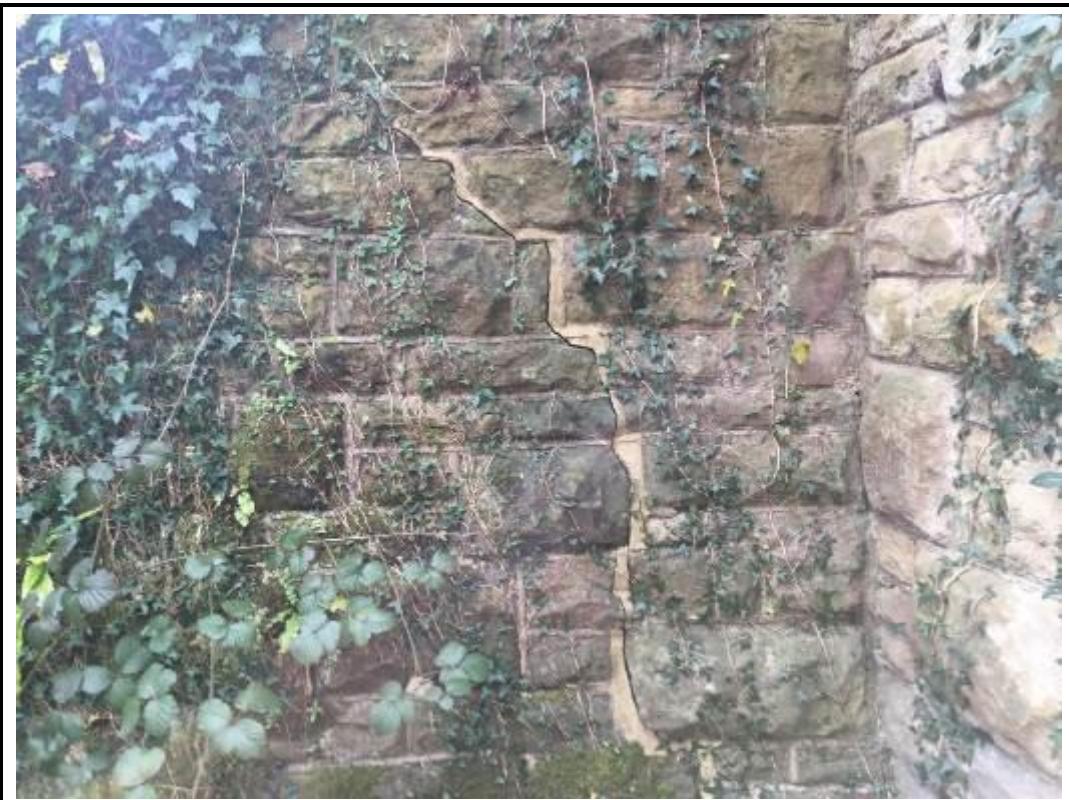
A diagonal step fracture was noted to the low mileage upside wall. Located 0.7m from downside end, 3.5m L open 10mm max. The fracture was re-pointed but has since re-fractured ([Photo 66](#)).

Photo 66. View of fracture to low mileage upside wing wall.

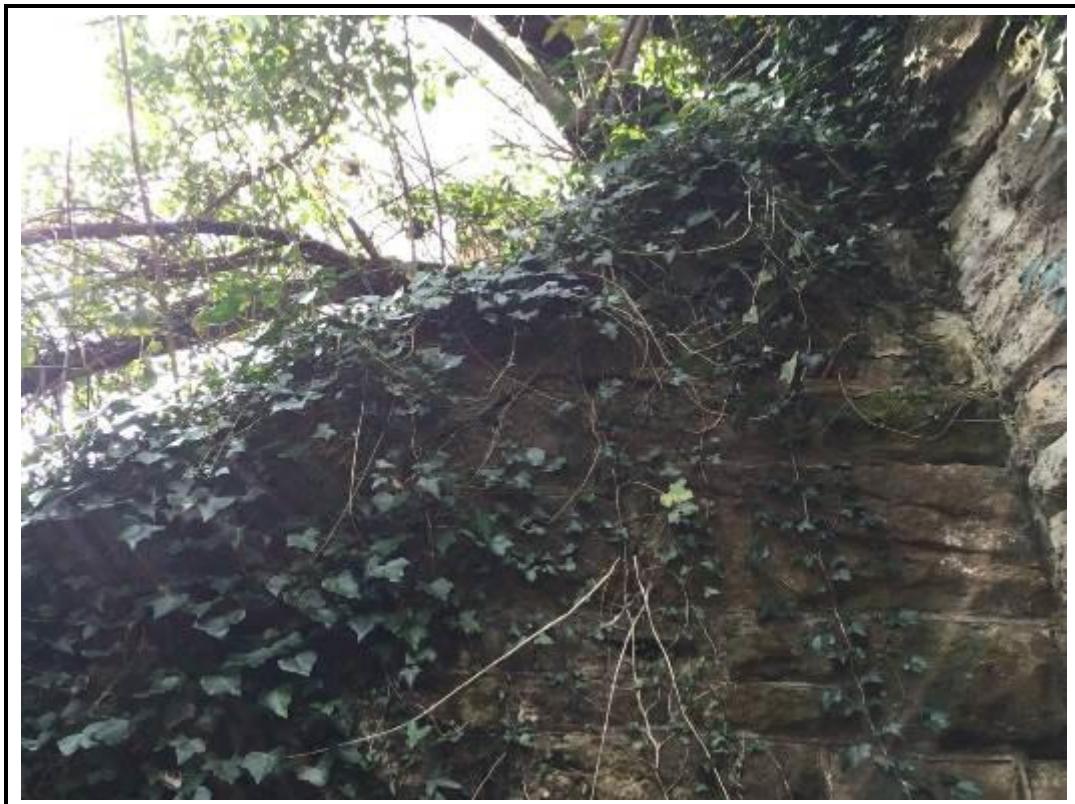
Diagonal fracture located below the coping on the low mileage upside wall, 1.5m L open 10mm max ([Photo 67](#)).

Photo 67. View of fracture below coping, LM upside wing wall.

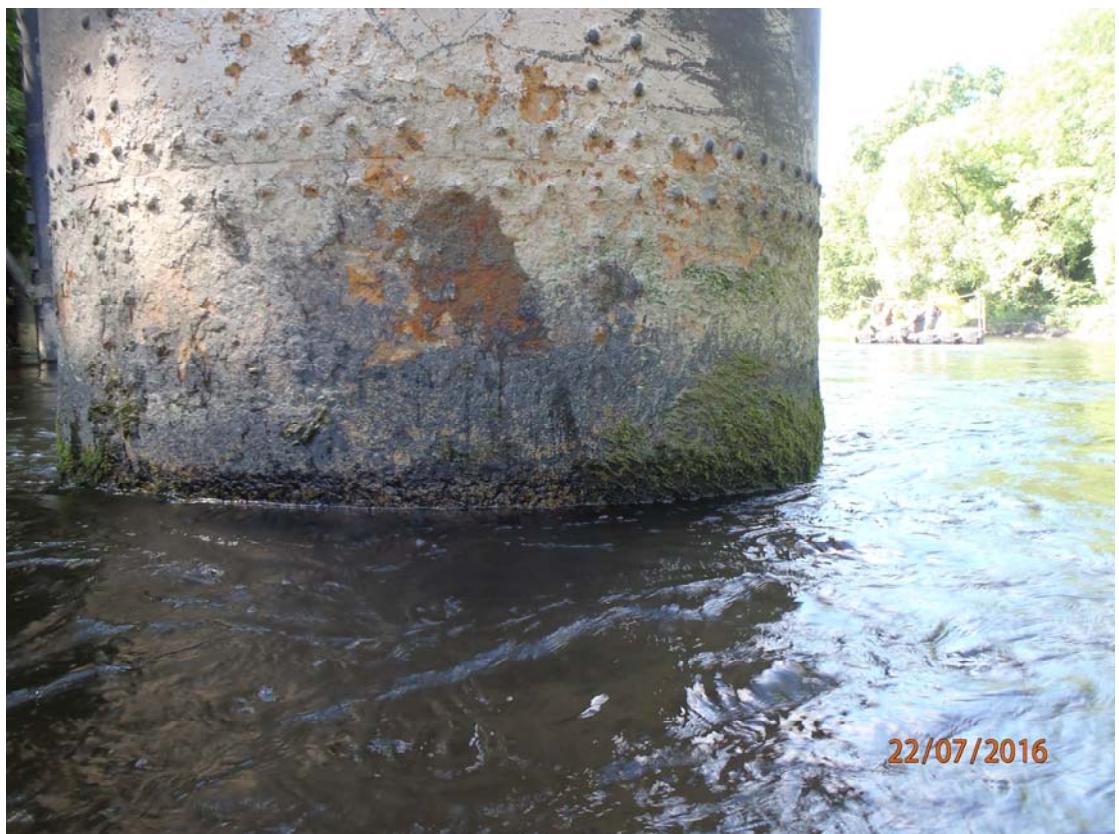
All four 2000mm \varnothing cylinders were found to be fair with paint loss and lamination blistering/ pitting occurring from bed level to 500mm above normal water level; corrosion was found to be up to 3mm in depth and covered a total of approximately 3m², concentrated at the upstream face of the upstream cylinders ([Photos 8 to 11](#)).

Photo 8 – View of Corrosion to Upstream Cylinder, Pier 4

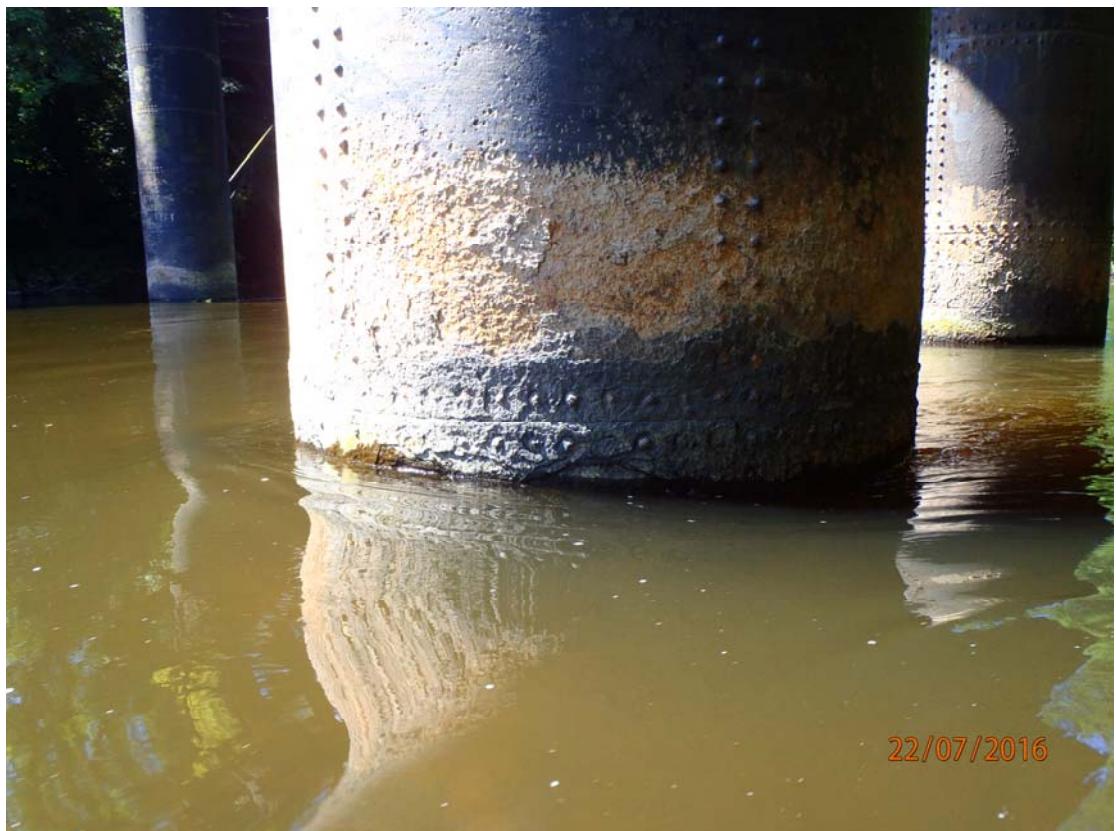
Photo 10 – View of surface corrosion / protective paint loss Upstream Cylinder, Pier 5

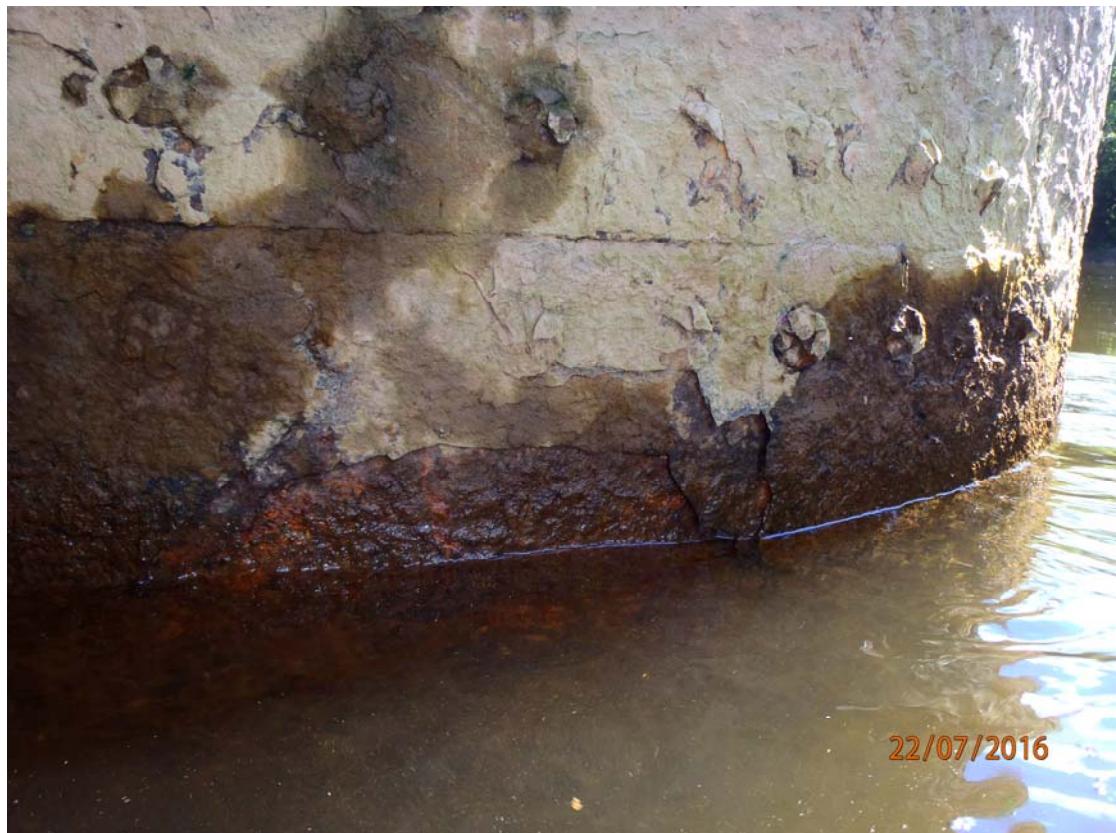
Photo 11 – View of surface corrosion Downstream Cylinder, Pier 5
