B976 LYDBROOK RAILWAY BRIDGE FEASIBILITY STUDY

B976 Revision D

August 2017

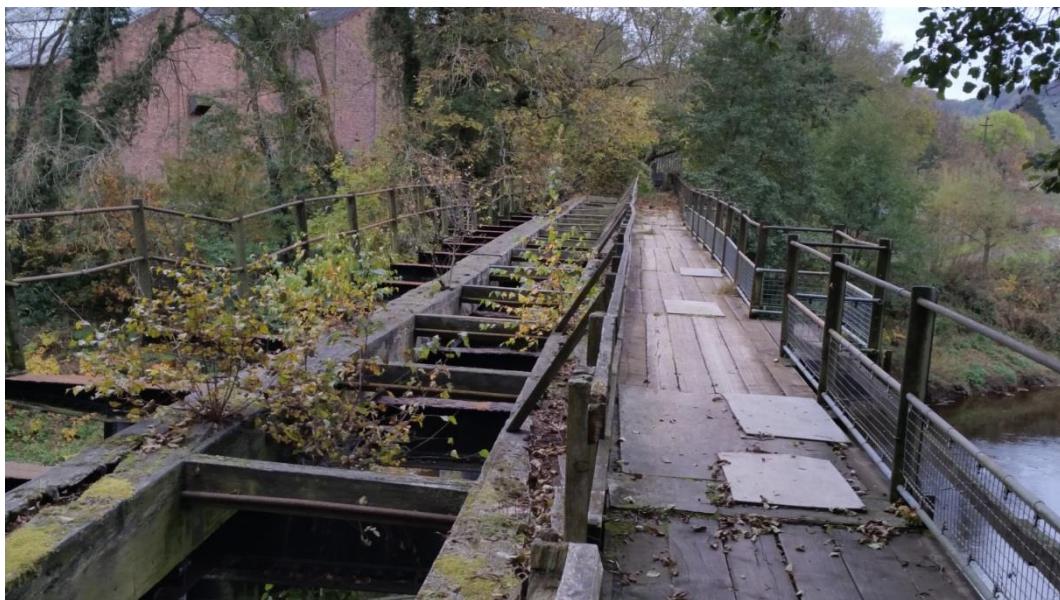
Picture 4. Walkway and handrailings

The footway is located at the western edge of the deck. The walkway is made of timber planks which span between the transverse beams. The timber planks are placed on and bolted to the top flange of the transverse beams with a pair of bolts at each end. The planks are severely rotten and several planks are completely missing and replaced with plywood panels which make the use of this walkway by pedestrians unsafe.

The decay of the timber walkway has been a problem with significant impact on the maintenance cost of the footway since it was opened. The main maintenance works were carried out in 1992 where the timber planks were taken up and replaced. Even though the new planks were treated to improve its lifespan, the maintenance works on these elements has been continuous. The last main repair works on the walkway were carried out in 2009 where 43 No timber planks were replaced. The historical maintenance records of the structure make it clear that the environmental conditions of the site must be considered when refurbishing the bridge.

The western parapet is made of three tubular rails which pass through 100x100x12 steel posts. Between the two bottom rails there are mesh panels connected to the rails with kee-klamp panels clips. The posts, which form part of the former railway bridge handrails, are bolted to the timber planks and connected to the transverse beams with a gusset plate. In 1992 short steel angle sections were welded on to stiffen up the gusset plates. The steel angles are in fair condition but the gusset plates are badly corroded.

An appraisal of the handrails in 2002 determined that **the handrails do not comply with BS 7818:1995 Specification for pedestrian restraint system in metal, on three dimensional issues**, the clear height between the top and the middle horizontal rails, the height of the top rail above the footpath, and the mesh sizes in the panels between the middle and the bottom rails. This appraisal found that the parapet is structurally understrength in relation to the horizontal rails, the angle posts and the strength of the gusset plates.

The eastern parapet is made of timber posts fixed to the timber bulks that previously supported the rail track and two horizontal wooden rails. **The wood is severely rotten and the posts are loose.**

At the eastern edge of the bridge deck there is an unused steel handrail made of two tubular rails and vertical steel posts. This **handrail is completely corroded and its poor stability represents a risk for members of the public that use the river or the track that passes underneath the bridge.**

Based on the condition of the handrails it is suggested that **new pedestrian handrails complying with current standard should be installed**. If it is decided not to refurbish the bridge, at least **the eastern handrail should be removed to prevent its collapse onto the river or existing track.**

As indicated in point 4.2.1 the poor condition of the existing handrails and their failure to meet the required standards make their replacement the only possible option to open the bridge. The new handrail must comply with BS 7818:1995 Specification for pedestrian restraint systems in metal.

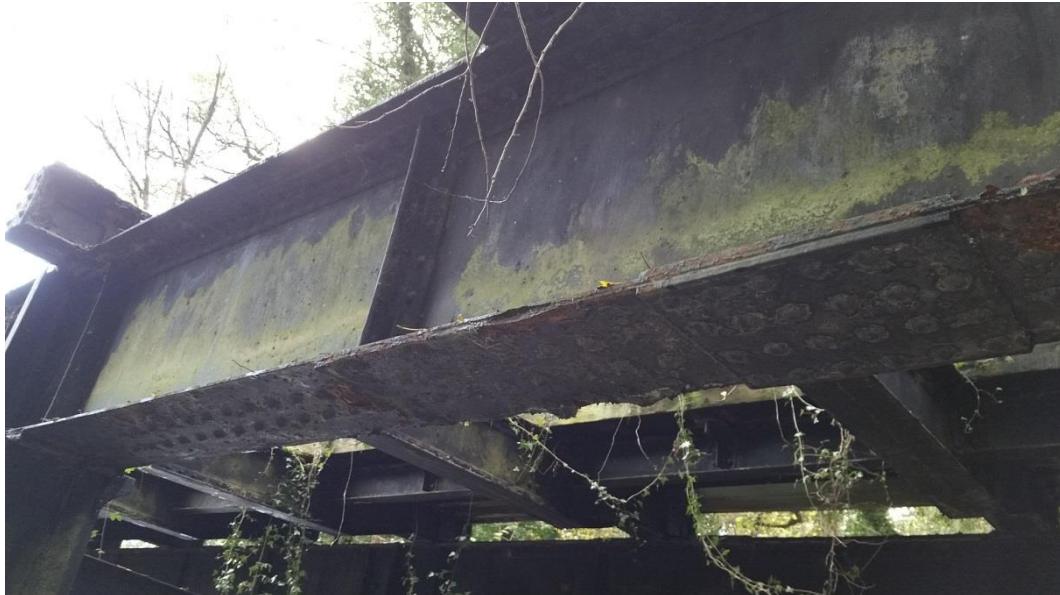
Picture 5 Detail of rust jacking on longitudinal girder

The girders are built-up girders with plates riveted together. Although the girders are in a general fair condition the bottom flanges present delamination due to a severe corrosion as well as a marked distortion induced by rust jacking. The 2016 PI report indicates that slight distortion was noted at the majority of joints with missing rivets.

Although an accurate survey would be necessary to determinate the actual strain of the plates, based on the visual appearance of the plates, it is possible to deduce that they have already reached the yielding point. The distortion of the plates has induced a significant tension in the rivets. This has implications on the safety of the structure as the elements would have become more brittle, and therefore its capacity to deform before failure.

Considering the stress-strain uncertainty of the bottom flanges and stiffeners and the consequences that a failure of these elements could have, it is recommended that an accurate assessment of these elements is undertaken before re-opening the bridge to the public.

To repair the rusting at the bottom flanges of the main longitudinal girders, a combination of flame cleaning, rivet removal and hammering could be used to get the rust out. However, it is possible that after removing the rust, a gap may appear between the plates. In this case, an inert filler material may be required to fill the gap. The replacement material may be recycled wrought iron or steel depending on the conservation requirements for the bridge.

The repair option described for the existing rusting may be possible if the distortion of the plates is not critical. Where the plates are badly distorted and delaminated, they may be removed (rivets drilled out) and replaced using hot set riveting so they can re-fixed.

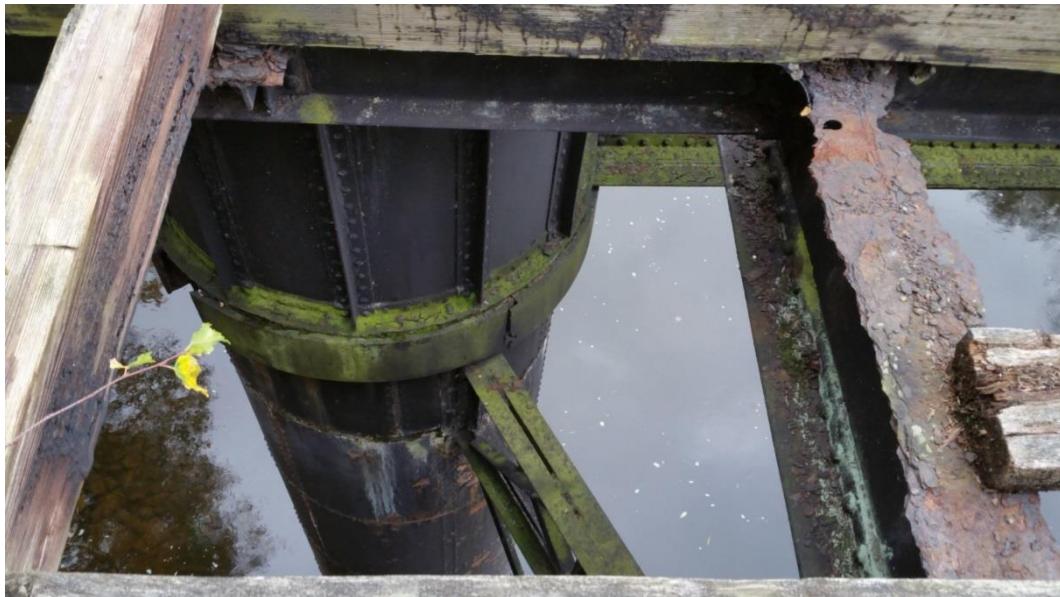
Picture 6 Detail of corrosion on top flange of transversal girder

However, the top flanges of the transverse girders (where the timber planks are bolted) are badly corroded with a severe delamination and knife edging (2016 PI estimates a loss of section of 35% at the top flanges).

Based on the dimension of the transverse beams, it may be said that the carrying capacity of these elements should be enough to carry the loads imposed by pedestrians once the top flanges are replaced.

Due to the poor condition of the top flanges it is vital to repair them before opening the bridge. The first option is to flame cut the top flanges and replace them with back to back bolted steel sections. After discussing with different contractor about this option, it has been agreed that it would be cheaper to replace the whole girder with a new steel girder as it would speed up the process.

The top flanges of the transverse girders are in a really poor condition. The works to repair the top flanges (cut and replace them with back to back steel angles) would be more difficult and expensive than to replace the entire girders with new steel beams. Therefore it is advised that the transverse girders are replaced.

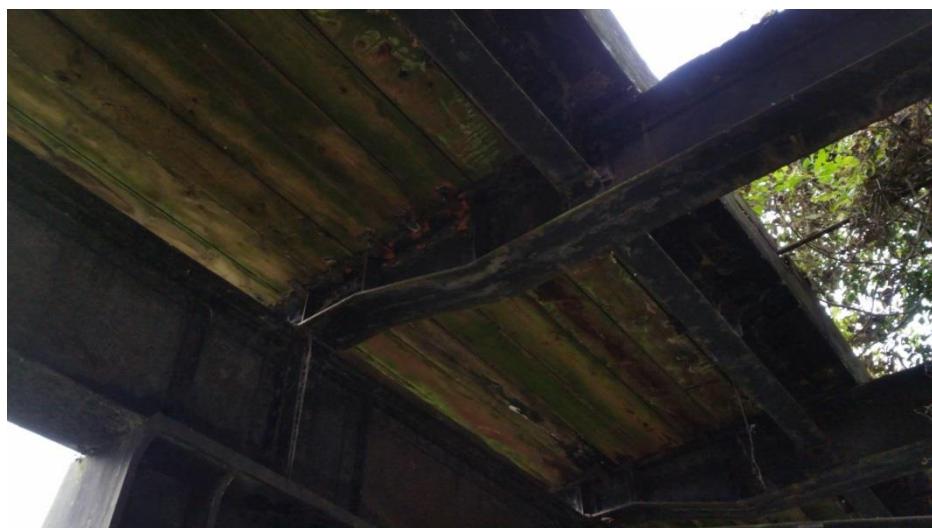
Picture 7 Transversal and secondary girders

A pair of longitudinal wrought iron built-up girders span between the transverse girders under the wood bulks. These girders are in fair condition although some connections to the transverse girders are badly corroded. Although these elements had importance when the structure was designed as a railway bridge (as they carried the load of the rail track), **as a footbridge, these elements are fairly redundant.**

These beams present a sound condition. Therefore the works would be limited to repairing some connections and repainting them.

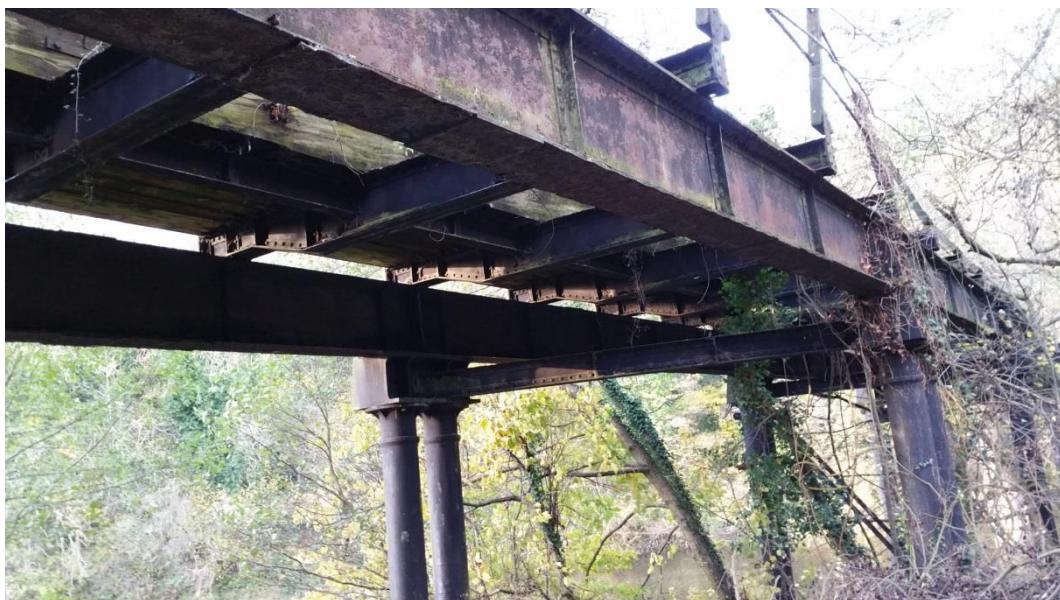
Picture 8 Cast Iron columns

The cast iron columns are made of hollow circular sections connected with split sleeves bolted together. At the top, the columns are bolted to a cast-iron "table" which receive the main longitudinal girders. The head of the piers are braced with a transverse built up wrought iron beam. The taller piers (located into the water course) are transversely braced with a cross made of angle sections. The 2016 PI found some of the crosses broken. These elements played an important role to prevent buckling and improve the capacity of the piers under the heavy loads imposed by the trains. Although these elements are not structurally necessary if the bridge is used as a footbridge, they should be maintained as they could be used to support the crash deck at the same time increasing the stability of the bridge.

In general all the piers are in a sound condition so that they could be used to support a new deck without significant repair works.

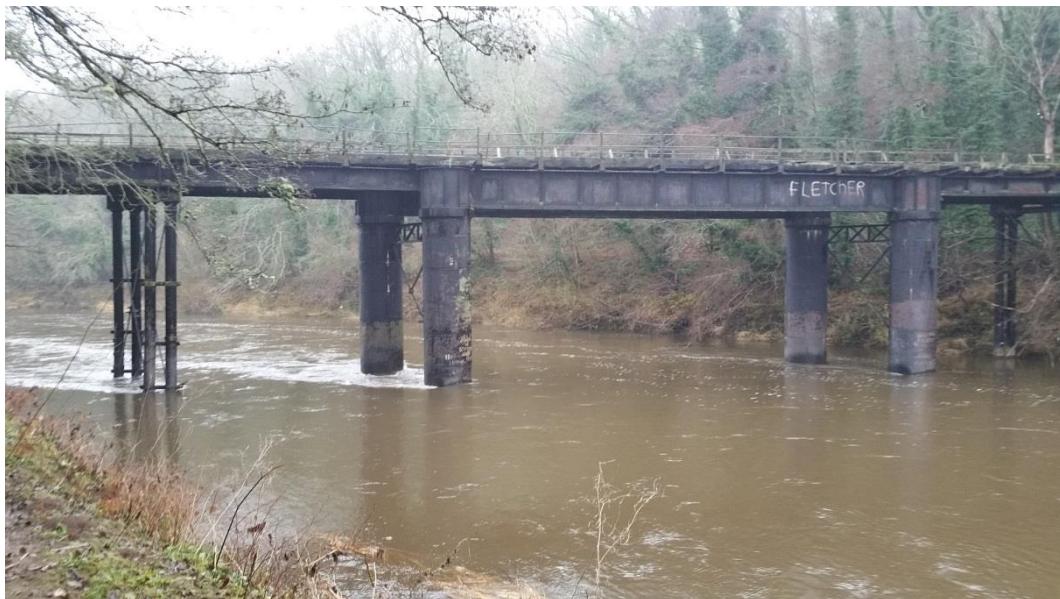
Picture 9 Caissons at central span

The central span is supported on two pairs of caissons made of wrought iron plates. The caissons are filled with concrete up to the level of the longitudinal girder (the caissons are hollow above this level). At the interface between the hollow and the filled section, there is a ring which has broken. Considering the position of this ring (where the caissons are filled with concrete), it can be said that these elements are purely aesthetic.

Some paint loss and pitting has been identified at the water level of the caisson.

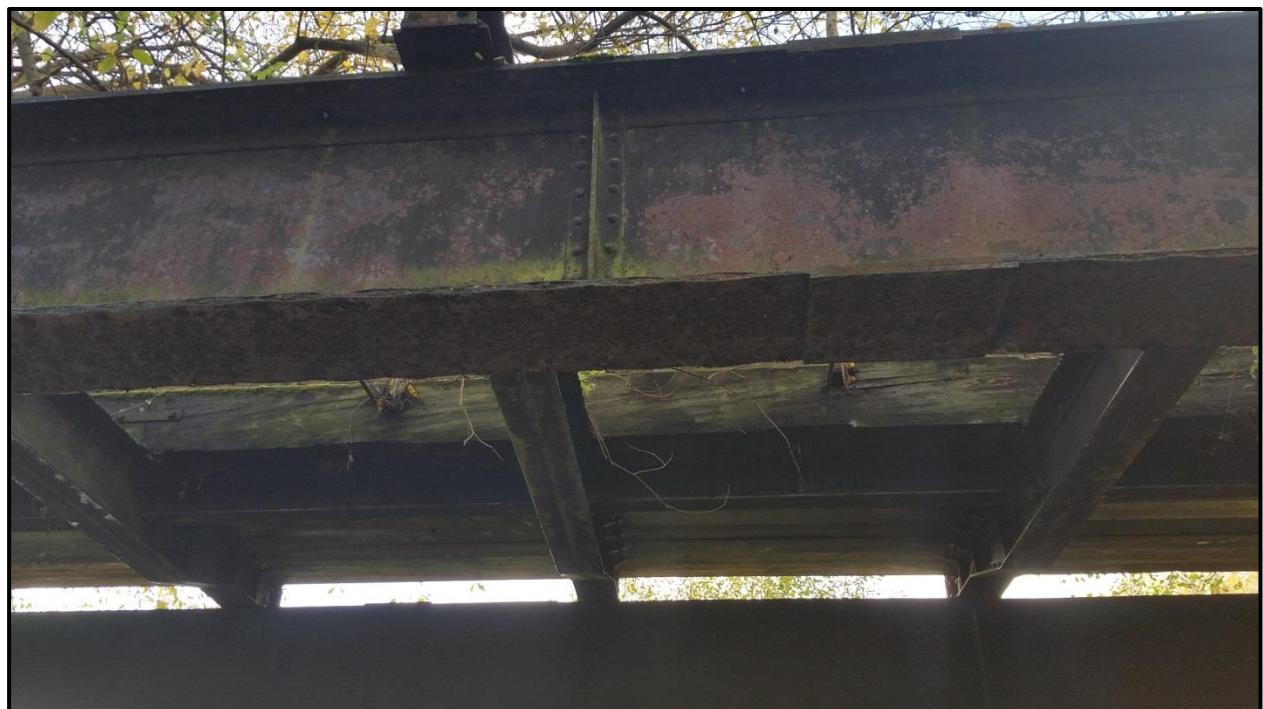
Picture 17. Jack rusting in main girders

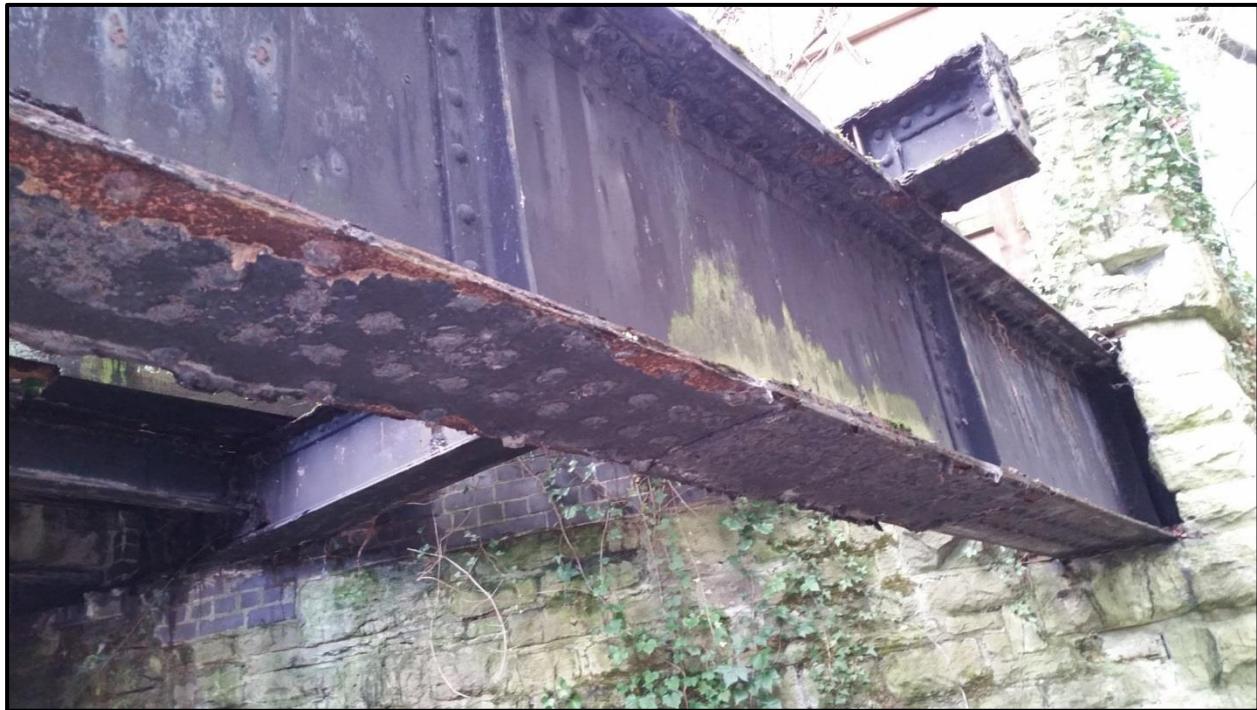
Picture 18. Main girder bottom flange

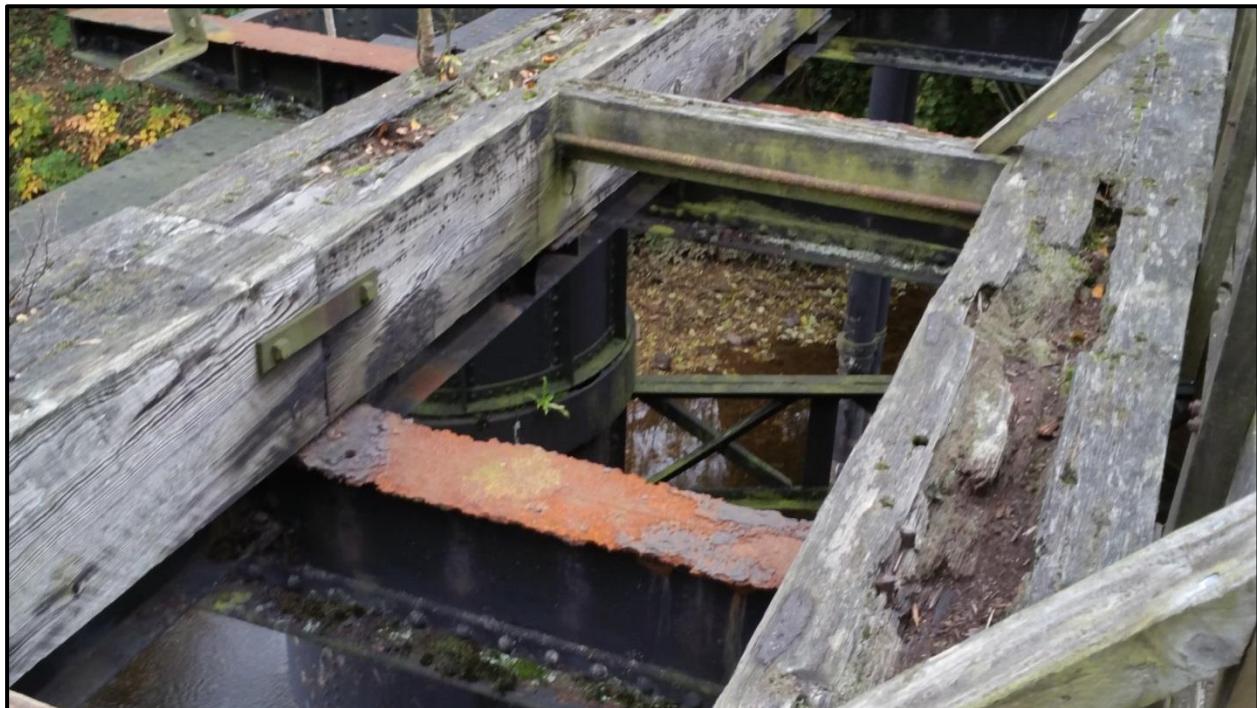
Picture 19. Transverse beam. Top flange

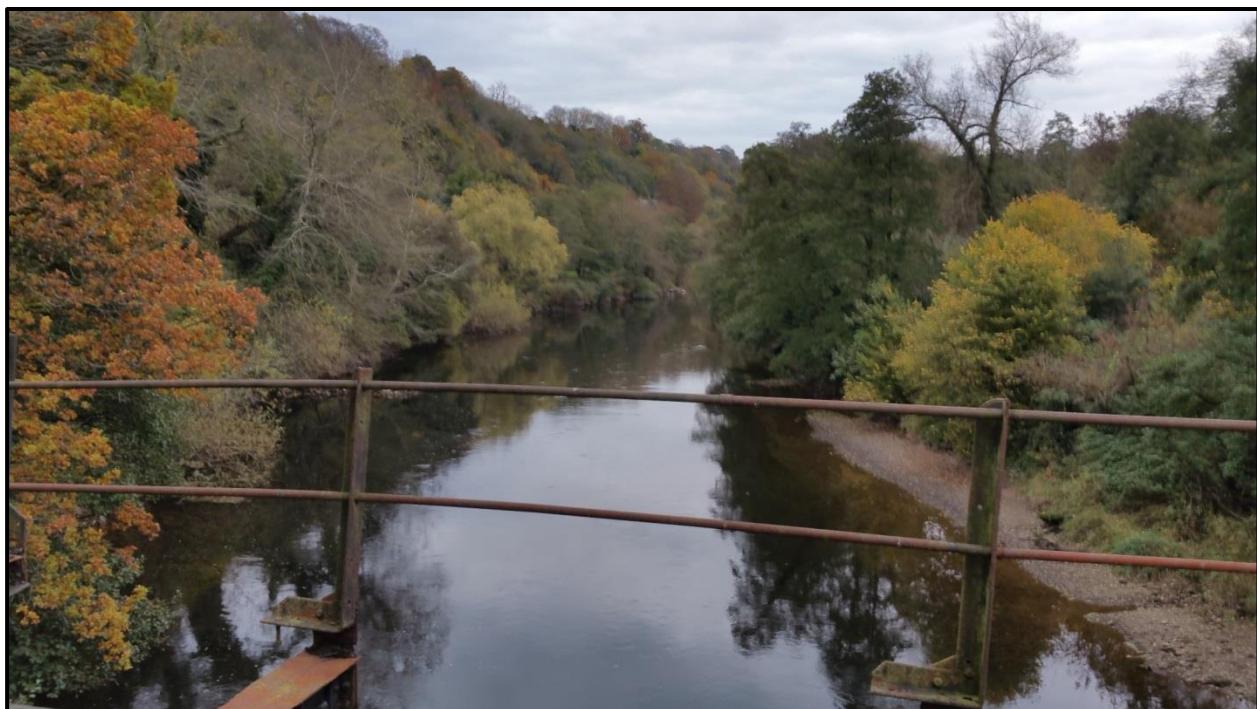
Picture 25. Railing at eastern side
