B976 LYDBROOK RAILWAY BRIDGE

RISK ASSESSMENT

B976 Revision A

January 2018

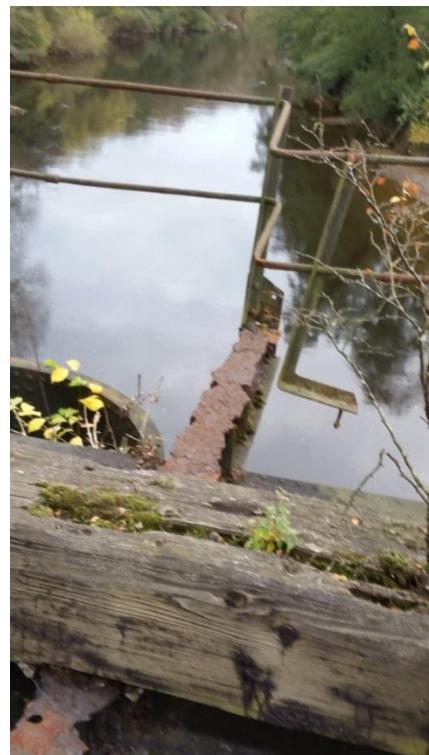
The upstream parapet is made of two tubular rails supported by steel posts spaced 2400 mm. The posts are connected to the bridge with a gusset plate. The gusset plate is the only element that keeps the parapets attached to the bridge and its failure will result in the parapet falling into the river or track. The gusset plates have suffered a severe corrosion which have produced a significant loss of their section. In 2006 a section of the parapet located next to the northern bank fell into the river resulting in emergency works to remove another section of parapet that remained attached to the bridge.

Therefore, it is considered that in their current condition, the gusset plate cannot hold the weight of the post and could fail at any time. Each post weighs thirty kilograms without including the tubular rails, this makes them a high risk to members of the public.

photo 1- Post loose

The upstream parapets and walkway represent a high risk. Given the impracticality of repairing them in future refurbishment works to the bridge, it is recommended to remove them within a period of six months to eliminate the risk.

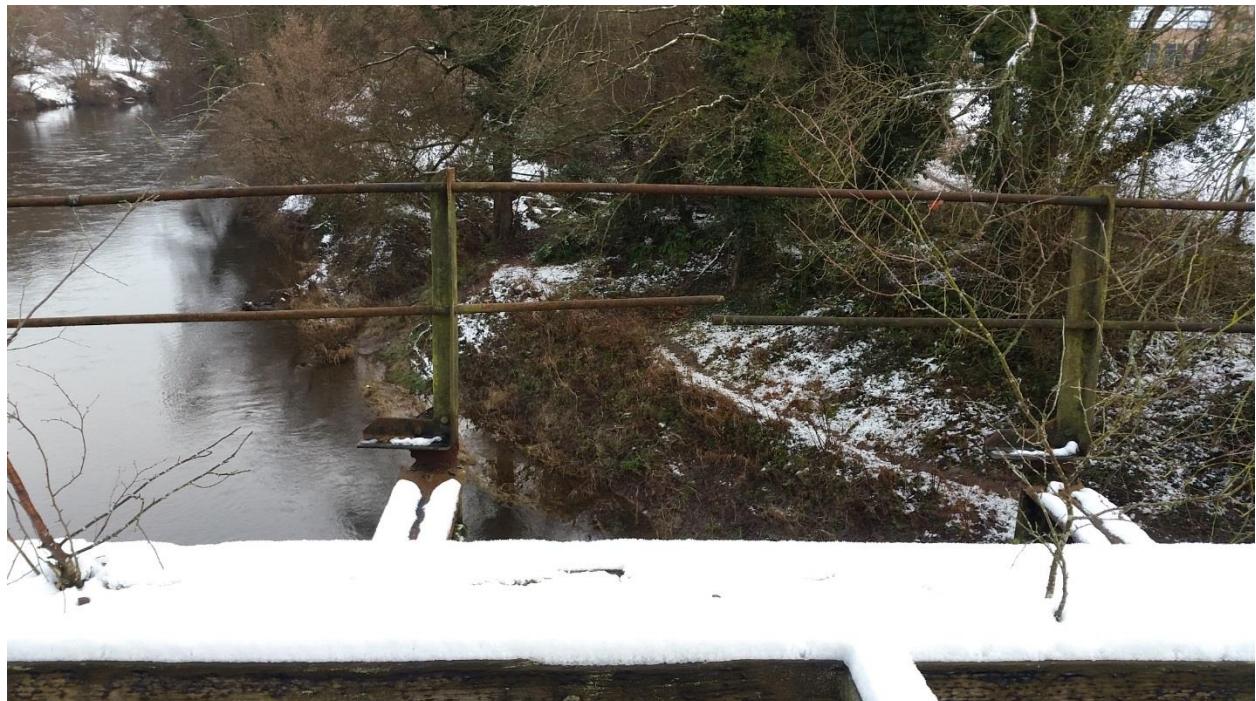
Given the high risk that the upstream parapets represent to members of the public, action must be taken to avoid the risk as the current risk is not acceptable.

photo 2- Upstream parapet

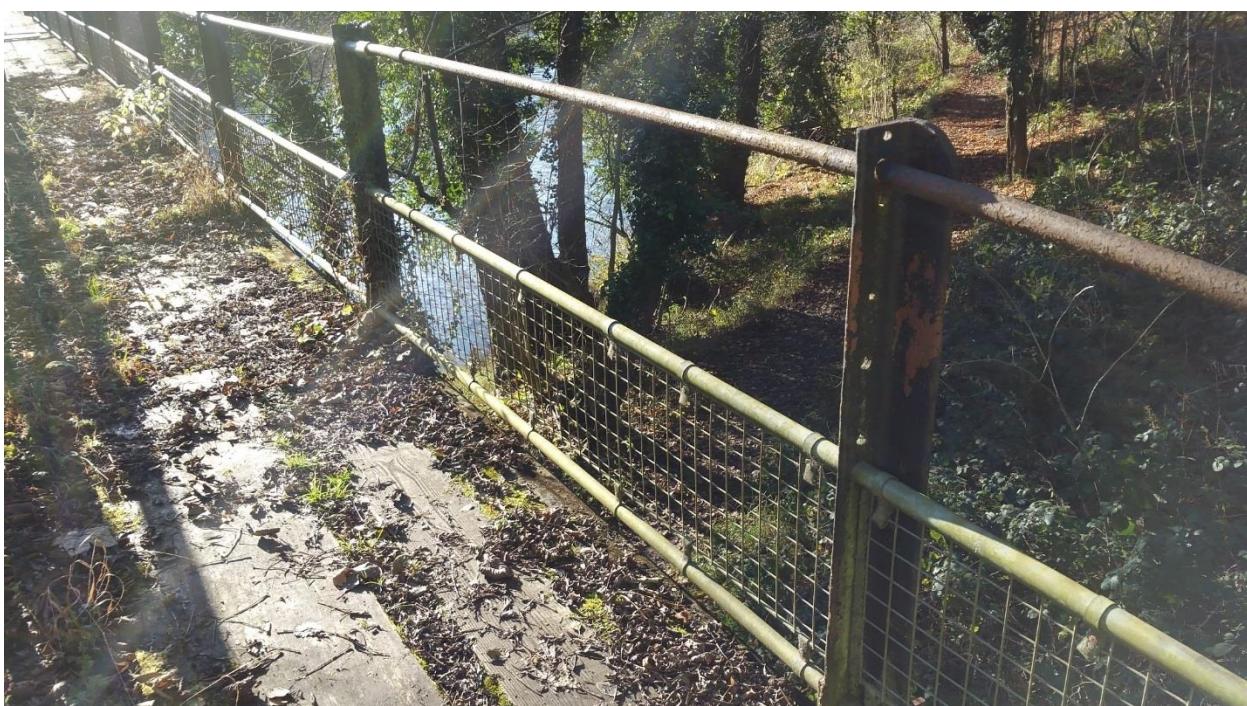
Originally the downstream parapet has the same configuration that the upstream parapets. However, works have been previously completed on this parapet. In 1992, the old gusset plate that connect the parapet to the bridge were strengthened using a steel gusset plate. A third horizontal tubular rail was incorporated to reduce the vertical space between them, and kee-klamp panels were installed. However, an appraisal of the handrails in 2002 determined that the handrails do not comply with BS 7818:1995 "Specification for pedestrian restraint system in metal". This appraisal found that the parapet is structurally understrength in relation to the horizontal rails, the angle posts and the strength of the gusset plates.

Like the upstream parapets, the collapse of the downstream parapet could produce a fatal injury to members of the public using the river Wye or track. However, **the failure of this parapet in its current condition is extremely unlikely, this means that they only represent a low risk to members of the public.**

photo 3- Downstream parapet

At present, the downstream parapet represents a low risk. However, it will deteriorate if no maintenance works are completed. In addition, they do not comply with current standards which makes them unsuitable.

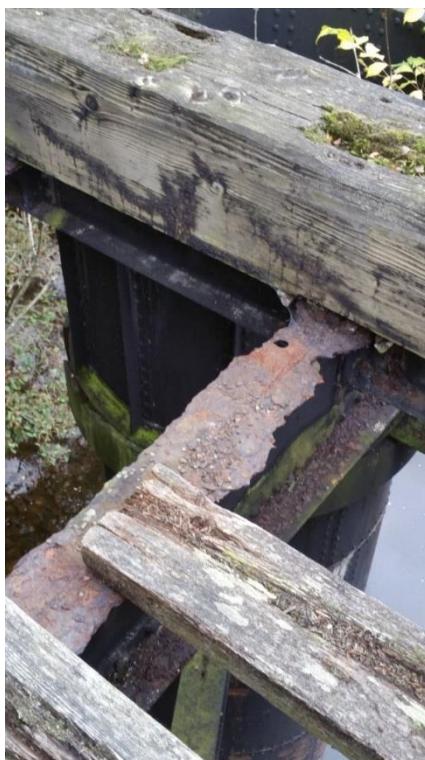
The top flanges of the transverse girders (where the timber planks are bolted) are badly corroded with severe delamination and knife edging. The failure of one of these flanges will result in the collapse of a section of 2.4m walkway which will result in 5 timber planks and pieces of steel falling into the river. This is a significant hazard to the public.

The collapse of the walkway (including timber planks and/or top flanges of transverse beams) represent a high risk for members of the public using the river Wye or the track and action must be taken to eliminate the risk.

photo 4-Transverse beam

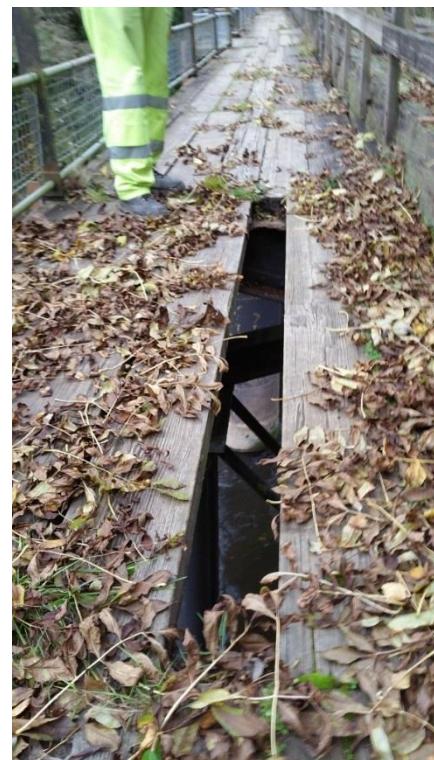
The walkway is made of timber planks which span between the transverse beams that span between the two main longitudinal beams. The timber planks are placed on and bolted to the top flange of the transverse beams with a bolt at each end. The planks are severely rotten and some have fallen into the river since the bridge was closed to the public. The planks are 2.4 m long with a section of 250x100 mm and weight approximately 20 kilograms each.

photo 5- Timber planks

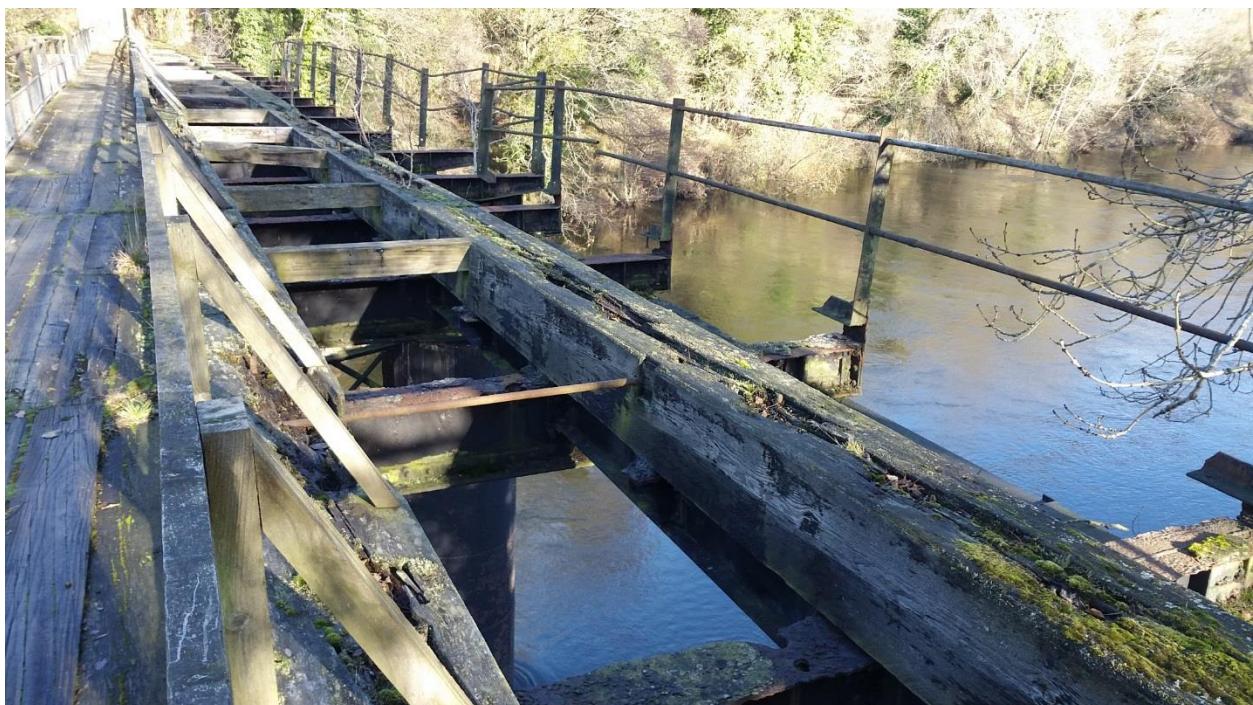
Next to the walkway there are two timber sleepers connected with a steel tie rod. The sleepers are supported by secondary longitudinal beams which span between the transverse beams. The sleepers have a section of 450x450mm while the flanges of the beams that support them are 200mm wide which leave part of the sleepers in the air. The timber of the sleeper is rotten which could cause pieces of timber fall into the river and onto the track.

In their current condition, the sleepers represent a medium risk to members of the public. However, if no action is taken to reduce their deterioration they will become a high risk within 1-2 years.

photo 6-Timber sleeper

The timber sleepers are elements that formed part of the rail track but will need to be removed if the bridge is to be refurbished as a footbridge. Additional inspections would be needed to establish the moment they become a high risk as a consequence of their deterioration. Given the ambient conditions in the Wye Valley, it is considered that they will become a high risk within one to two years.

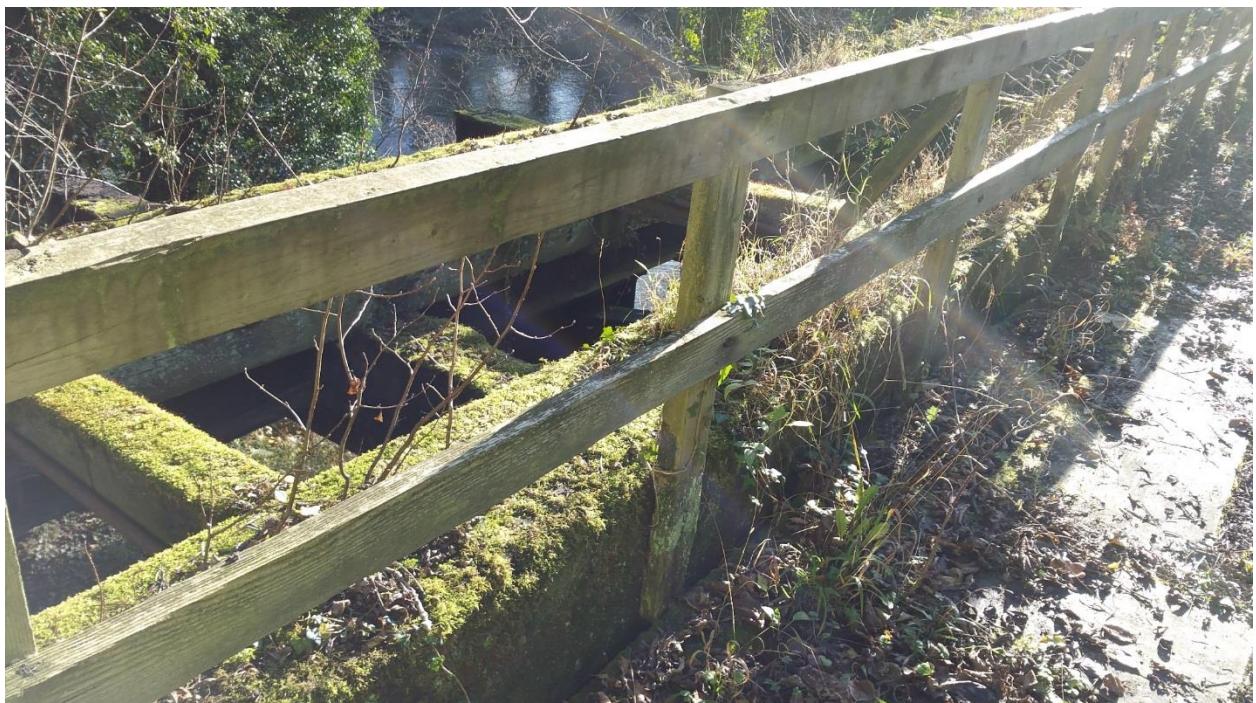
The inner edge of the footway is protected with a timber parapet fixed to the timber sleepers. This parapet is made of timber beams with a section of 100x50mm. The parapet is loose and do not comply with current standards. However, **they do not represent a significant risk to the members of the public in their current condition.**

photo 7-Timber parapet

The inner timber parapet represents a low risk. However, it does not comply with current standards and will need to be replaced in the future if the bridge is re-opened.
