Memo

To: Gloucestershire County Council From: Alex Macdonald
Subject: **Northleach – Prison Copse Wall** Checked: Steve Carter
Your ref: Our ref:
Date: 30.11.2015

Following a request from GCC members of the Amey Geotechnical Team undertook a site visit to determine the current condition of the Northleach – Prison Copse Wall site on 25/11/2015. Previously the site has been inspected by the Amey Structures Team.

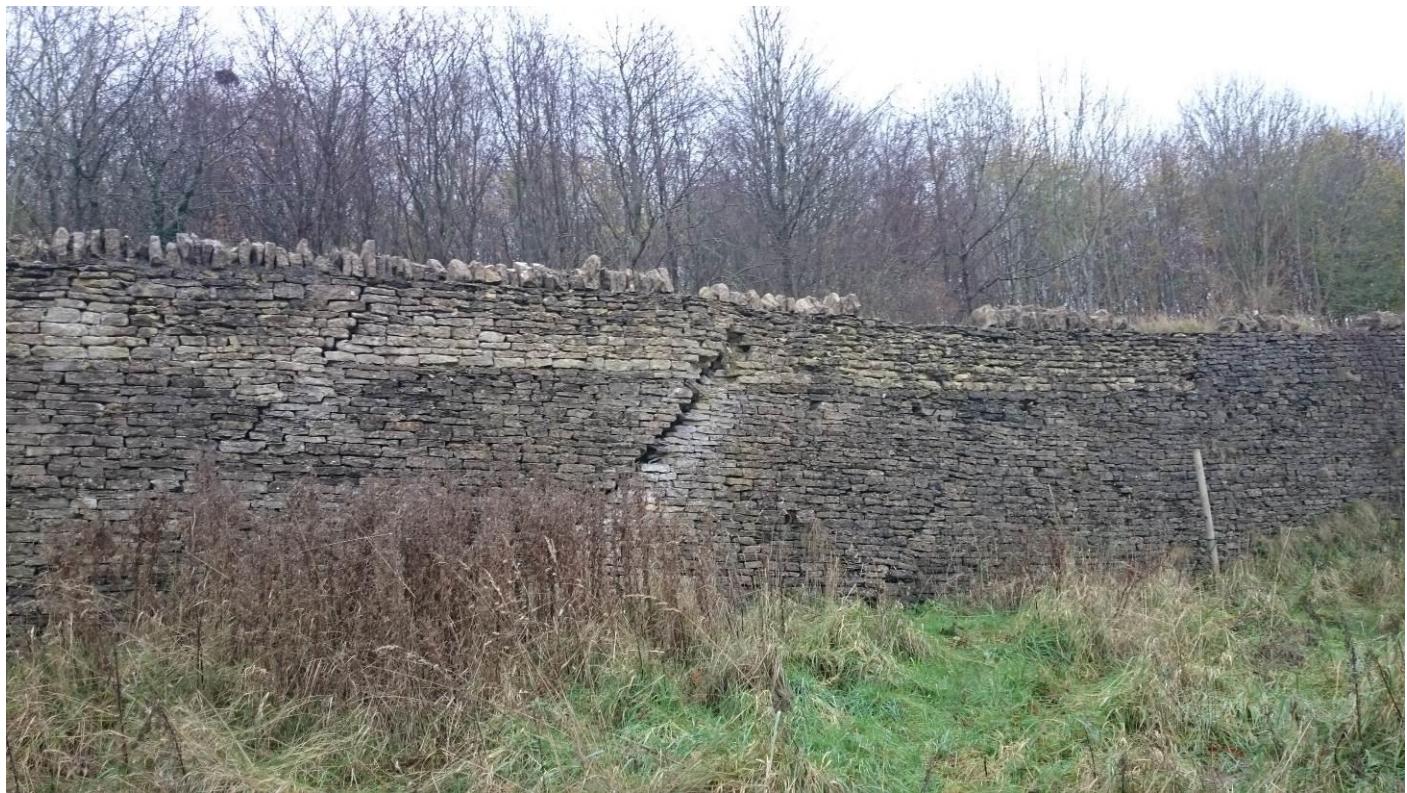
The retaining wall has become visibly distressed with 6 No. diagonal tension cracks located along the central third of the retaining wall (Photographs 1 and 2). The most severe section of defective retaining wall comprises an 8m section that has become detached from the rest of the wall and is leaning out towards the field (Photograph 3 to 5). The retaining wall exposed by the cracking indicates that the concrete behind the brick facing is at least 800mm thick.

Photograph 1. View to the north of the retaining wall cracking (25.11.2015)

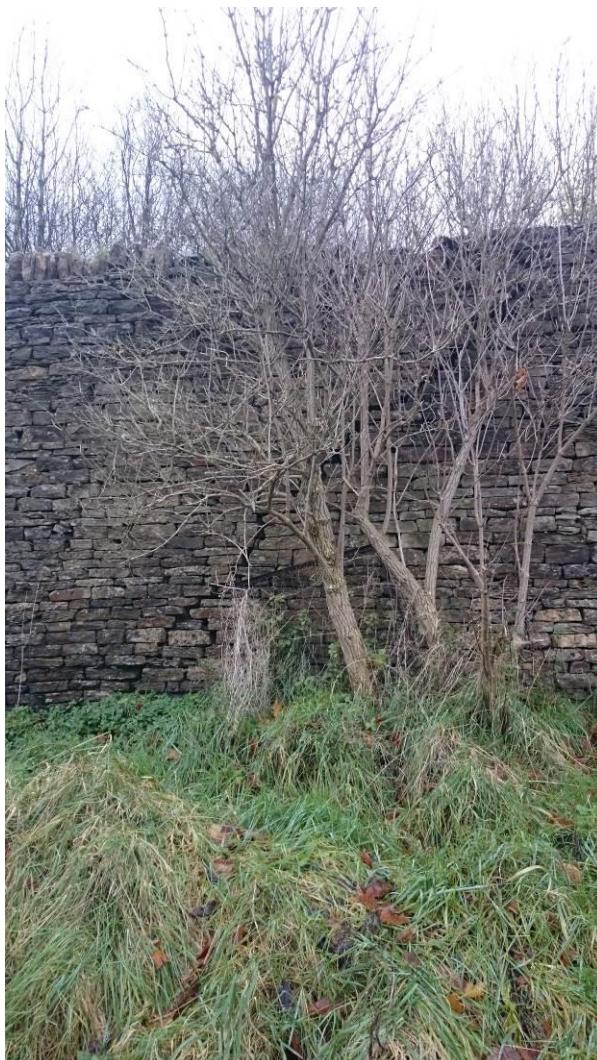
Photograph 2. View to the north of the retaining wall cracking (25.11.2015)

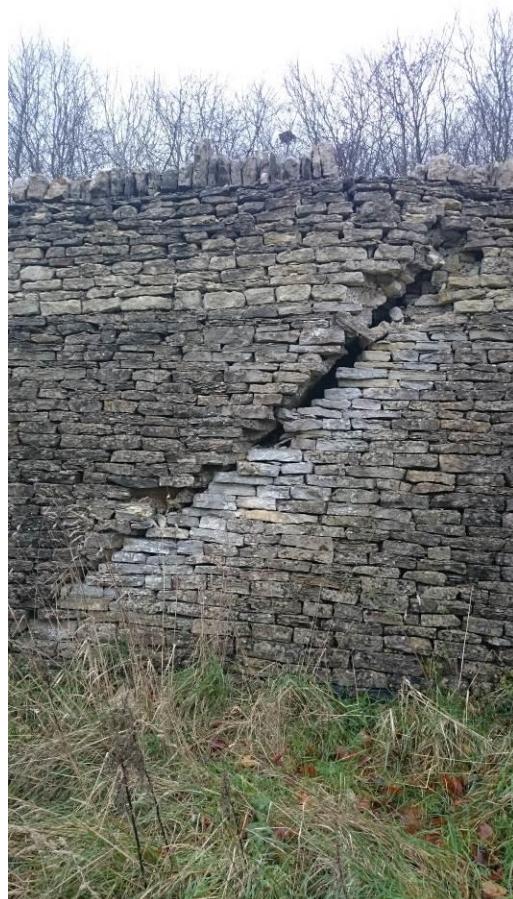
Photograph 3. View to the north of the retaining wall cracking and displacement (25.11.2015)

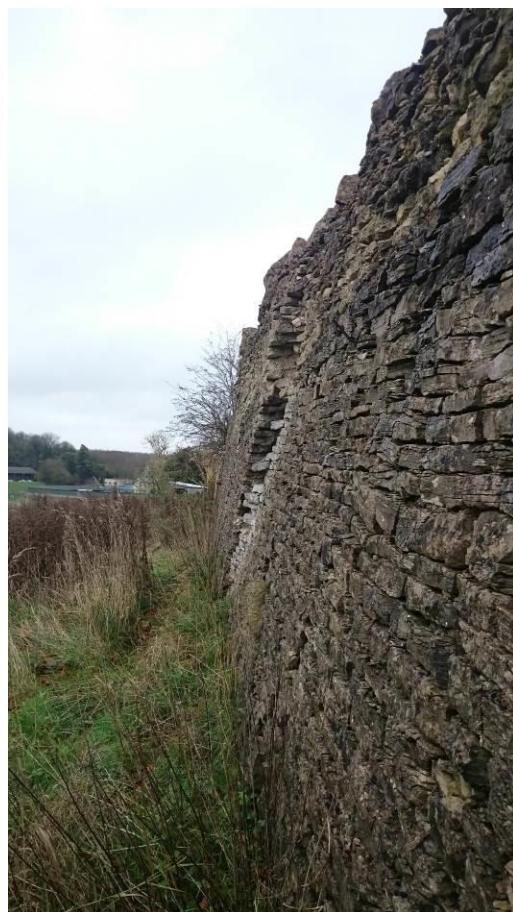
Photograph 4. View to the east of the retaining wall cracking and displacement (25.11.2015)

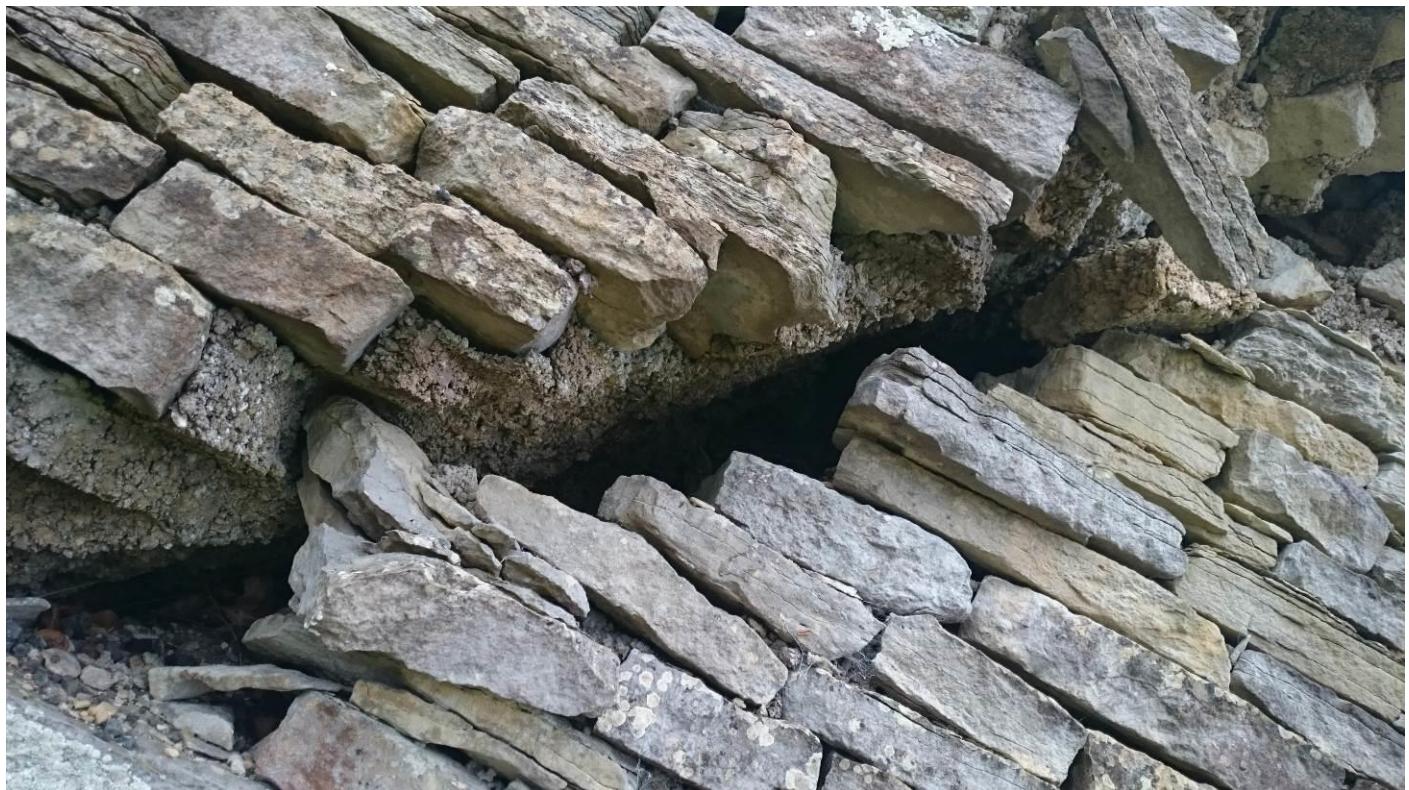
Photograph 5. Detailed of the retaining wall cracking and construction (25.11.2015)

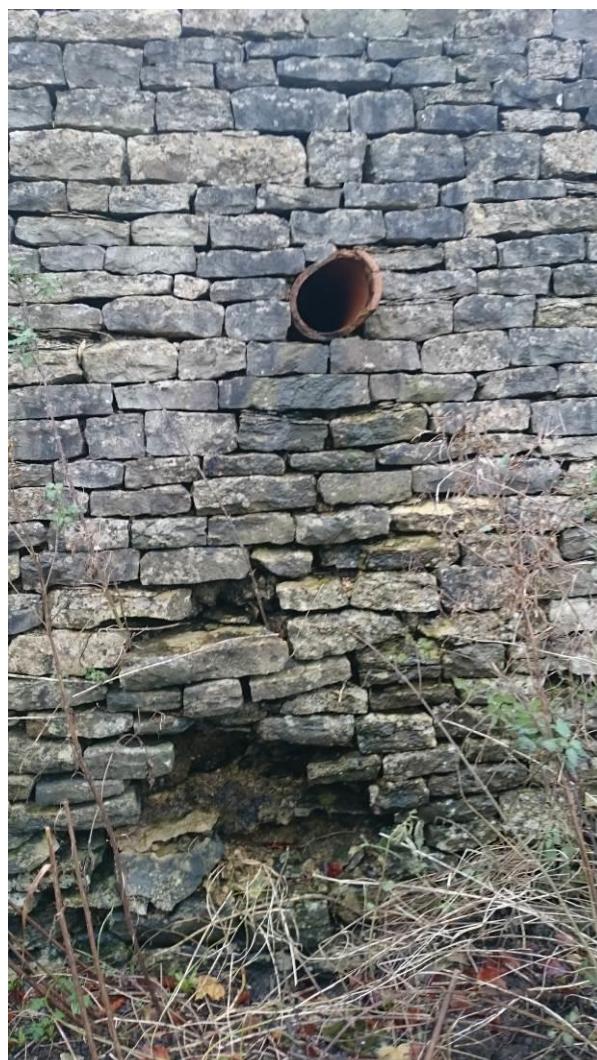
A 6" drainage outfall is located 1.5m above ground level approximately 10m to the east of the detached section of retaining wall (Photograph 6). The site walkover indicated that this drainage pipe forms the outfall for a drainage gully located in the carriageway above. The pipe is cracked and deformed, potentially leaking water within the retaining wall (Photograph 7). The stone work around the outfall was damp and the ground below showed signs of scour indicating a significant flow of water through the outfall.

Photograph 6. Drainage outfall (25.11.2015)

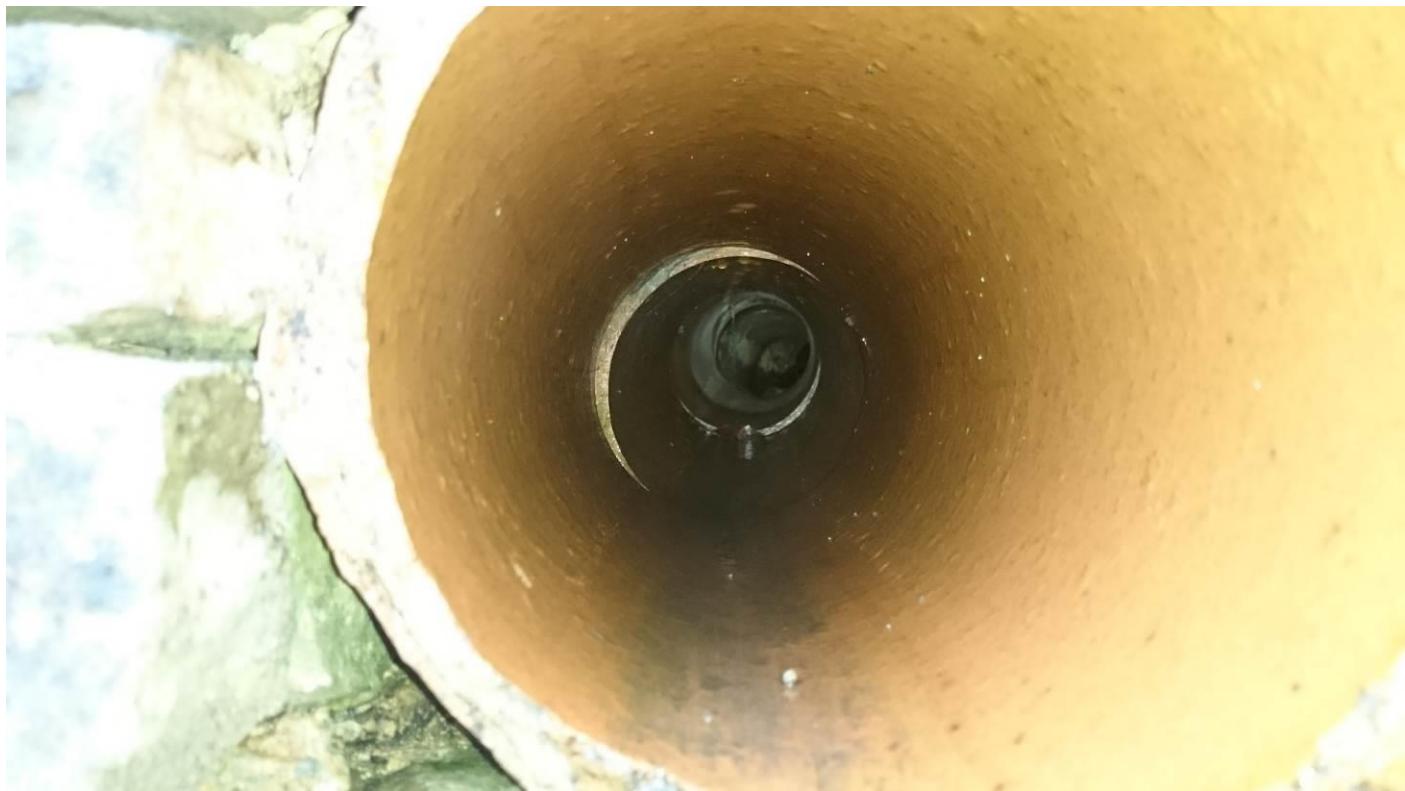
Photograph 7. Cracked drainage outfall pipe (25.11.2015)

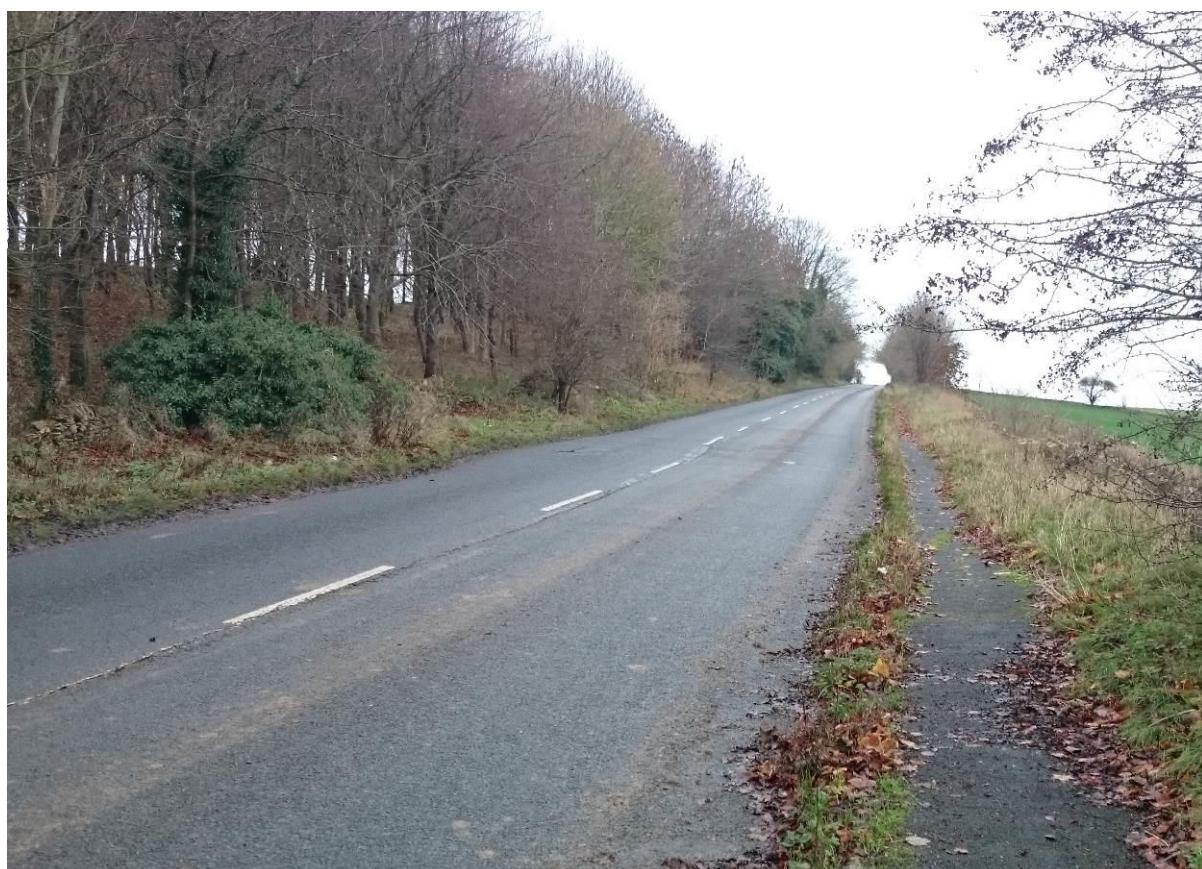
An approximately 50mm deep depression has formed in the carriageway above the detached section of retaining wall (Photograph 8). A 2m long, 30mm wide crack is located in the west bound carriageway (Photograph 9). Approximately 4m of cracking, up to 20mm wide has developed diagonally across the eastbound carriageway, it appears that this has occurred relatively recently (Photograph 10). A void has formed in the grass verge in between the cracked carriageway and the defective section of retaining wall.

Photograph 8. Area 1 – View towards the west of the depression within carriageway (25.11.2015)

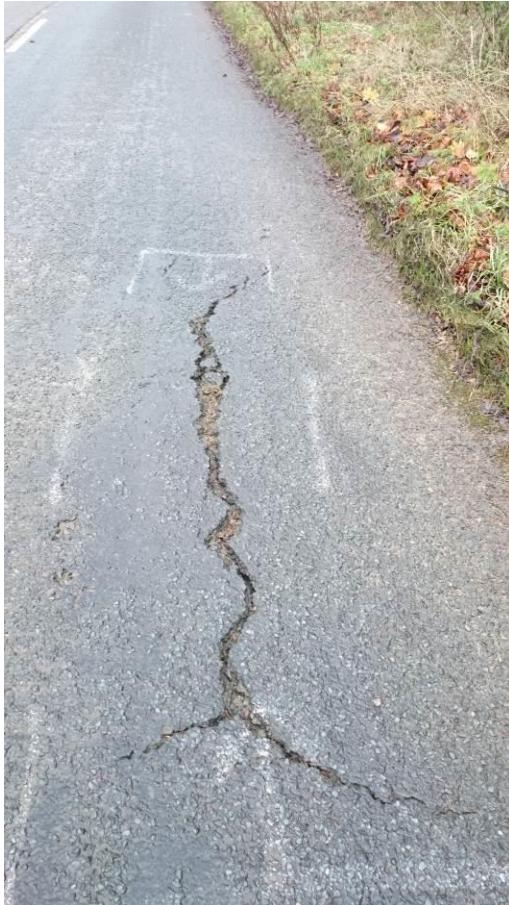
Photograph 9. Area 1 - Cracking within the westbound carriageway (25.11.2015)

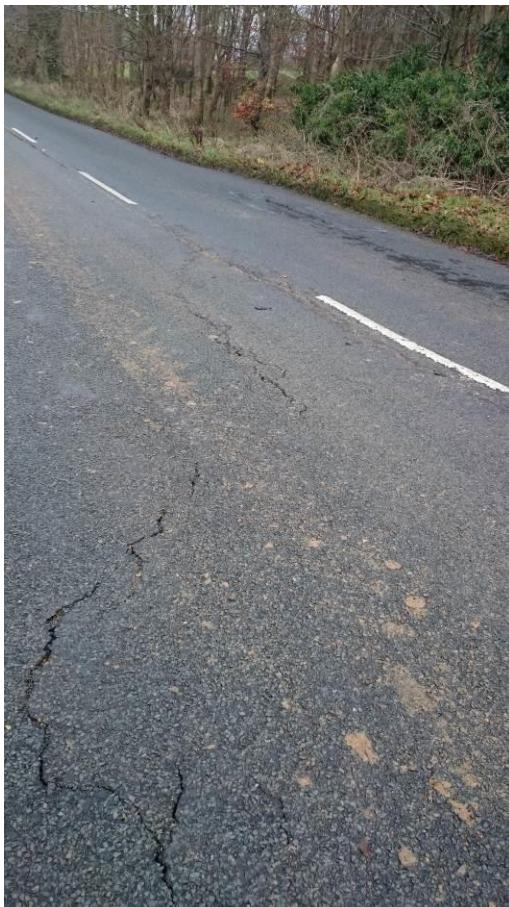
Photograph 10. Area 1 - View towards the east of the cracking within the eastbound carriageway (25.11.2015)

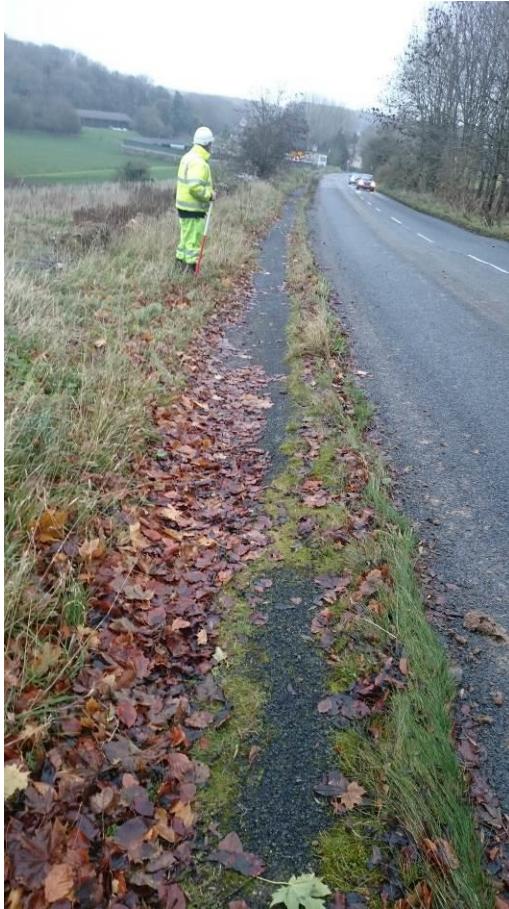
This area is located immediately to the west of Area 1 and is defined by an approximately 10m long, 50mm deep depression (Photograph 11) within the pedestrian footpath which extends along the top of the defective section of retaining wall shown in Photograph 2.

Photograph 11. Area 2 – View towards the east of the depression within the pedestrian pavement
(25.11.2015)

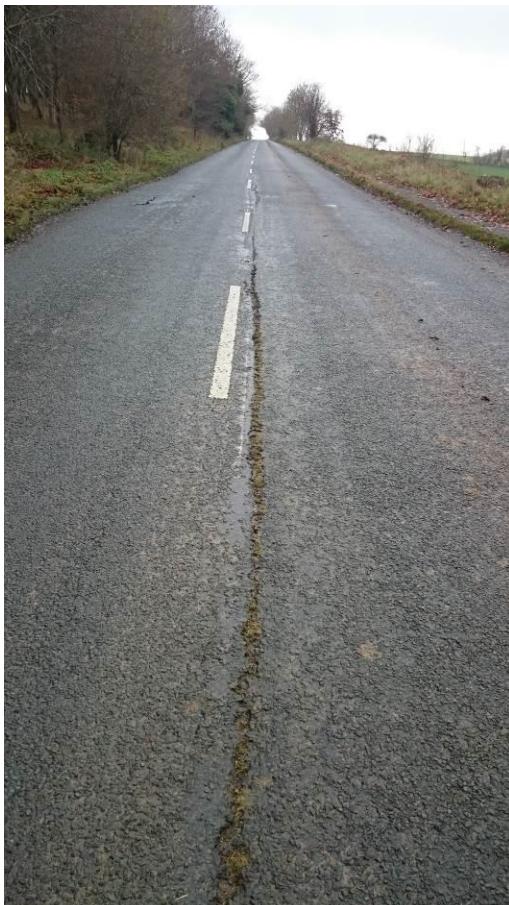
This area is located immediately to the east of Area 2 and is defined by an approximately 60m long, 20mm wide crack running along the centre of the carriageway. It is probable that this cracking has formed along the carriageway construction joint (Photograph 12). Several cracks approximately 0.5m long and 5mm wide have formed in the east bound carriageway within this area, these appear to have occurred relatively recently (Photograph 13).

Photograph 12. Area 3 - View towards the west of the cracking along the centre of the carriageway
(25.11.2015)

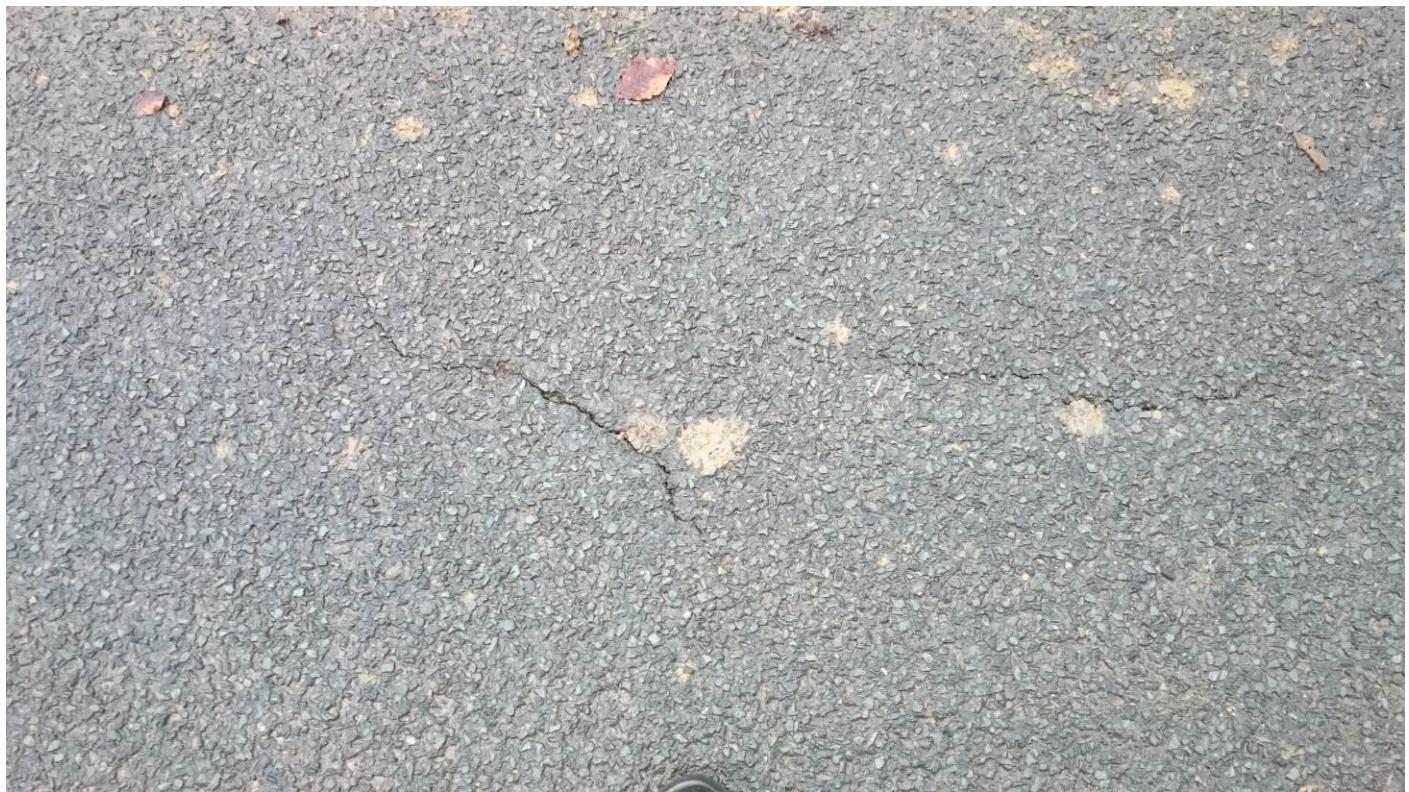
Photograph 13. Area 3 - Cracking within the eastbound carriageway (25.11.2015)
