## **Waste Core Strategy Site Options Consultation**

### **Waste Site Assessment**

#### **Appendix C.6: Site 051 - Cinderford - Northern United**

**October 2009**

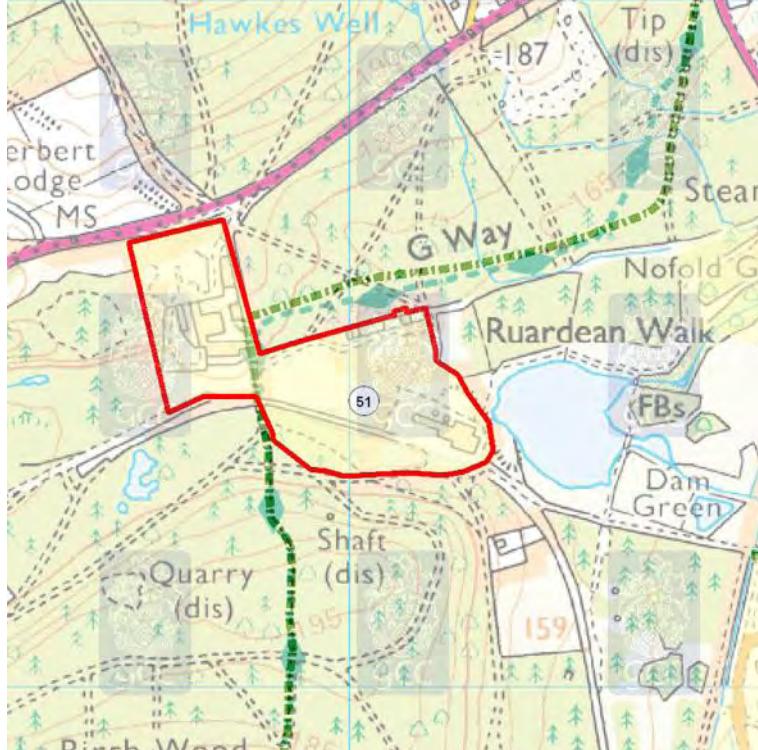
<b>Public Right of Way</b>
PRoW Map

Public Rights of Way (Based on information provided by Gloucestershire County Council's Public Rights of Way (PRoW) team)	
Score	--
Score Definition	Major adverse impact on the Public Rights of Way Network – potential closure of the route or major deviation / re-route required.
Additional Comments	Path may need diversion - Enhancements possible.
Map Legend

PRoW/Ecology/Biodiversity/Archaeology: Further consultations may be required in relation to potential impacts upon the above mentioned areas.

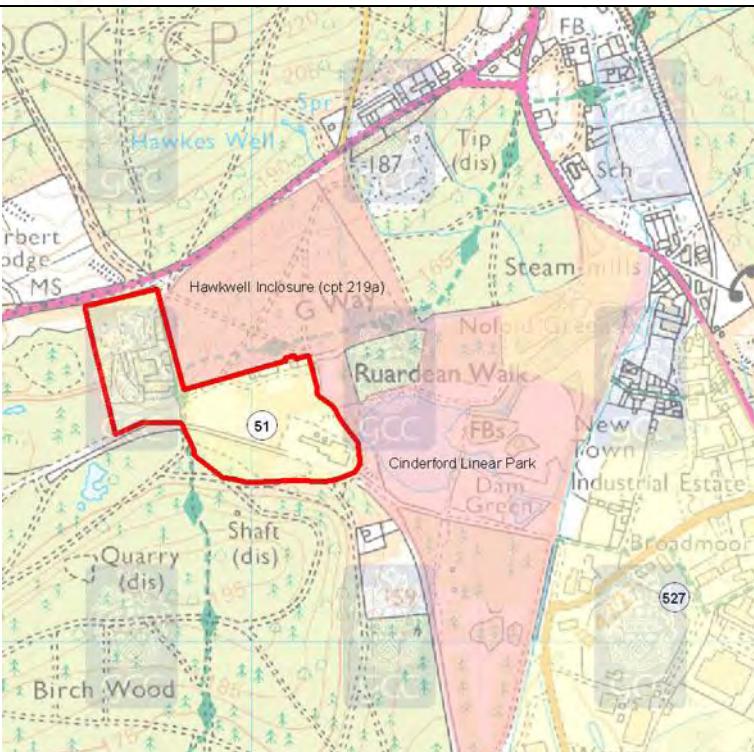
Constraints Map

Ecology/Biodiversity (Based on information provided by Gloucestershire County Council's Ecologist and the Gloucestershire Centre for Environmental Records (GCER))	
Score	0
Score Definition	Overall impact on biodiversity could be potentially negative, uncertain or positive. Identified important ecological constraint up to and including 250 metres distant.
Additional Comments	Scores with * indicate designated aquifer fed/surface water/flood water dependent site(s) over 1km distant which may be affected, site as named above.
Nearby Internationally & Nationally Designated Sites Recorded	None
Other Internationally & Nationally Designated Sites (wetlands)	None
Ecology Legend	<ul style="list-style-type: none"> <li><span style="display: inline-block; width: 15px; height: 15px; background-color: green; border: 1px solid black; margin-right: 5px;"></span> SSSI Site of Special Scientific Interest</li> <li><span style="display: inline-block; width: 15px; height: 15px; background-color: pink; border: 1px solid black; margin-right: 5px;"></span> Key Wildlife Site - area</li> <li><span style="display: inline-block; width: 15px; height: 15px; background: repeating-linear-gradient(45deg, transparent, transparent 2px, black 2px, black 4px); border: 1px solid black; margin-right: 5px;"></span> SAC Site</li> <li><span style="display: inline-block; width: 15px; height: 15px; background: repeating-linear-gradient(45deg, transparent, transparent 2px, blue 2px, blue 4px); border: 1px solid black; margin-right: 5px;"></span> Ramsar Site</li> <li><span style="display: inline-block; width: 15px; height: 15px; background: repeating-linear-gradient(45deg, transparent, transparent 2px, black 2px, black 4px); border: 1px solid black; margin-right: 5px;"></span> SPA Site</li> </ul>

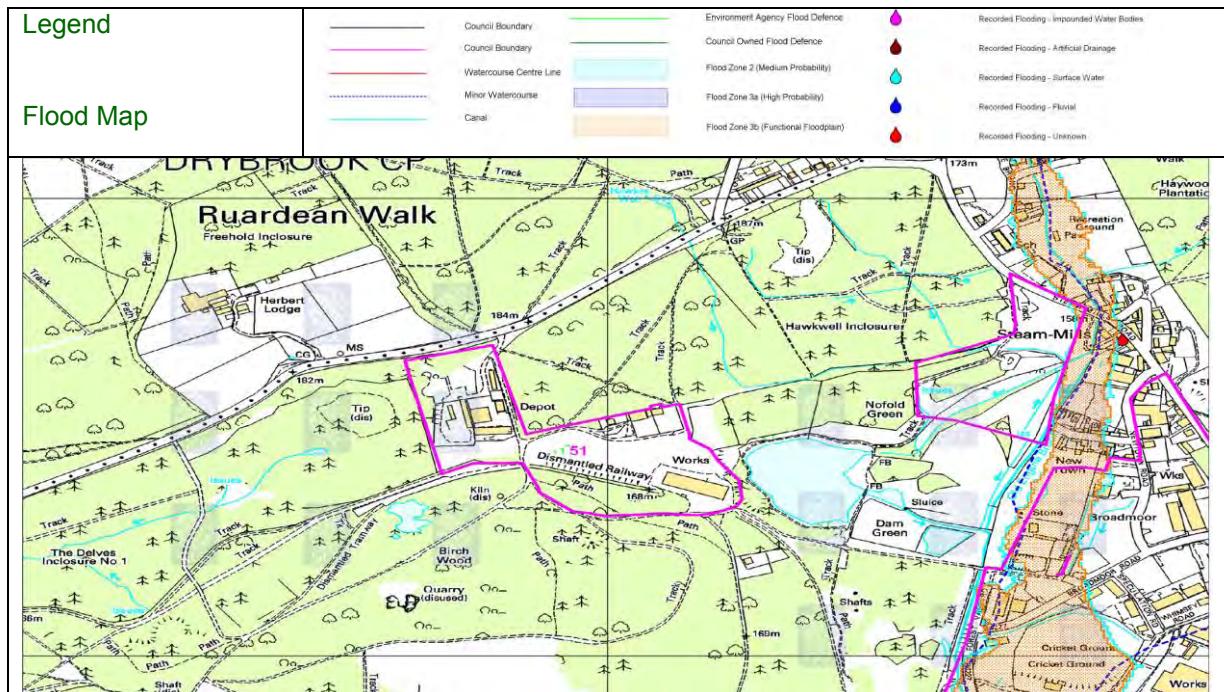
Flood Risk <i>(Based on information provided by Halcrow)</i>	
Site Description	Site lies fully in Flood Zone 1. An impounded water body lies to the east of the site (SO 6432 1539).
Watercourse(s)	No major watercourses, minor watercourses or drains are located within the site.
Flood Zone	1
Flood Zone Information (Method used to derive Flood Zones & Confidence in Flood Zone information)	n/a
Fluvial Flood Risk Posed to Site (including climate change)	Site lies fully in Flood Zone 1. Fluvial flood risk is low.
Historic Flooding/Flooding From Other Sources	There are no records of historic flooding and flooding from other sources including groundwater and surface water have not been recorded on the site. The impounded water body to the east of the site may present some risk. The risk of breach or overtopping should be investigated as part of a FRA.
Canals (Raised - breach/overtopping)	No canals exist in or adjacent to the site.

Flood Defences (Location/Type/SoP/Residual Risk)	No formal EA defences are known to exist in the site. The OS map indicates that there is an embankment on the western side of the impounded water body.
Culverts (Location/Type/Watercourse/Residual Risk)	No culverts are known to exist in the site.
Score	+
Score Definition	Site is mainly in Flood Zone 1 but affected by Flood Zones 2, 3a and 3b.
Additional Comments	Flood risk criteria reduced from 5 to 4 because of potential residual risk to site from impounded water body.
