Ground Investigation Report **Prison Copse Wall, Northleach**

CON-GE-BHAM-COGL43048589-GIR-001 Revision 1

August 2017

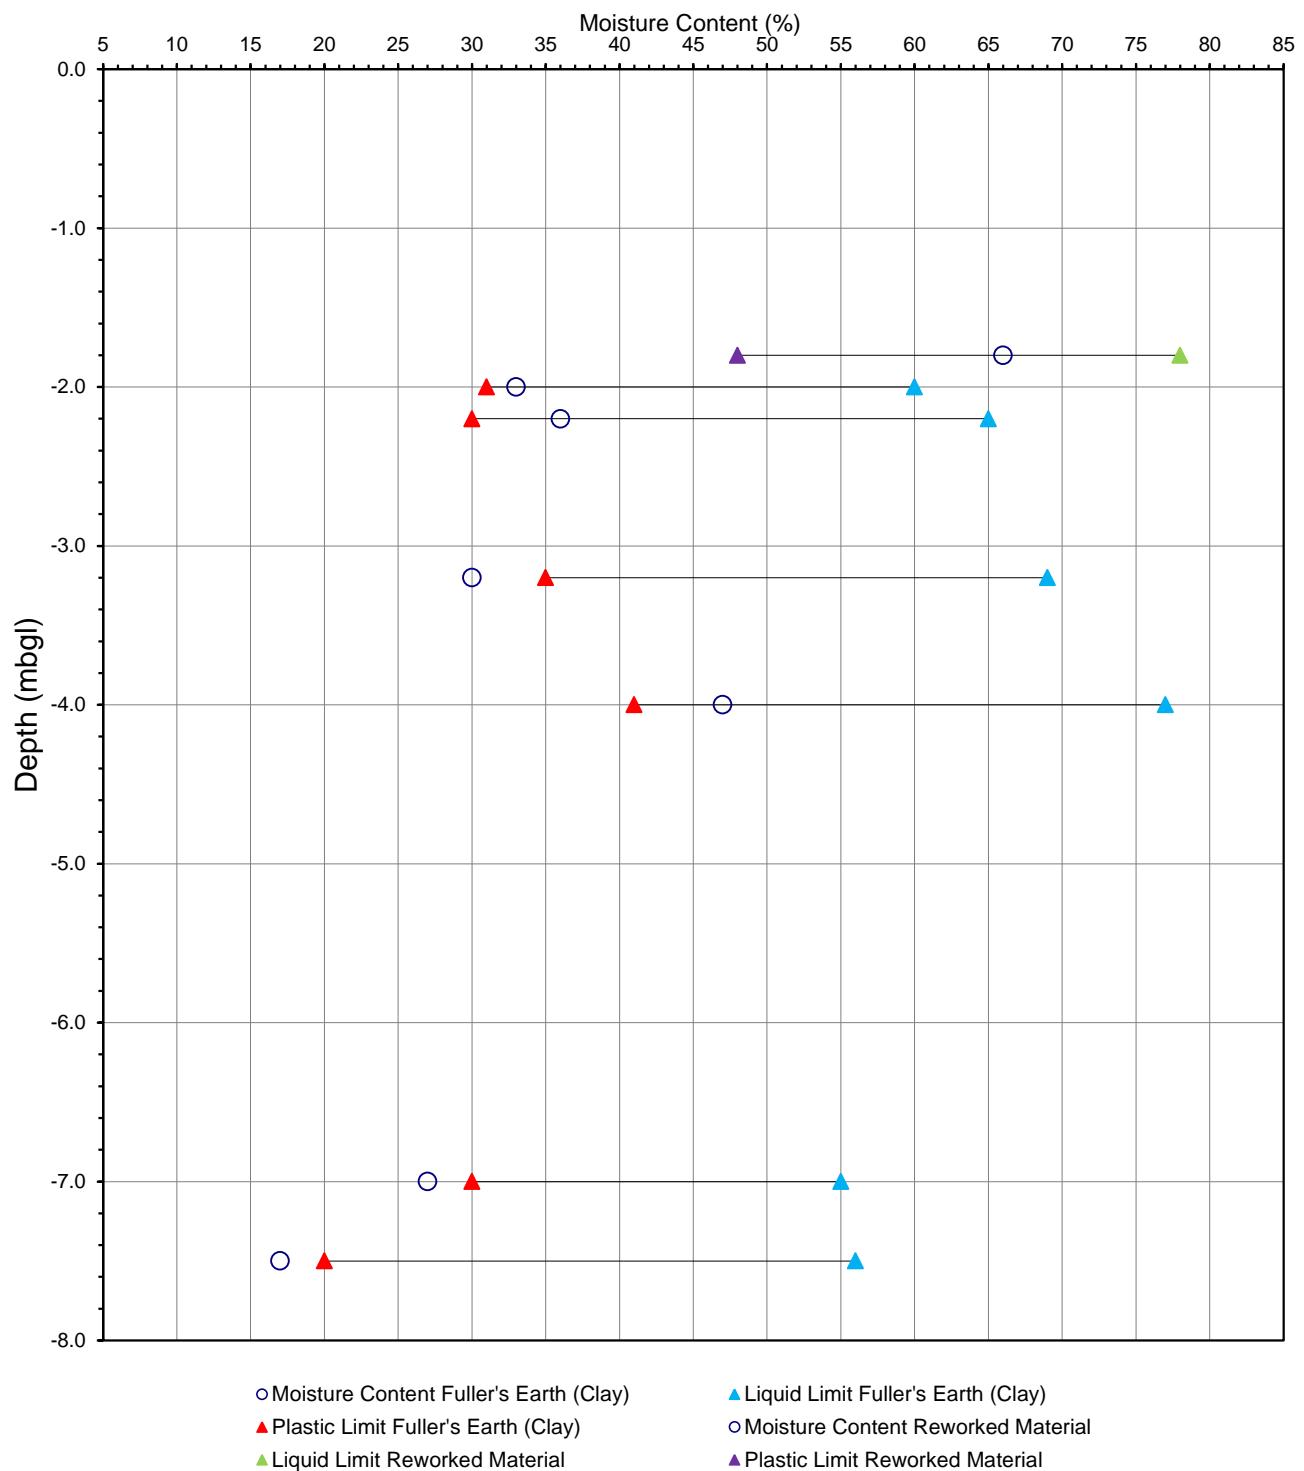
| Report Reference: | CON-GE-BHAM-COGL43048589-GIR-001 | Figure Reference: | Figure 7 |

Six moisture content determinations within the Fuller's Earth Formation (Clay) revealed moisture contents of between 17% and 47%, with Plastic Limit and Liquid Limit determinations of between 20% and 41% and 55% and 77% respectively, thus indicating plastic index values of between 25% and 36%; a characteristic value for plastic index of 33% is suggested. Moisture content, plastic limit and liquid limit are plotted against depth in **Figure 7**. When plotted on a Casagrande Plasticity Chart (**Figure 8**), these results indicate this material to comprise clays and silts of moderately high to very high plasticity as defined in BS5930 (2015) [**Ref 11**].

Moisture Content, Liquid Limit and Plastic Limit

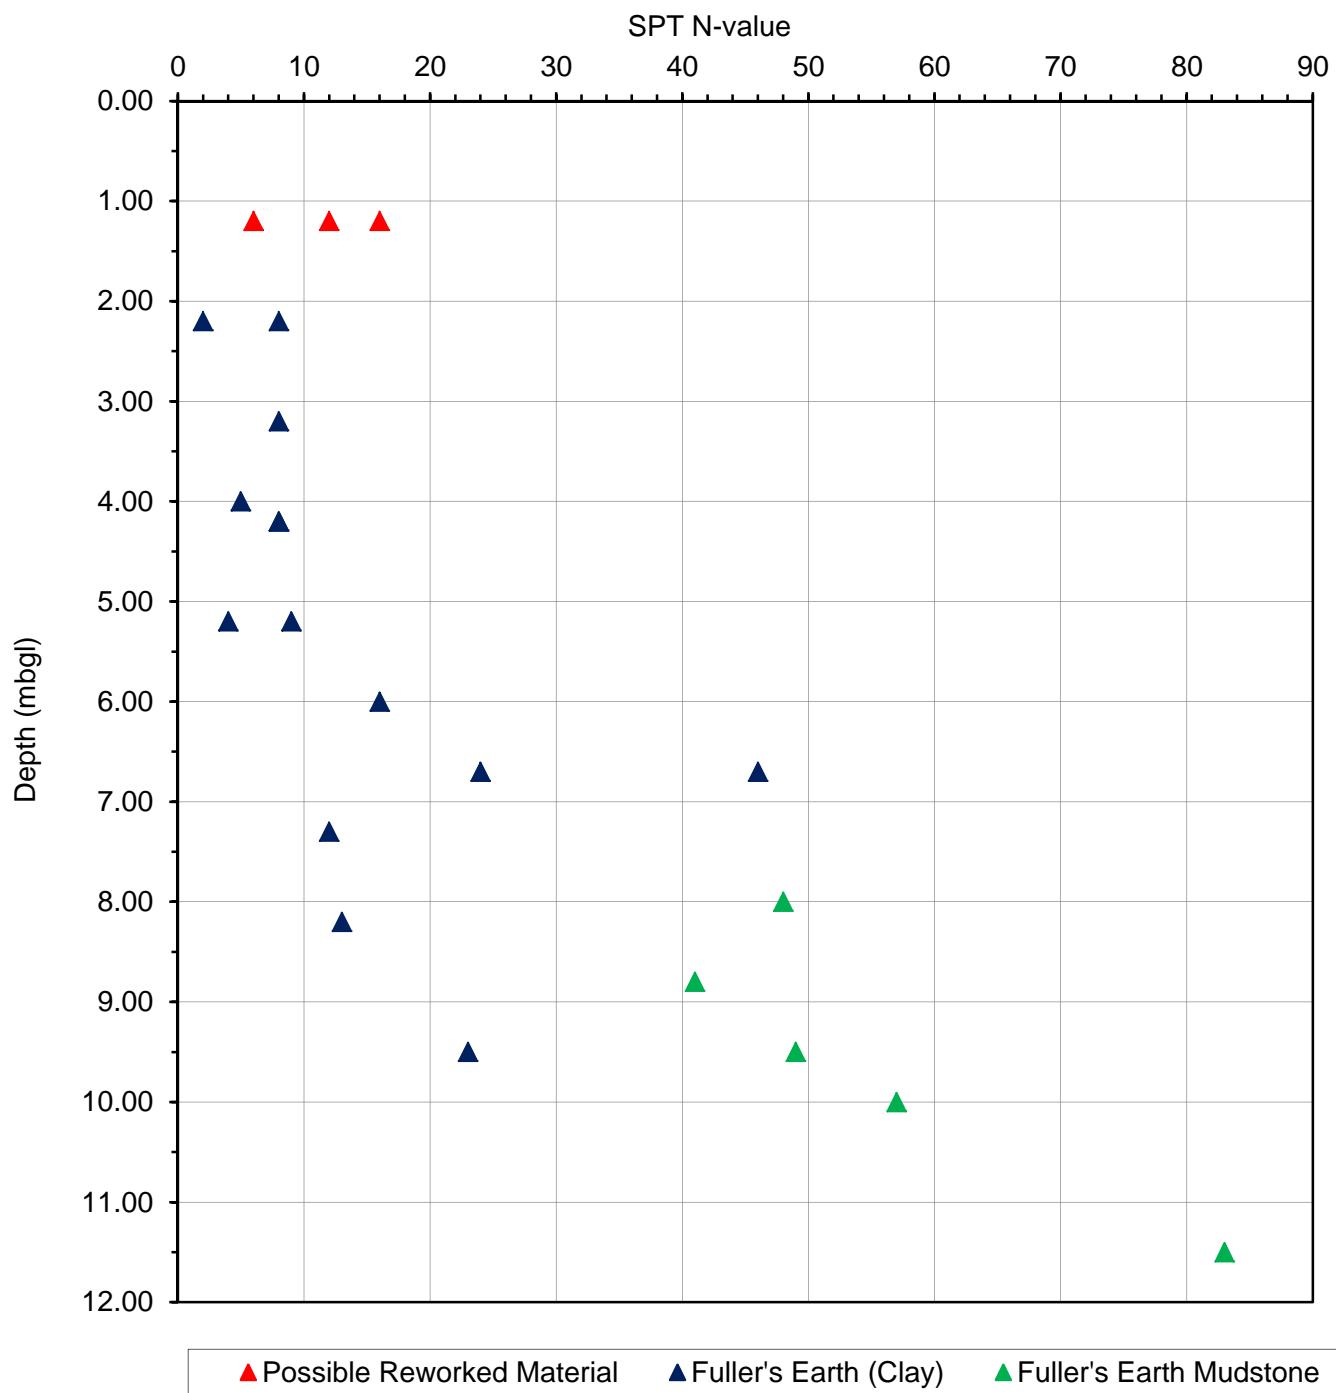
| Report Reference: | CON-GE-BHAM-COGL43048589-GIR-001 | Figure No: | Figure 9 |

Five standard penetration tests (SPT) were carried out within the Fuller's Earth Formation (Mudstone) with 'N' and extrapolated 'N' values ranging from of 41 to 83 being obtained. SPT 'N₆₀' values are plotted against depth in **Figure 9**. SPT 'N' values can be used to very loosely estimate uniaxial compressive strength of the rock using the correlation $C_u = f \cdot N$ proposed by Stroud [**Ref 17**] for clays, where a factor $f = 5$ can be used to estimate undrained shear strength, with uniaxial compressive strength being double the undrained shear strength. This suggests uniaxial compressive strengths of between 0.41MN/m² and 0.83MN/m²; a uniaxial strength compressive strength of 0.5MN/m² is suggested for design in this extremely weak rock.

SPT 'N₆₀' Value v Depth (mbgl)

Note: Values of N₆₀ greater than 50 are extrapolated values.

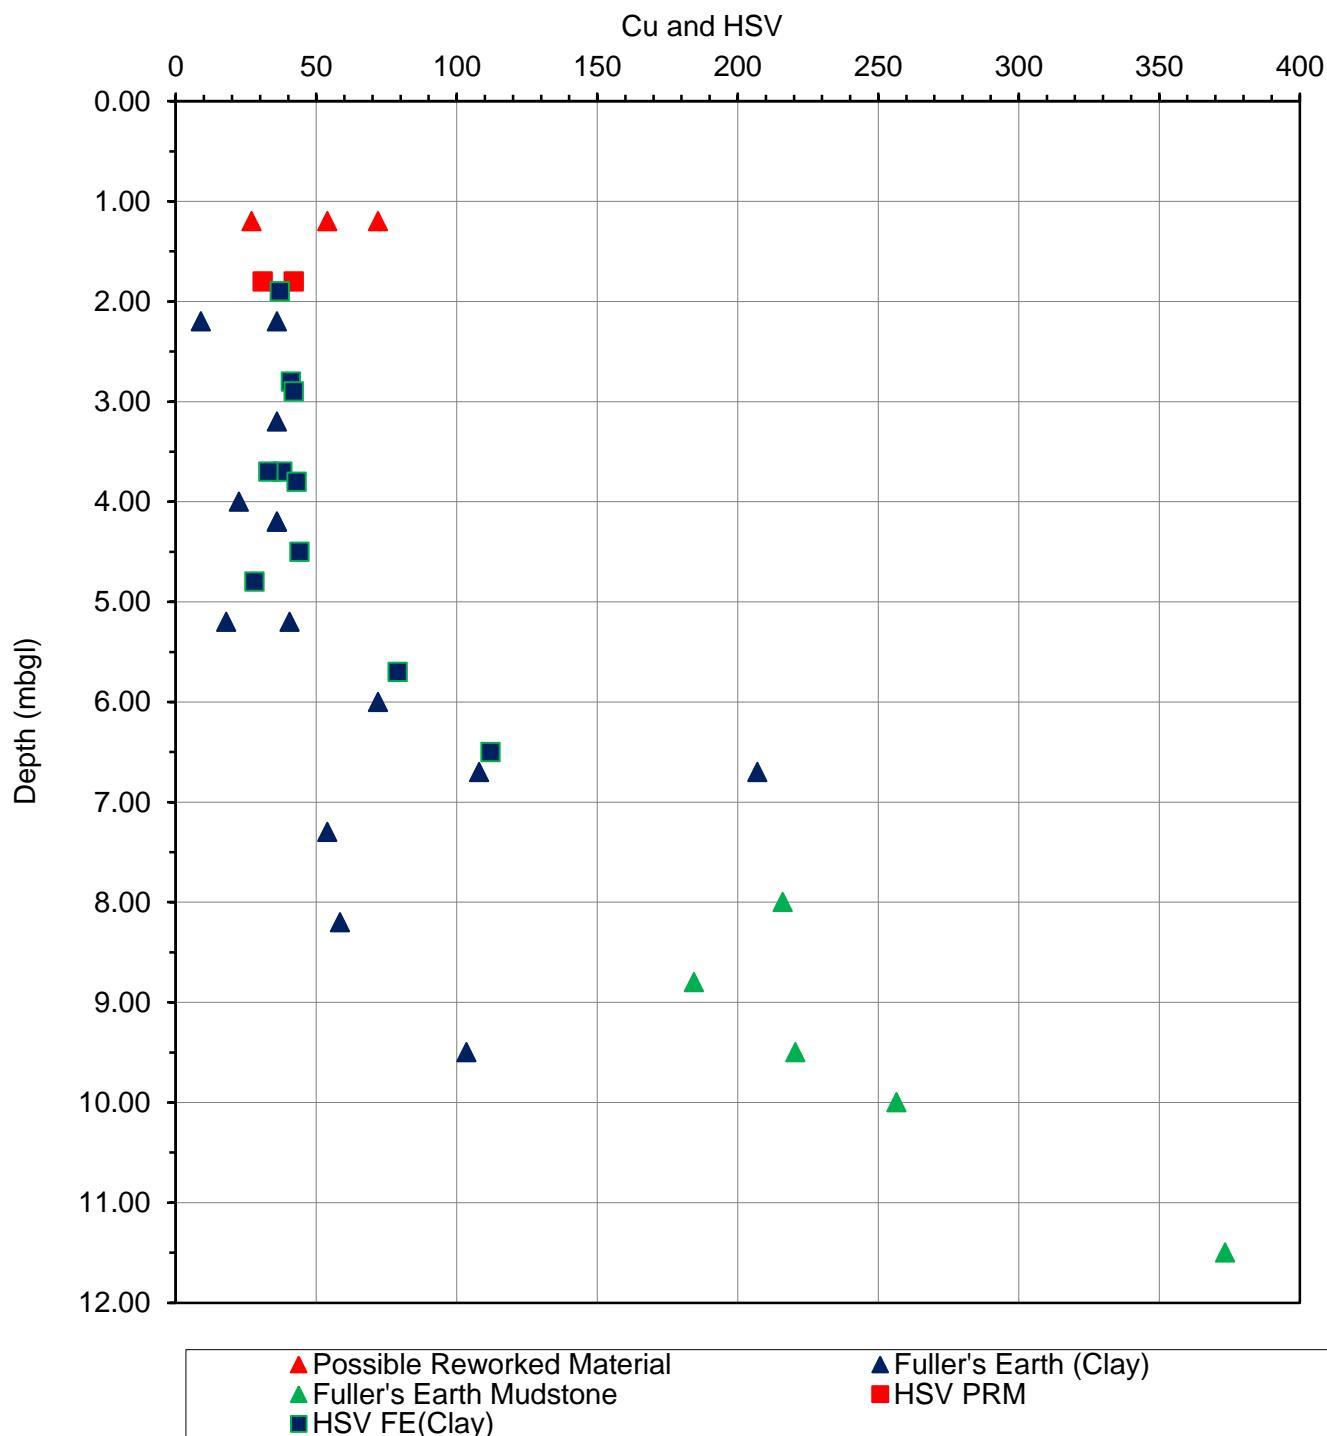
| Report Reference: | CON-GE-BHAM-COGL43048589-GIR-001 | Figure No: | Figure 10 |

Undrained shear strengths derived from SPT and HSV results are shown in **Figure 10**. Based on these values, a value of 35kN/m² is recommended for design to a depth of 5.5m bgl. Undrained shear strength increases beneath a depth of 5.5m bgl and it is suggested that a shear strength profile varying from 35kN/m² at a depth of 5.5m bgl to 100kN/m² at a depth of 10.0m bgl be employed for design.

Cu based on SPT 'N' Value and HSV v Depth (mbgl)

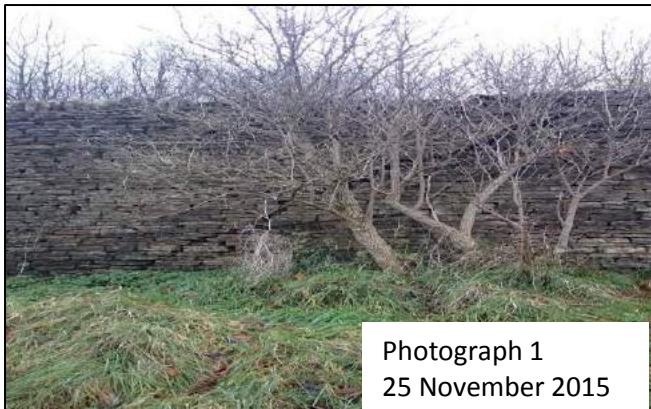
Photograph 1
25 November 2015

The central section of the retaining wall has become visibly distressed with 6 No. diagonal tension cracks located along its central third (see **Photographs 1 to 5** in **Appendix A**). The most severe section of defective retaining wall comprises an 8m section that has become detached and leans out towards the field below (see **Photographs 6 & 7**). Exposure of the concrete suggests it is approximately 800mm thick.

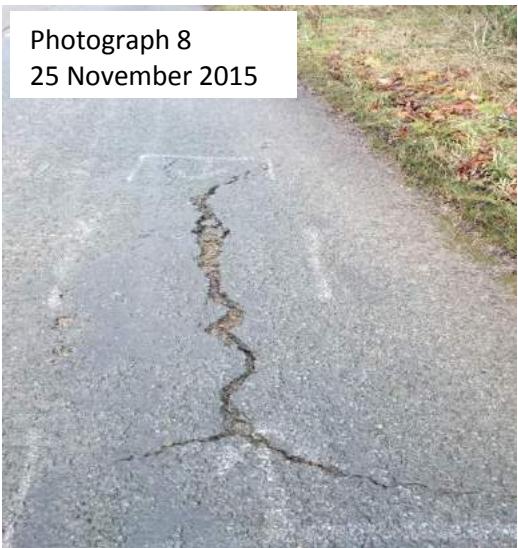
Photograph 9
29 November 2016

An approximately 50mm deep depression has formed in the eastbound carriageway above the detached section of retaining wall (**Photograph 8**), and a 2m long, 30mm wide, crack is located in the westbound carriageway (**Photograph 9**). Approximately 4m of cracking, up to 20mm wide, has developed diagonally across the eastbound carriageway (**Photograph 10**); it appears that the diagonal cracking has occurred relatively recently. A void has formed in the grass verge between the cracked carriageway and the defective section of retaining wall.

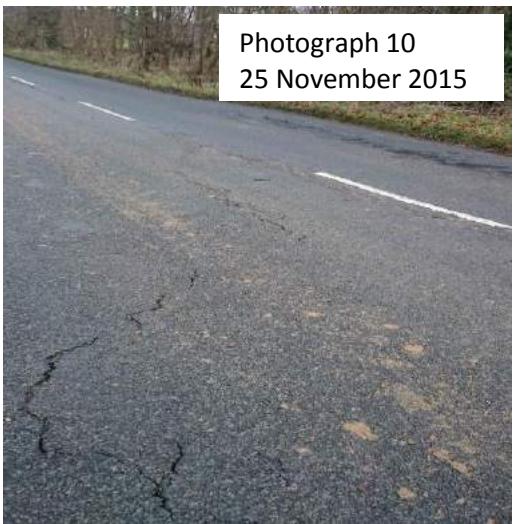
Photograph 11
25 November 2015

This area is located immediately to the west of Area 1 and is defined by an approximately 10m long, 50mm deep depression within the footway (**Photograph 11**), and extends along the top of the defective section of retaining wall.

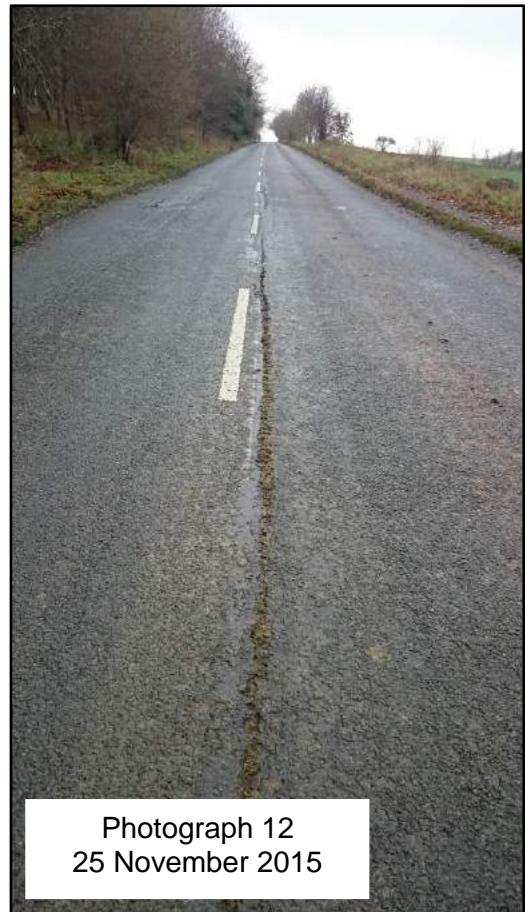
Photograph 12
25 November 2015

This area is located immediately to the east of Area 1 and is defined by an approximately 60m long, 20mm wide crack running along the centre of the carriageway (**Photograph 12**). It is probable that this cracking has formed along a construction joint. Several cracks approximately 0.5m long and 5mm wide have formed in the eastbound carriageway within this area (**Photograph 13**).

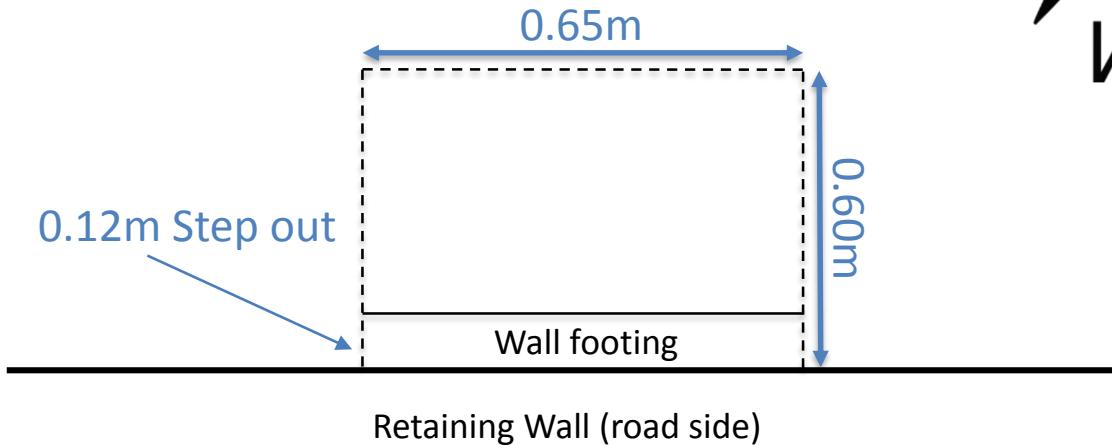
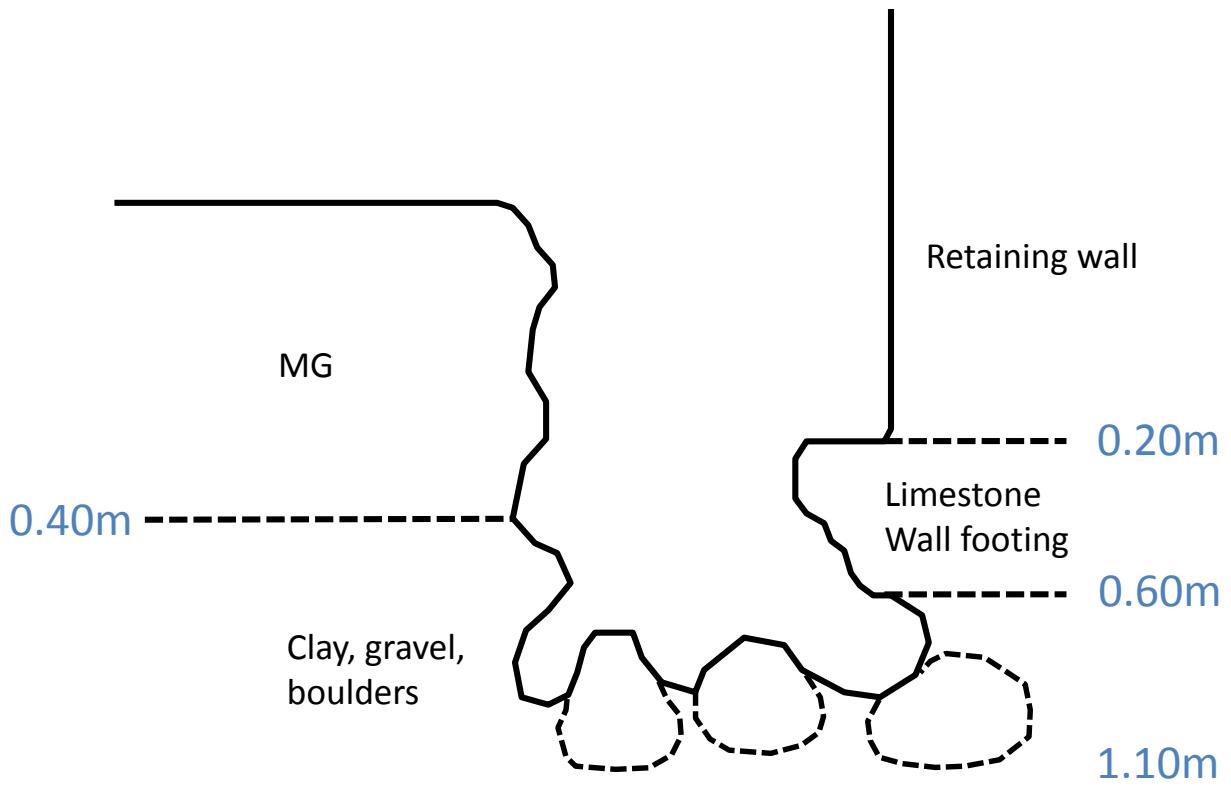
Trial Pit Sketch

The two trial pits (TP01 and TP02) undertaken at the toe of the wall in order to investigate the masonry wall foundation revealed the foundation to comprise a 350mm or 400mm thick limestone foundation with a 120mm or 300mm step out and founded at a depth of 0.55m or 0.60m below general ground level. The founding material comprised Possible Reworked Material comprising soft slightly gravelly slightly sandy CLAY or slightly sandy sub-angular and sub-rounded fine to coarse GRAVEL of limestone with a high cobble content as discussed later in **Section 6**.

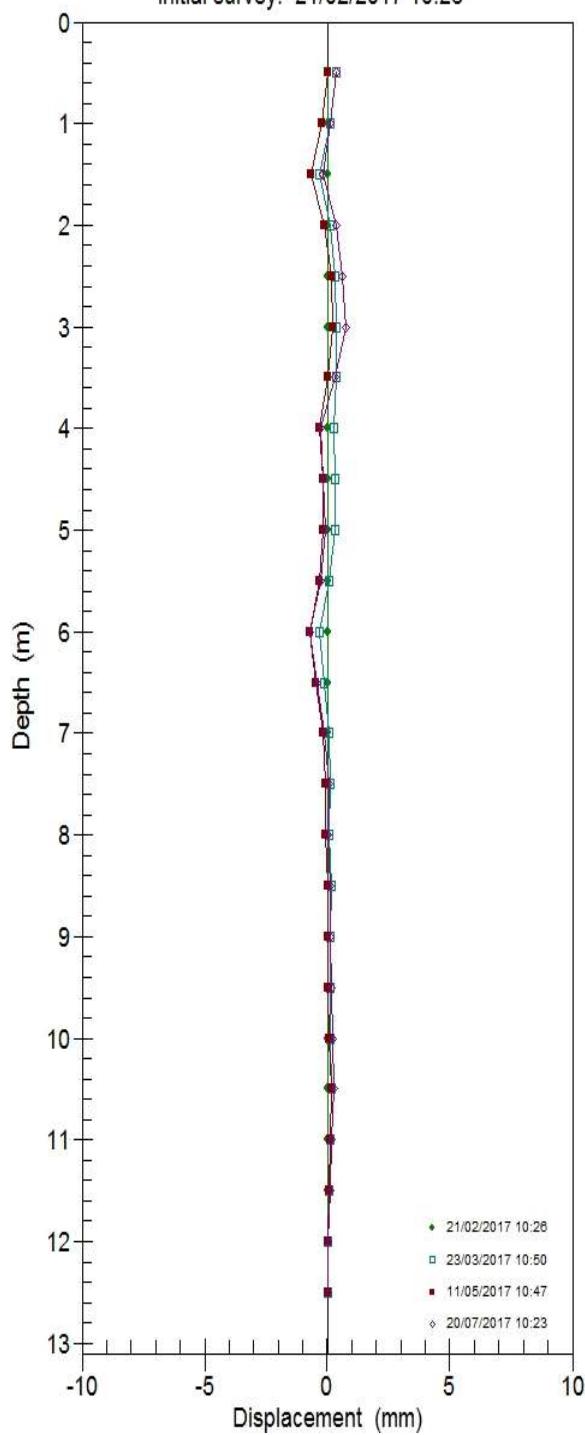
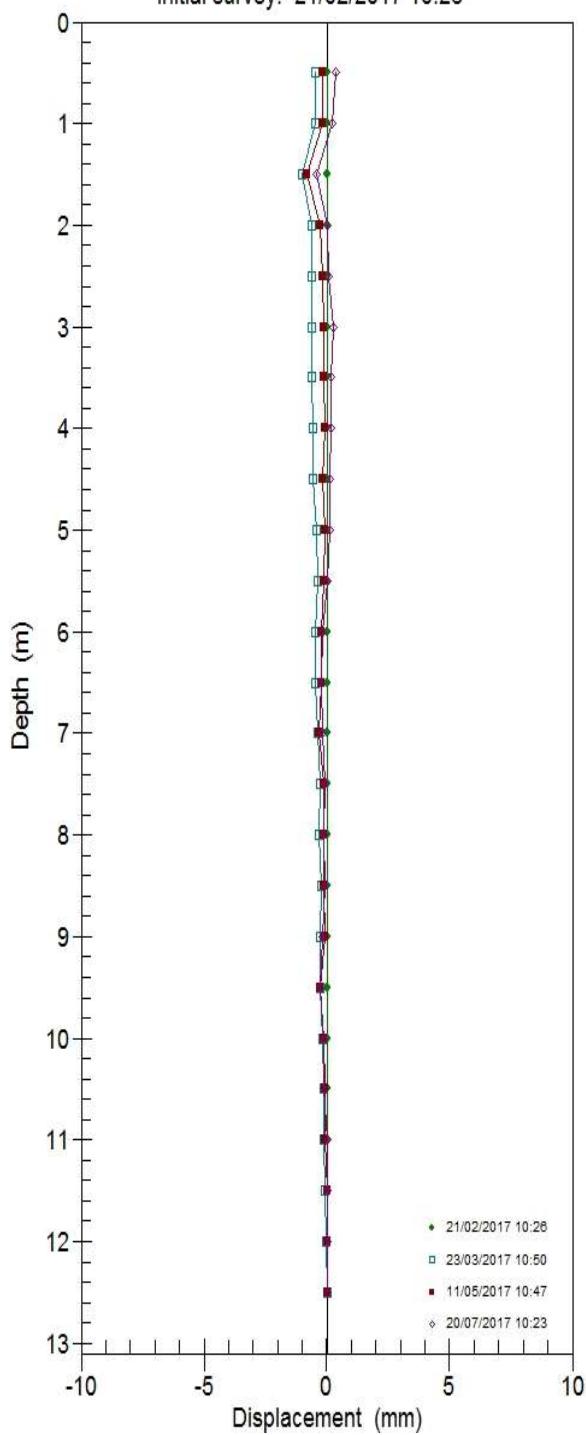
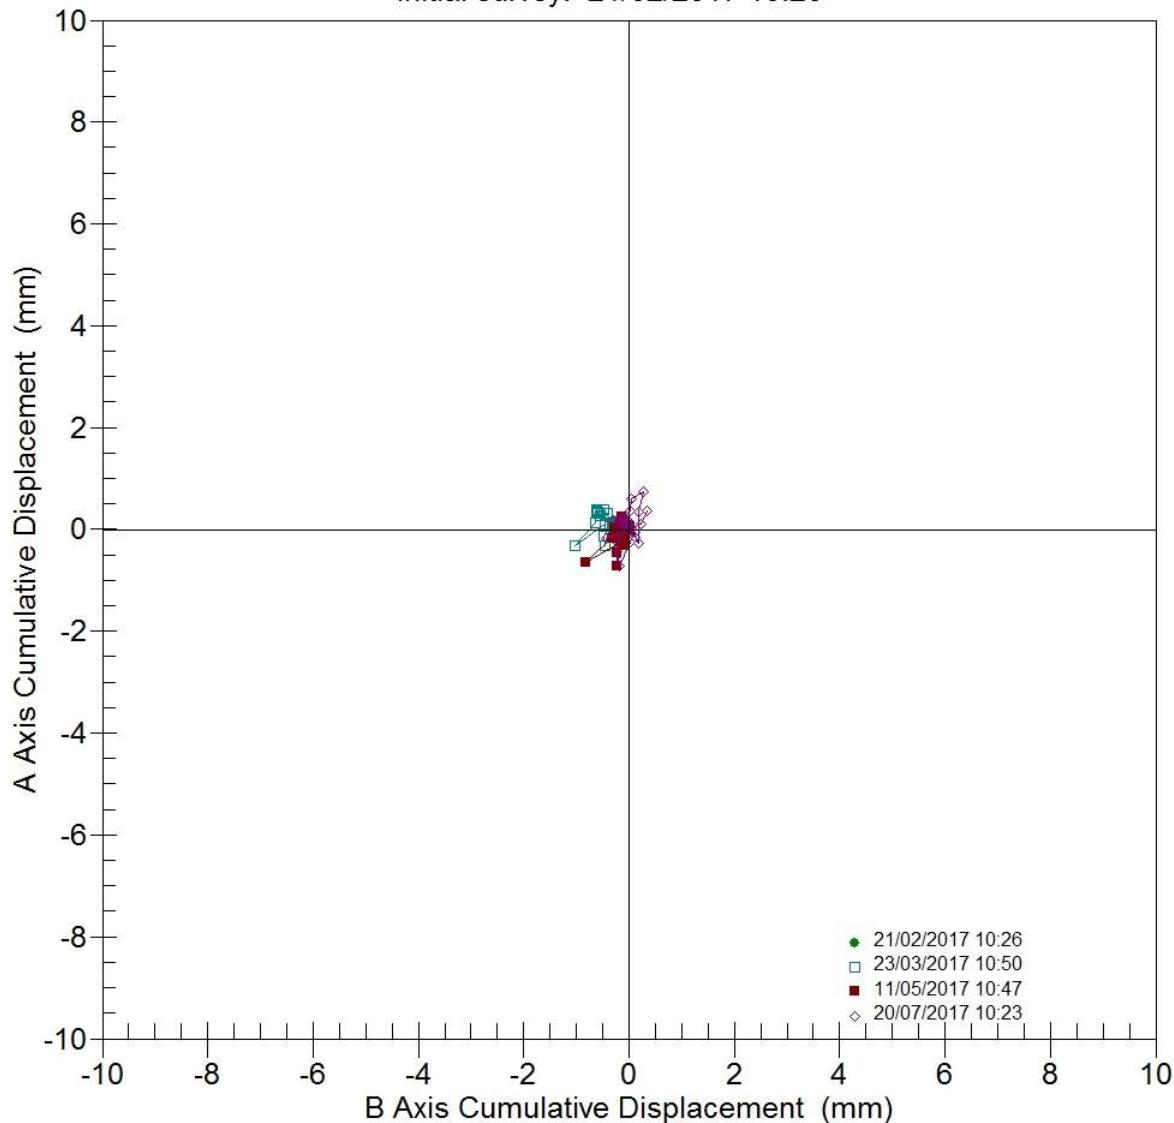
Visual inspections have indicated that the failure mechanism may comprise a shallow slip failure passing below the toe of the retaining wall. However the results of the inclinometer monitoring undertaken to date have been inconclusive and further monitoring will be required to determine the failure mechanism. The piled retaining wall and king post wall solutions would be suitable for remediating a shallow failure. If a deeper seated failure plane is present, further design options will need to be considered.

PriCop:BH02 - A Axis Cumulative

PriCop:BH02 - B Axis Cumulative

PriCop:BH02 - A Axis vs B Axis
