## **Waste Core Strategy Site Options Consultation**

### **Waste Site Assessment**

#### **Appendix C.97: Site 556 - Cainscross**

**October 2009**

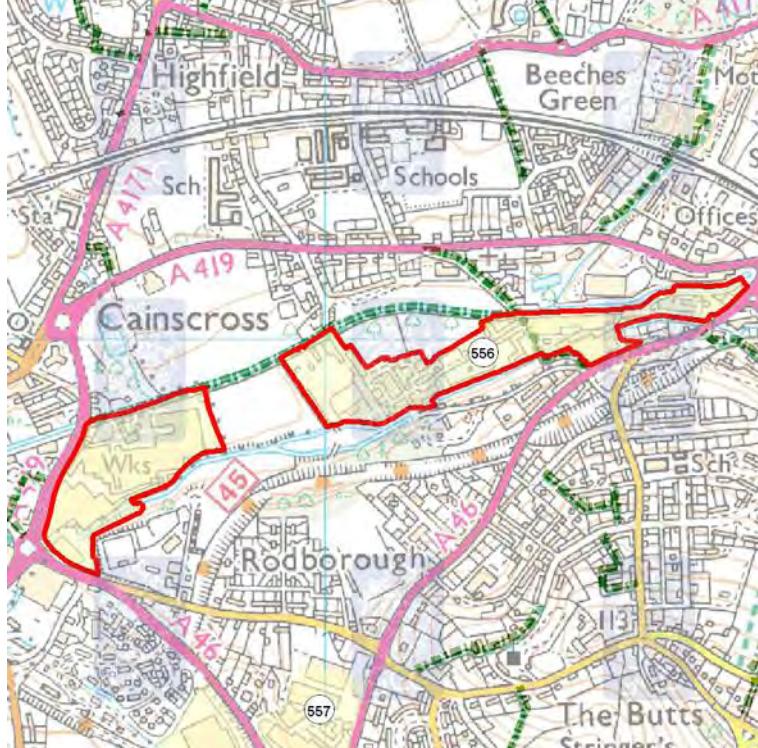
<b>Public Right of Way</b>
PRoW Map

Public Rights of Way (Based on information provided by Gloucestershire County Council's Public Rights of Way (PRoW) team)	
Score	--
Score Definition	Major adverse impact on the Public Rights of Way Network – potential closure of the route or major deviation / re-route required.
Additional Comments	Diversions may be necessary - No enhancements likely.
Map Legend

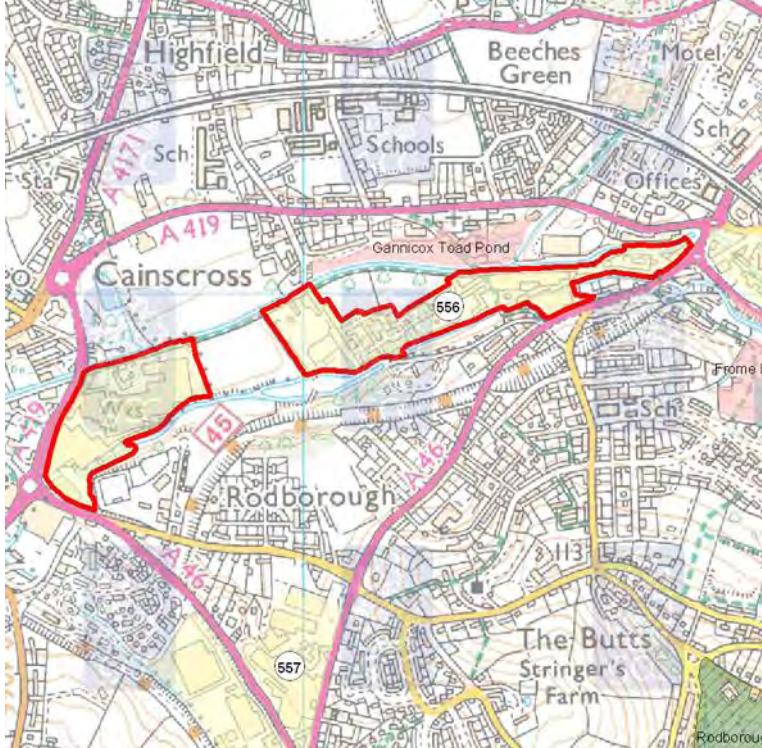
<b>Constraints Map</b>

<b>Ecology/Biodiversity</b> <i>(Based on information provided by Gloucestershire County Council's Ecologist and the Gloucestershire Centre for Environmental Records (GCER))</i>	
<b>Score</b>	--*
<b>Score Definition</b>	Overall impact on biodiversity could be potentially negative or uncertain including potential impact on an internationally designated site Scores --* indicate designated aquifer fed/surface water/flood water dependent site(s) over 1km distant which may be affected (where chosen waste technology and development design poses a risk to the water environment)
<b>Additional Comments</b>	Scores with * indicate designated aquifer fed/surface water/flood water dependent site(s) over 1km distant which may be affected, site as named above.
<b>Nearby Internationally &amp; Nationally Designated Sites Recorded</b>	Rodborough Common SAC/SSSI [725m], Selsey Common [975m]
<b>Other Internationally &amp; Nationally Designated Sites (wetlands)</b>	Severn Estuary SAC/SPA/Ramsar/SSSI [15,100m]

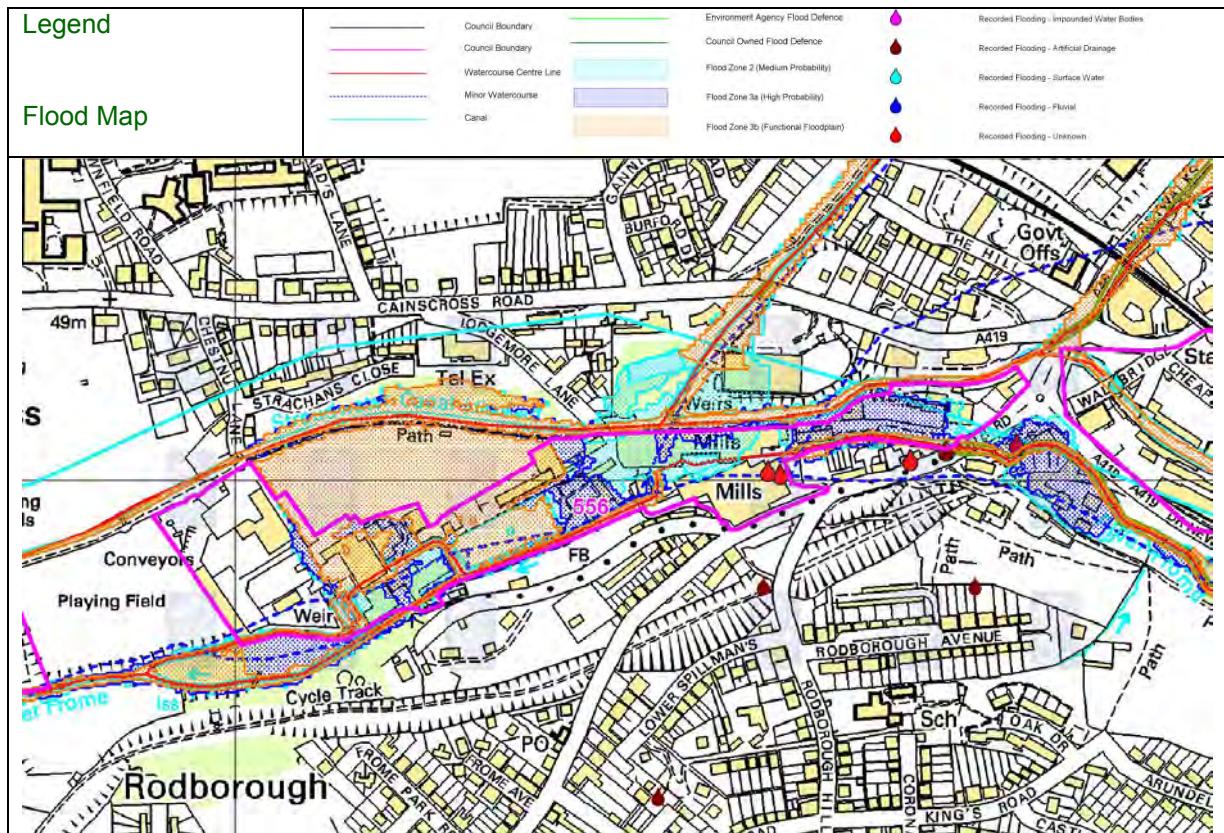
Flood Zone Information (Method used to derive Flood Zones & Confidence in Flood Zone information)	Modelled Flood Zone data exists for Flood Zones 3a and 3b which are based on Flood Zone maps produced as part of the River Frome SFRA and are deemed suitable for FRA. Flood Zone 2 has been used to represent the 100 year climate change scenario which is based on the JFLOW modelled outlines.
Fluvial Flood Risk Posed to Site (including climate change)	The majority of the western part of the site is located within Flood Zone 3b and the flood risk is considered high. The central area within the eastern part of the site is located within Flood Zone 3b. The far eastern part of the site is located within Flood Zones 2 and 3a. Small isolated areas within the site are located within Flood Zone 1. It is expected that with climate change, the depth of flooding within the site will increase but the extent of flooding will remain similar. In steep areas the velocity of flooding may also increase impacting on the flood hazard to the site.

<b>Flood Risk</b> <i>(Based on information provided by Halcrow)</i>	
Site Description	<p>This site is split into the parts with a playing field located between the western and eastern parts of the site. The River Frome flows along the southern boundary of the site intermittently entering the site itself on a number of occasions. A series of Mill channels are associated with this part of the watercourse. Two small water bodies are located within the eastern part of the site adjacent to the Mills. The Stroudwater Canal flows along the northern boundary of the site but does not enter the site itself. A number of minor watercourses flow into the canal.</p>
Watercourse(s)	River Frome
Flood Zone	1, 2, 3a and 3b

Historic Flooding/Flooding From Other Sources	Historical flood outlines for the River Frome do not extend into the site. Records of flooding from other sources were identified within the Level 1 SFRA in both the western and eastern parts of the site. The exact source of flooding is unknown. Flooding from surface water and artificial drainage sources has been identified to the west and south east of the site although there have been no reported incidents within the site itself.
Canals (Raised - breach/overtopping)	The Thames and Severn Canal is located along the northern boundary of both parts of the site. The Level 1 SFRA identified that complex interactions exist between the canal and the River Frome for much of its length, which must be considered when assessing flood risk at individual sites. There are large scale plans to re-instate the canal in the next few years. The impact of any proposals to reinstate the canal must be considered in relation to future development within the District. Consultation with BW did not identify incidents of breach or overtopping from the canal at this location. In addition, no raised sections of canal were identified at this location.

Flood Defences (Location/Type/SoP/Residual Risk)	No defences are known to exist in the site. A series of flood defence are located along the River Frome upstream of the eastern part of the site. There may be a residual risk to the site should these defences breach or overtop. This should be investigated as part of a FRA.
Culverts (Location/Type/Watercourse/Residual Risk)	Sections of culverted channel were not identified within NFCDD. Parts of the watercourse may be culverted through the site. This should be verified on site and any residual risk investigated as part of a FRA.
Score	--
Score Definition	Site is mainly in Flood Zone 3b (Historical flood risk, flood risk from other sources and residual risk has been incorporated into the determination of the suitability score).
Additional Comments	Although not all of the site is located within Flood Zone 3b, a large part of the site is located within Flood Zones 2 and 3a and there are records of flooding from other sources. In addition, the canal may present a residual risk to the site.
