B976 LYDBROOK RAILWAY BRIDGE FEASIBILITY STUDY

B976 Revision D

August 2017

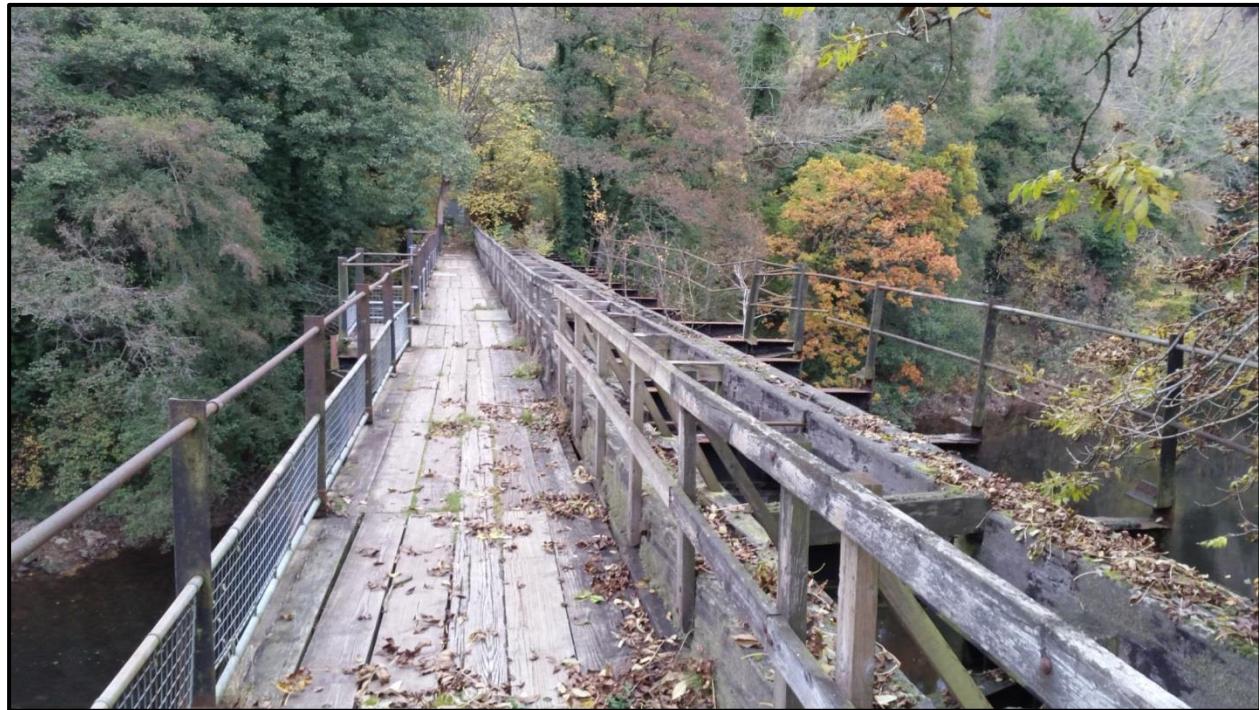
Picture 14. Walk way

The footway is located at the western edge of the deck. The walkway is made of timber planks which span between the transverse beams. The timber planks are placed on and bolted to the top flange of the transverse beams with a pair of bolts at each end. The planks are severely rotten and several planks are completely missing and replaced with plywood panels which make the use of this walkway by pedestrians unsafe.

The decay of the timber walkway has been a problem with significant impact on the maintenance cost of the footway since it was opened. The main maintenance works were carried out in 1992 where the timber planks were taken up and replaced. Even though the new planks were treated to improve its lifespan, the maintenance works on these elements has been continuous. The last main repair works on the walkway were carried out in 2009 where 43 No timber planks were replaced. The historical maintenance records of the structure make it clear that the environmental conditions of the site must be considered when refurbishing the bridge.

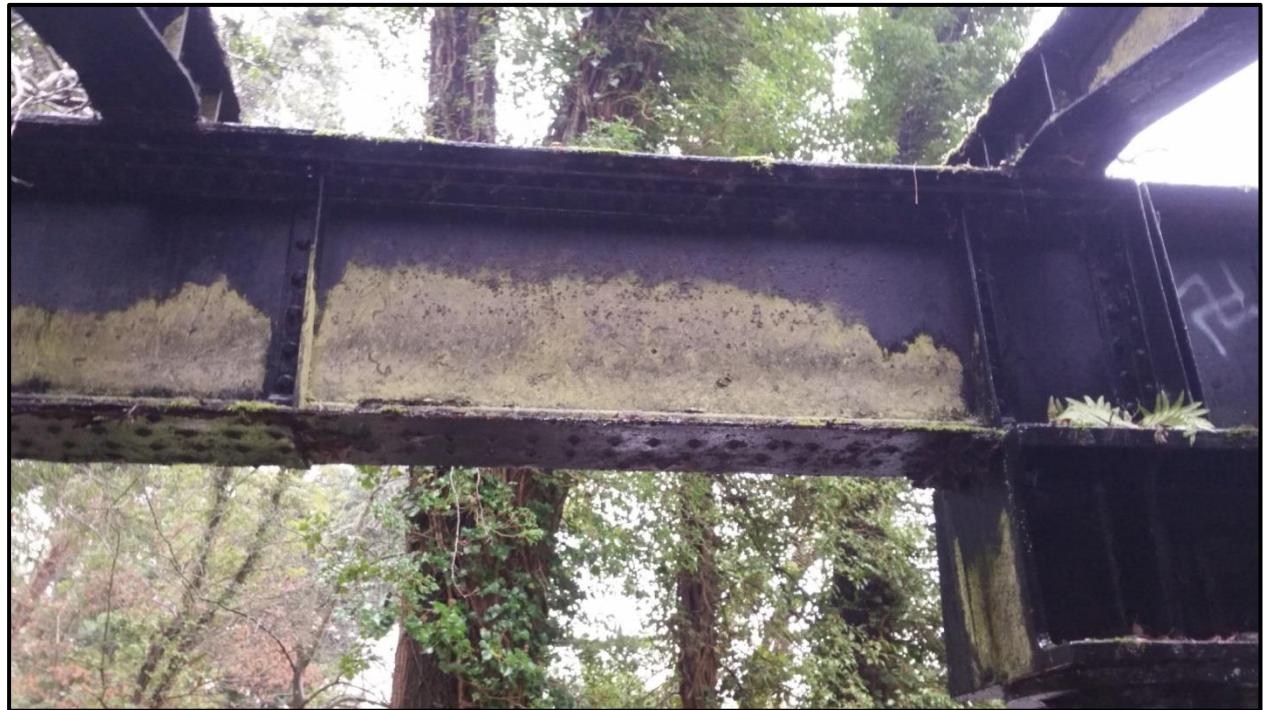
Picture 16. Main girder

The girders are built-up girders with plates riveted together. Although the girders are in a general fair condition the bottom flanges present delamination due to a severe corrosion as well as a marked distortion induced by rust jacking. The 2016 PI report indicates that slight distortion was noted at the majority of joints with missing rivets.

Although an accurate survey would be necessary to determinate the actual strain of the plates, based on the visual appearance of the plates, it is possible to deduce that they have already reached the yielding point. The distortion of the plates has induced a significant tension in the rivets. This has implications on the safety of the structure as the elements would have become more brittle, and therefore its capacity to deform before failure.

Considering the stress-strain uncertainty of the bottom flanges and stiffeners and the consequences that a failure of these elements could have, it is recommended that an accurate assessment of these elements is undertaken before re-opening the bridge to the public.

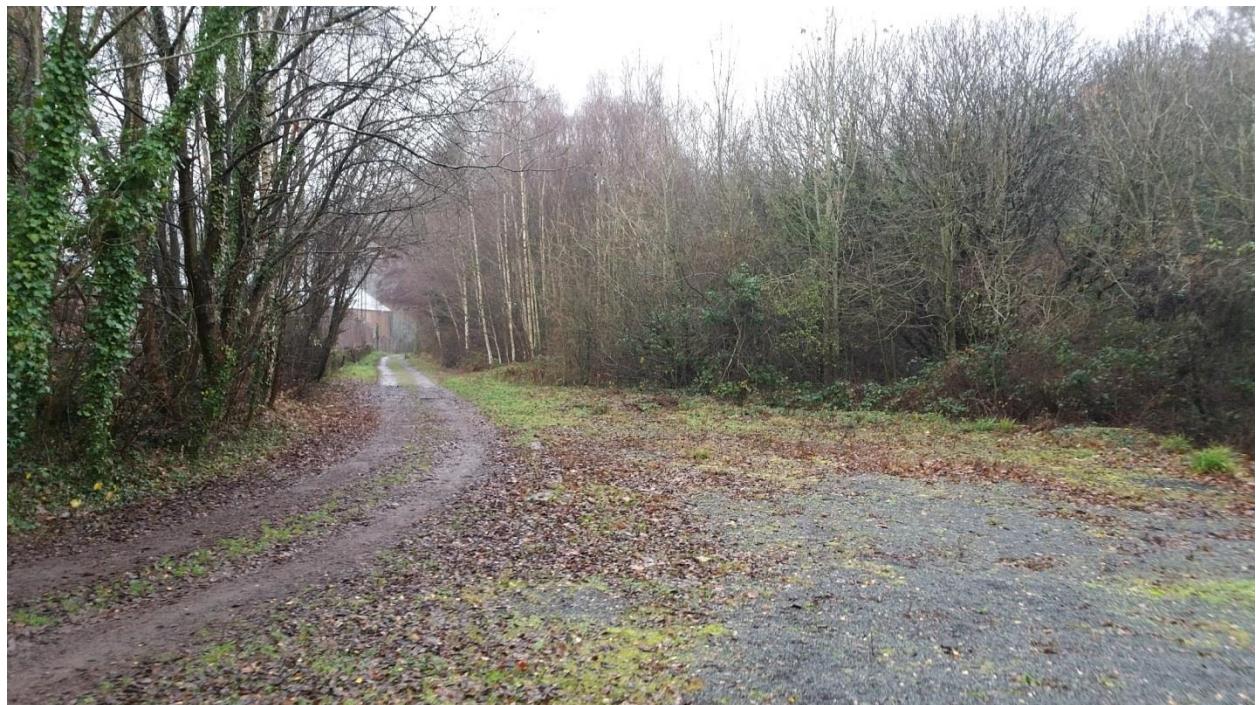
Picture 26. Access to bridge

The bridge is accessed from the track via approach steps made of timber boards backed with compacted granular material located at the east side of the southern abutment.
