PRINCIPAL INSPECTION

Lydbrook Rail Bridge B976

21st – 24th March 2016

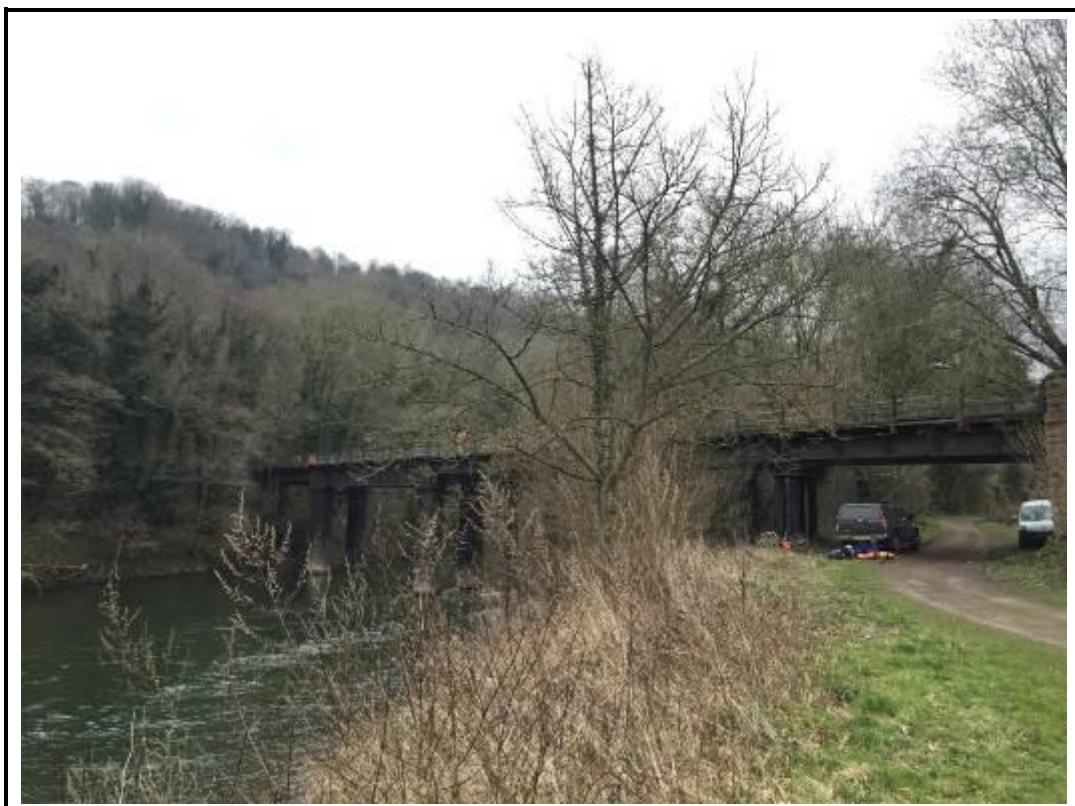
Photo 1. View from downside.

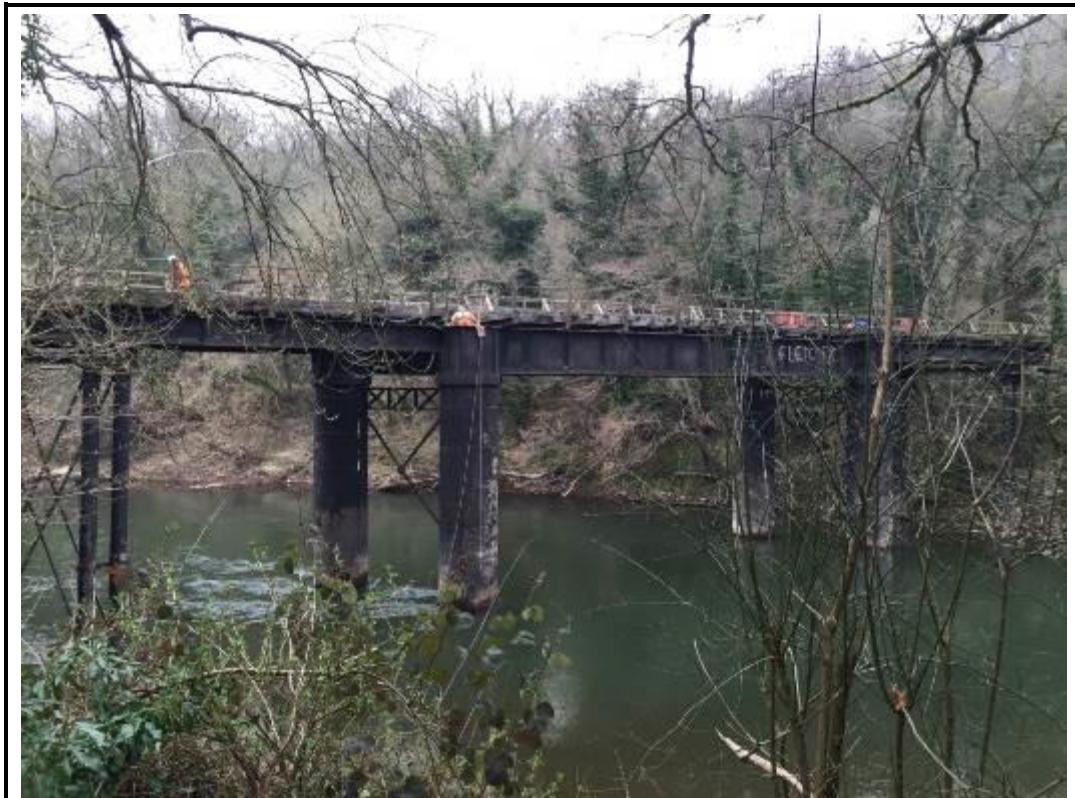
Photo 2. View from upside.

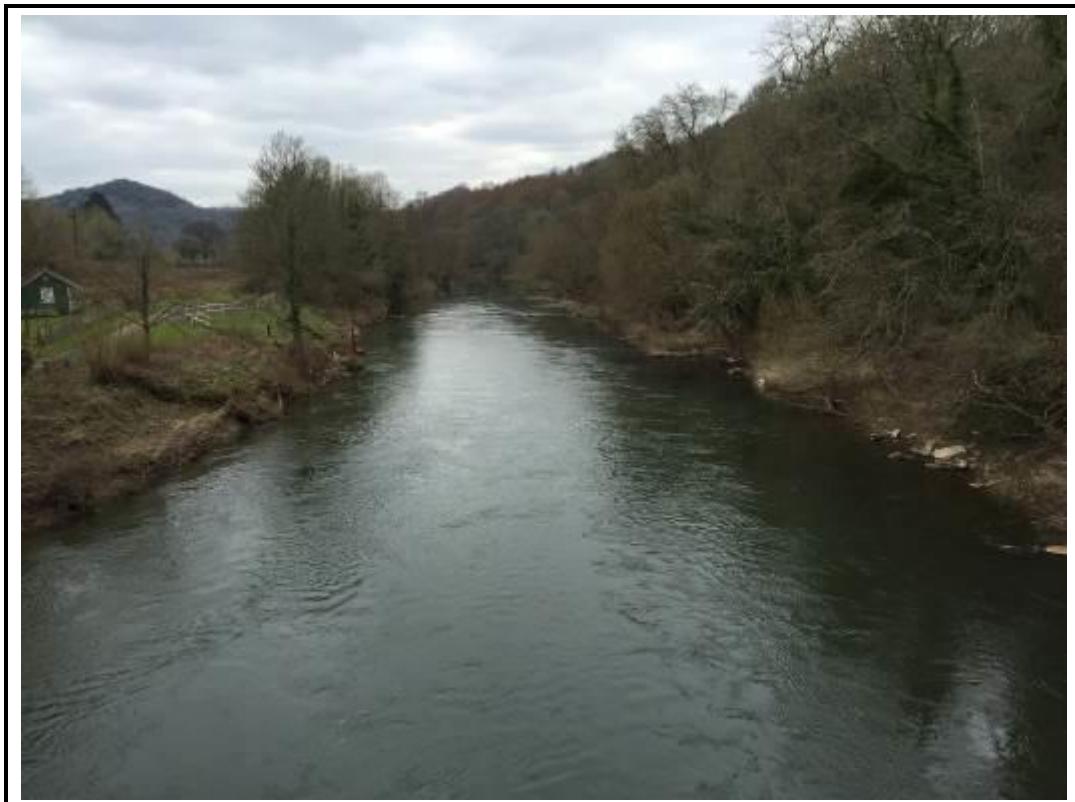
Photo 3. View looking away to downside.

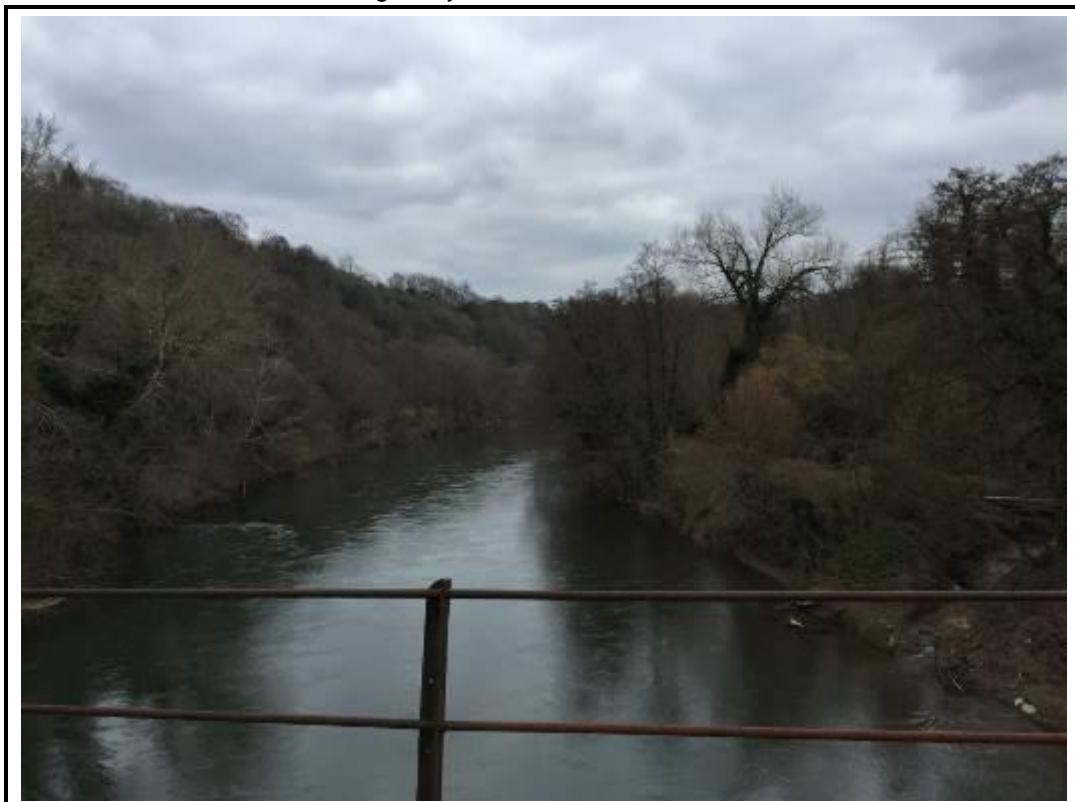
Photo 4. View looking away to upside.

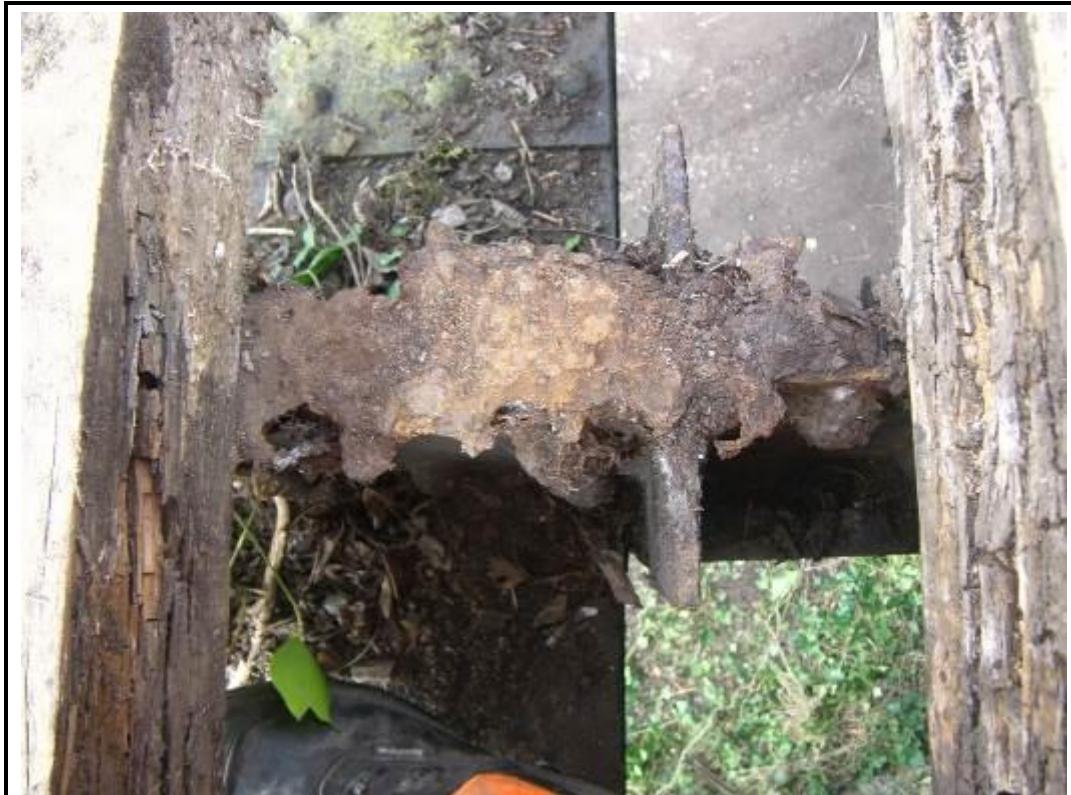
Loss of section was noted throughout the top flanges with an estimated 35% loss to over half of the beams ([Photo 11](#)). The worst affected areas are below the walkway timbers. In places the timber decking is supported directly on the web of the beams. This is particularly bad where the path steps out over the caissons ([Photo 12](#)).

Photo 12. View of loss of section to transverse beams below walkway.

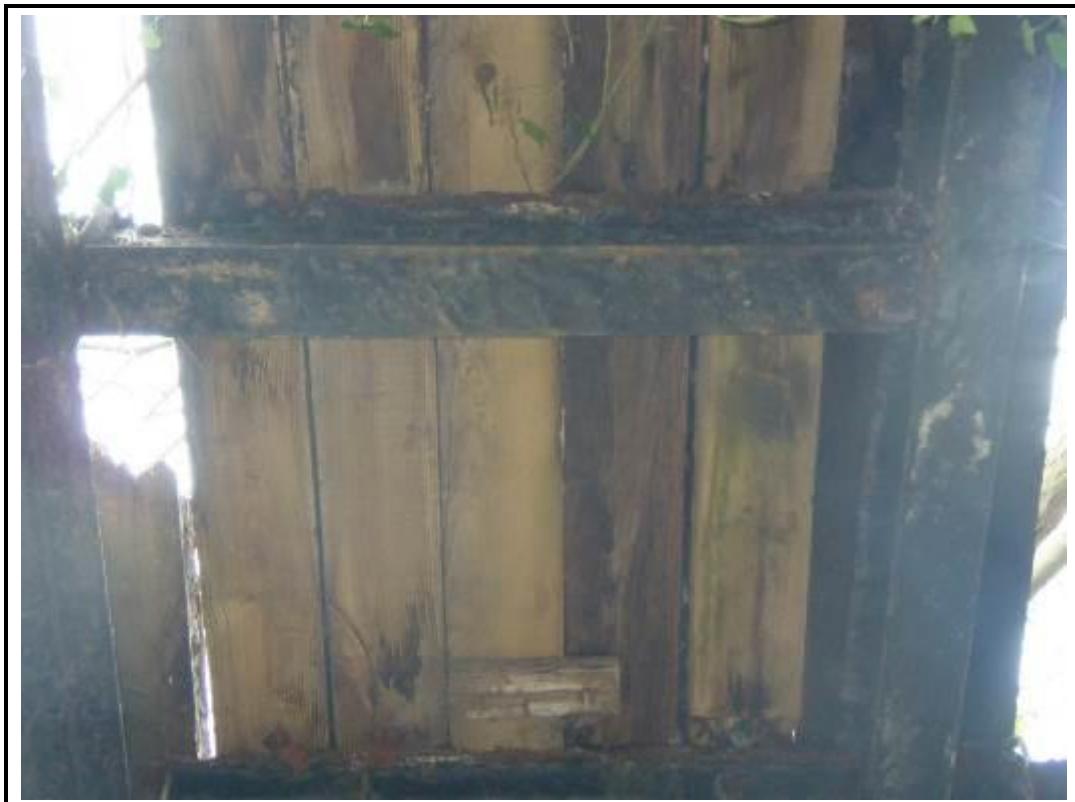
The timbers are fixed with clamps; in some areas due to corrosion these clamps are ineffectual ([Photo 13](#)).

Photo 13. View of ineffectual timber clamps beneath walkway.

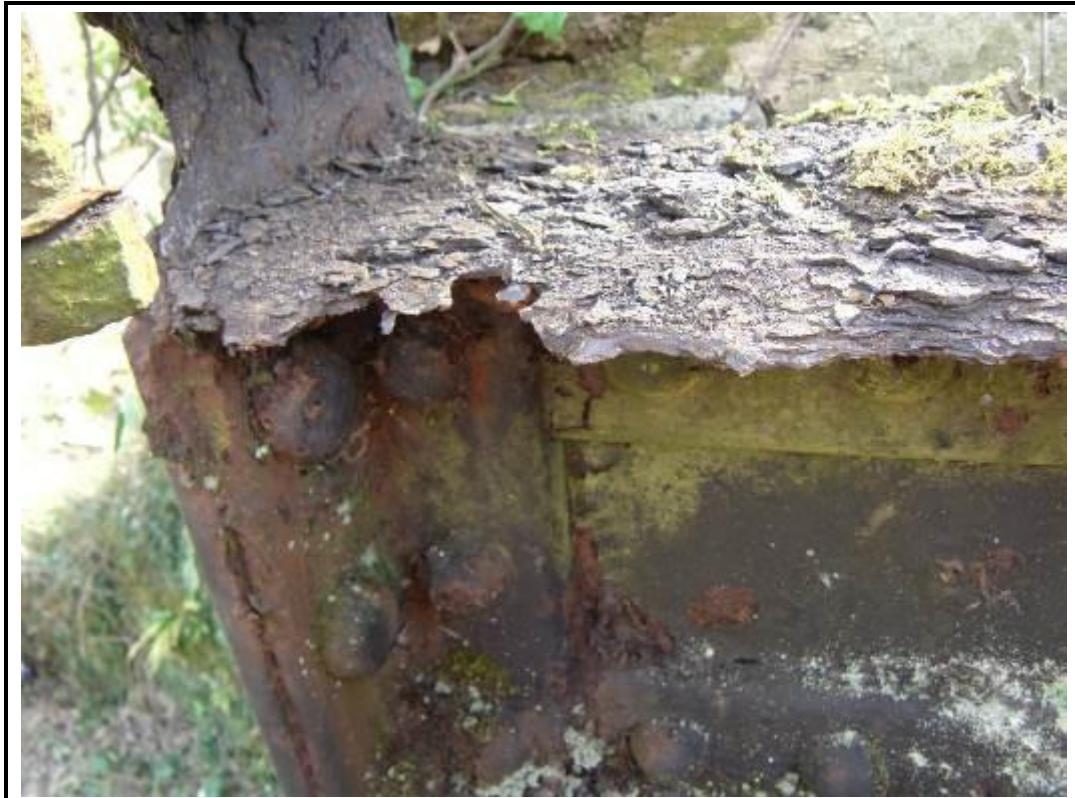
The top flanges also show severe lamination and knife edging throughout the structure ([Photo 14](#)).

Photo 14. View of lamination, loss and knife edging to top flange, transverse beams.

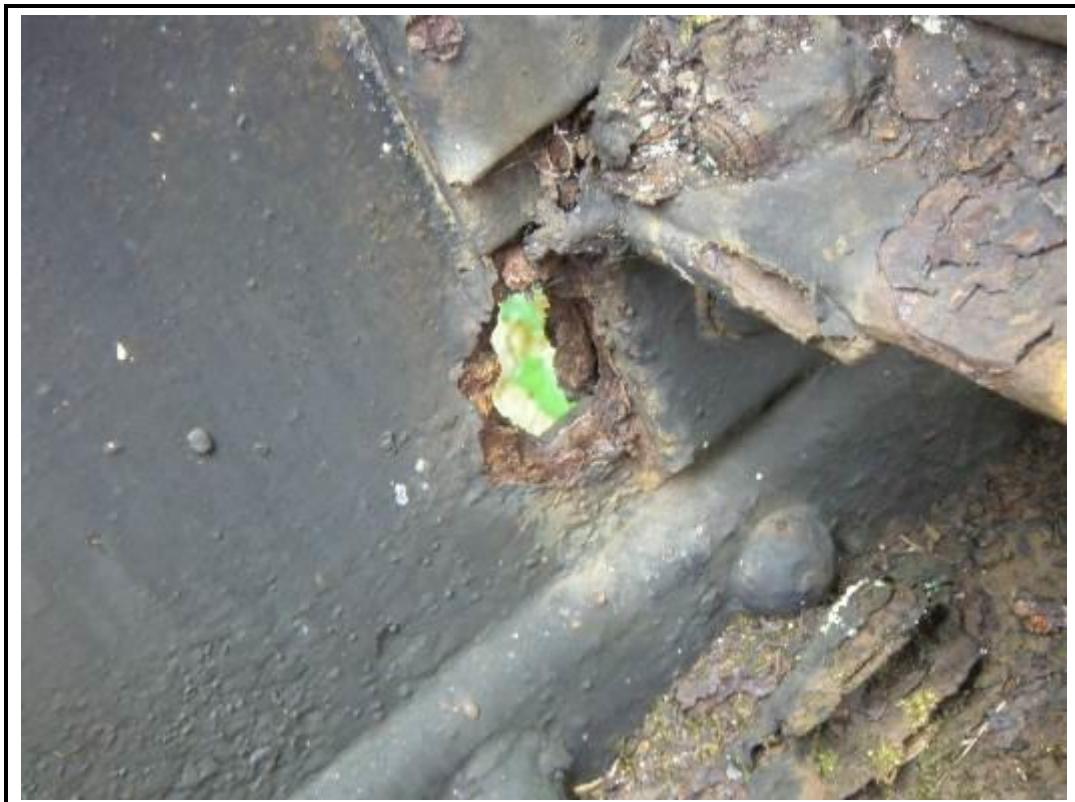
The final girder at the high mileage end show specific loss of section to the web measuring 80mm L x 40mm W ([Photo 15](#)).

Photo 15. View of loss of section to web of transverse beam.

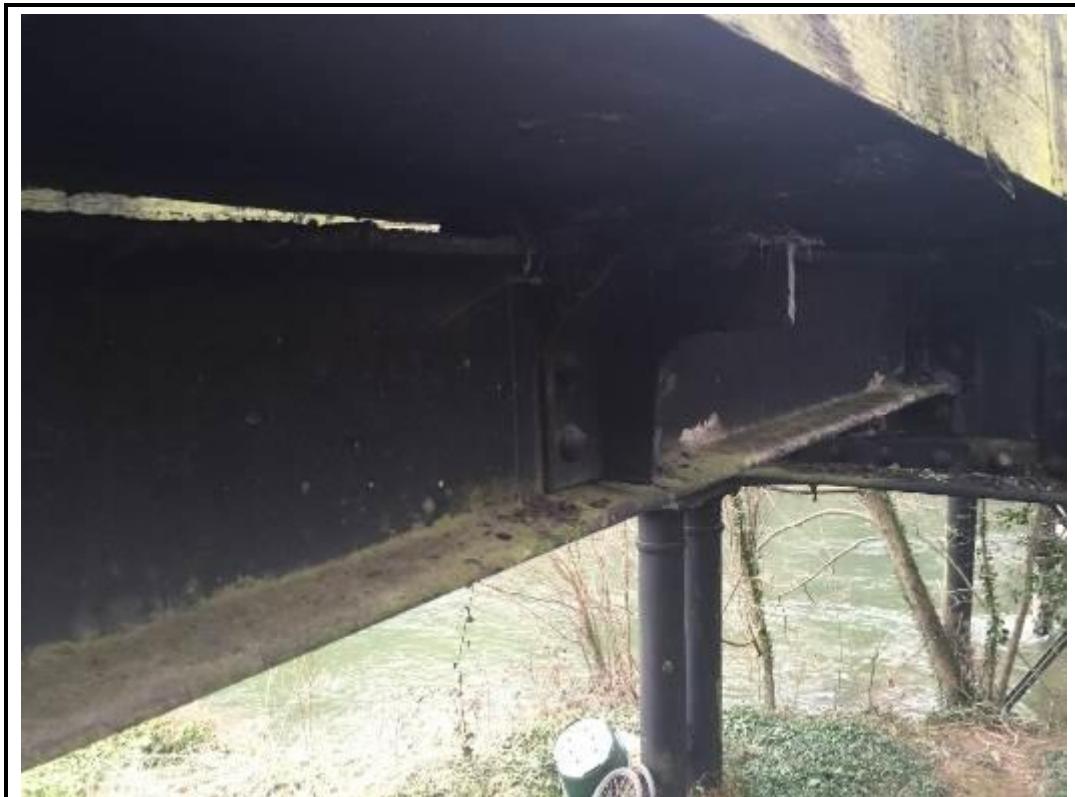
The longitudinal beams (constructed from rolled steel) which support the timber baulks are in fair condition ([Photo 16](#)). There are some isolated areas of loss of section to the top flanges where packing pieces between the beam and timber baulk used to be ([Photo 17](#)). Some of the connections to the transverse beams are badly corroded ([Photo 18](#)).

Photo 16. View of longitudinal support beam.

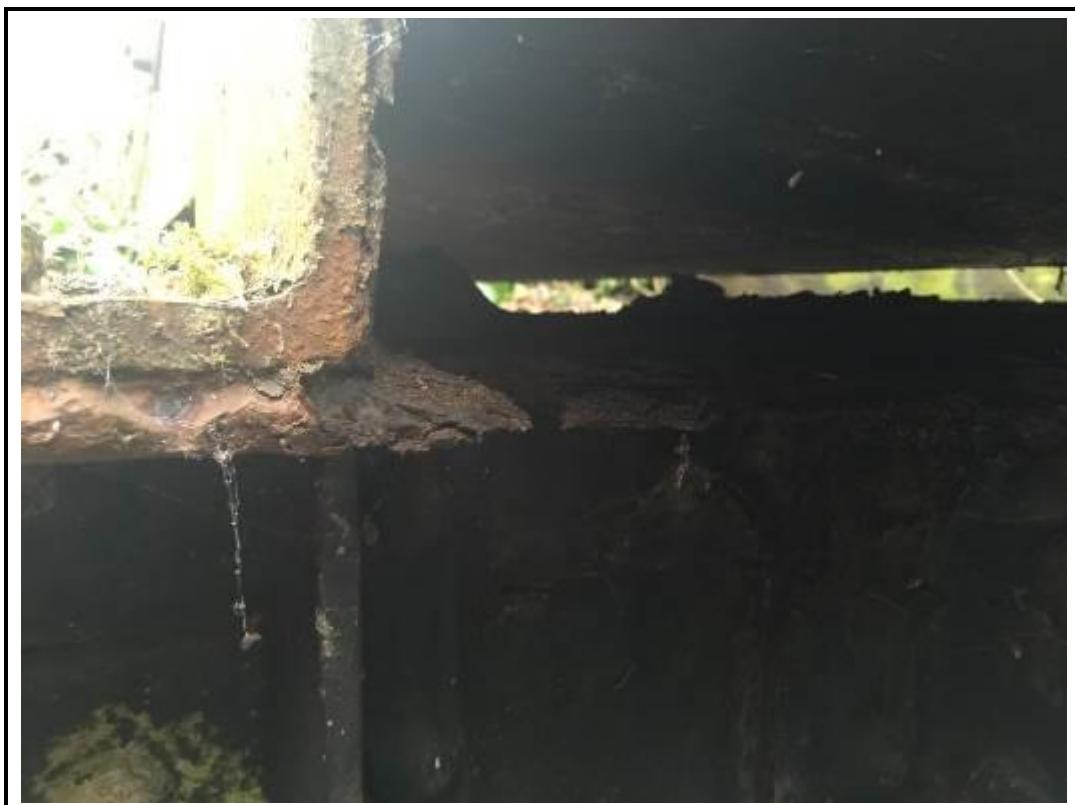
Photo 17. View of loss of section to top of longitudinal beams.

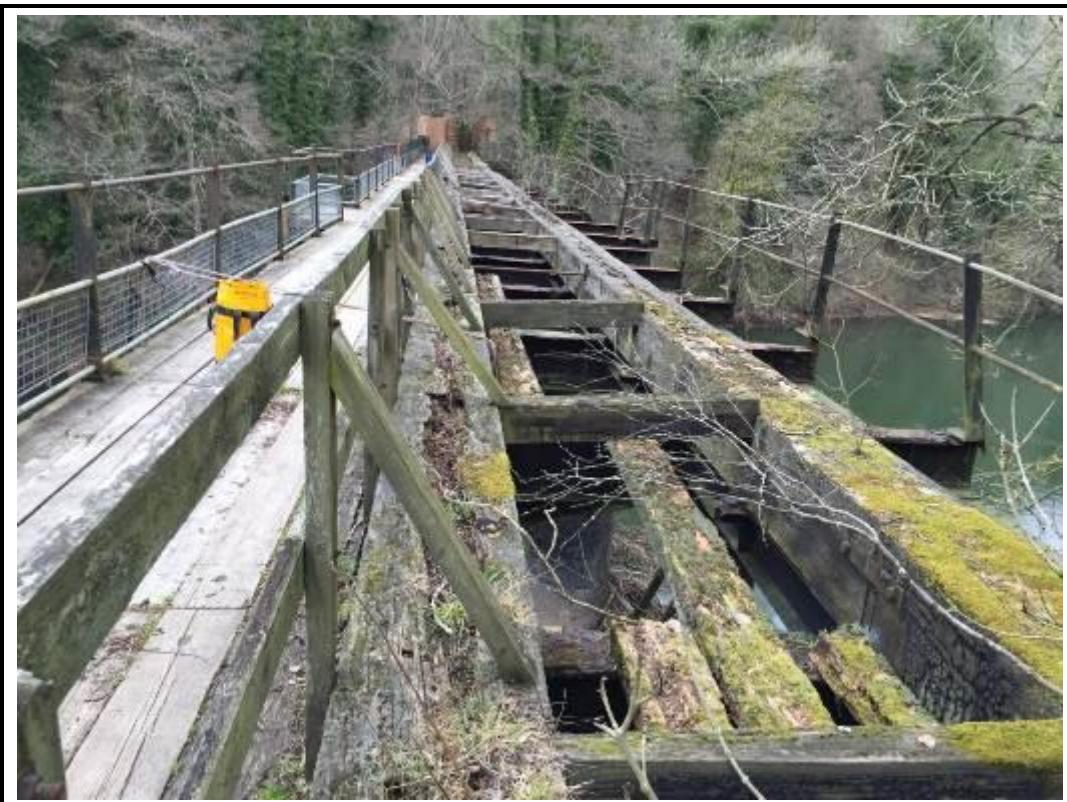
The timber baulks are in a poor condition ([Photo 19](#)). They are rotten throughout to a max depth of 250mm with loss of section to half depth to around 10% of both timbers ([Photo 20](#)) making them structurally irrelevant. There is also a large split to the upside timber above pier 6 ([Photo 21](#)); numerous small splits were found throughout both timbers. Vegetation is growing from the timbers throughout; some of this was removed at the time of inspection ([Photo 22](#)). There are also transverse steel tie bars ([Photo 23](#)) and transverse timbers ([Photo 24](#)) running between the two timber baulks. The tie bars are corroded throughout up to 3mm deep. There are 5no missing cross timbers and 4no of displaced timbers ([Photo 25](#)). The remaining timbers are in poor condition.

Photo 19. View of timber rail bearers.

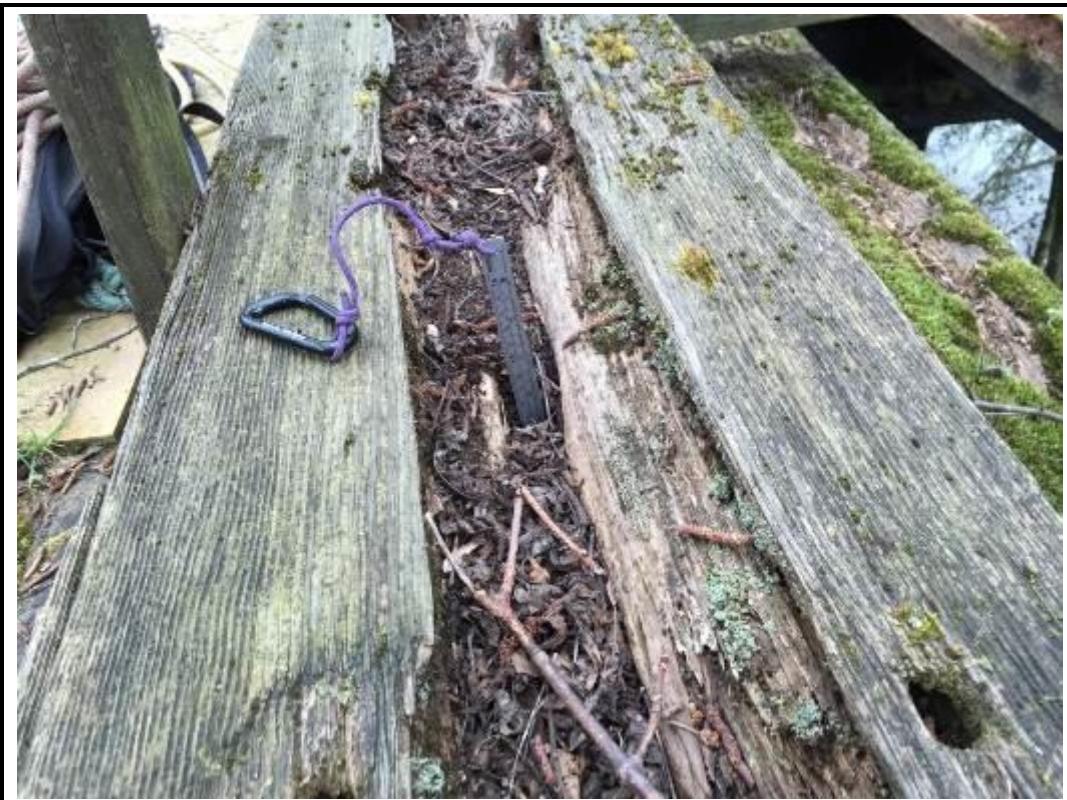
Photo 20. View of loss of section and rotting to timber baulk.

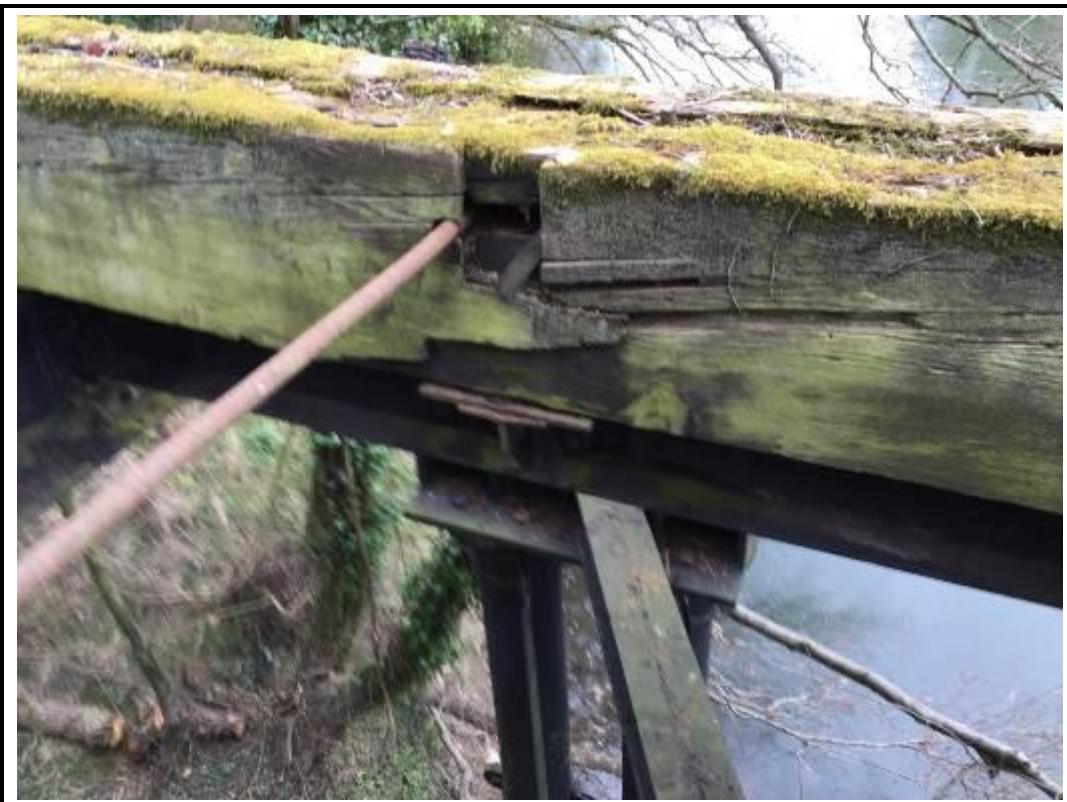
Photo 21. View of splitting to timber baulk.

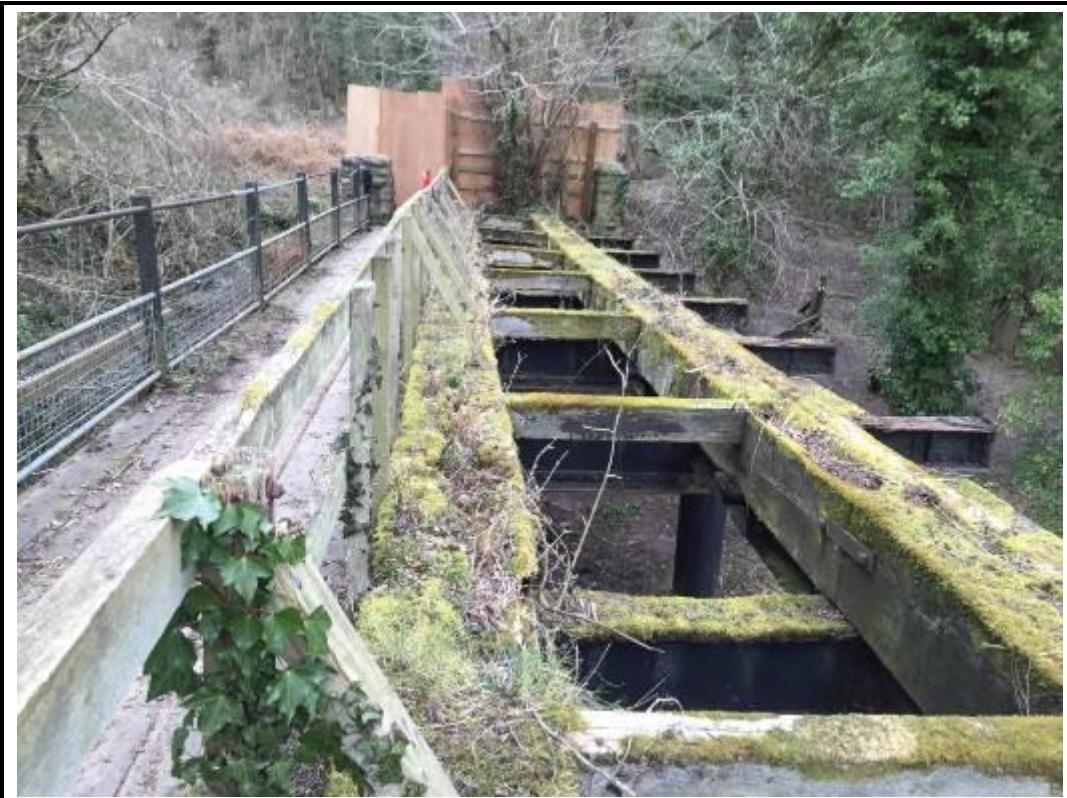
Photo 22. View of vegetation growth on timber baulks.

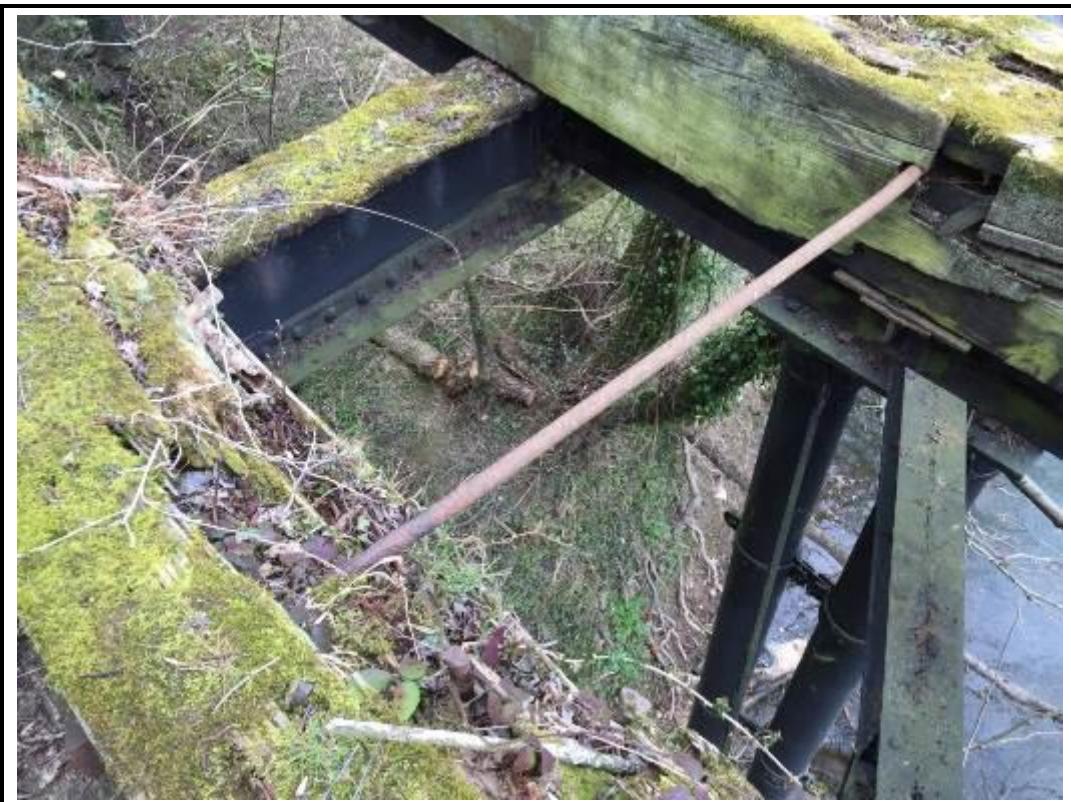
Photo 23. View of steel tie bar between timber baulks.

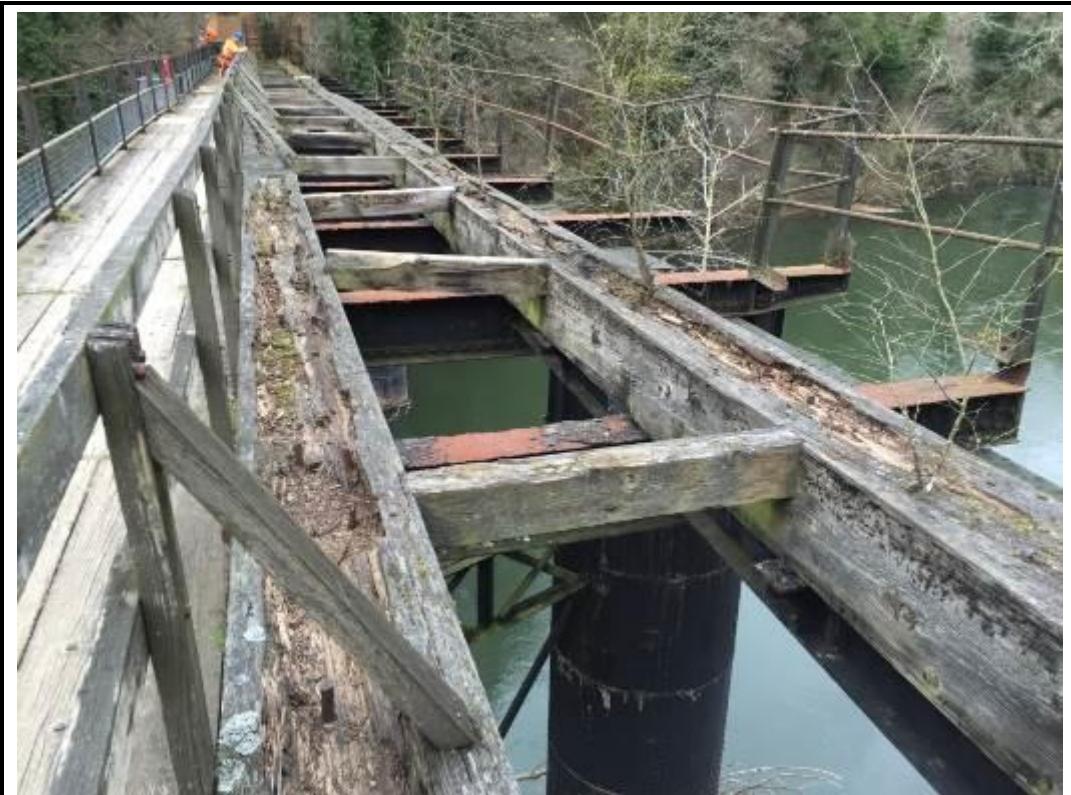
Photo 24. View of timber cross beams between timber baulks.

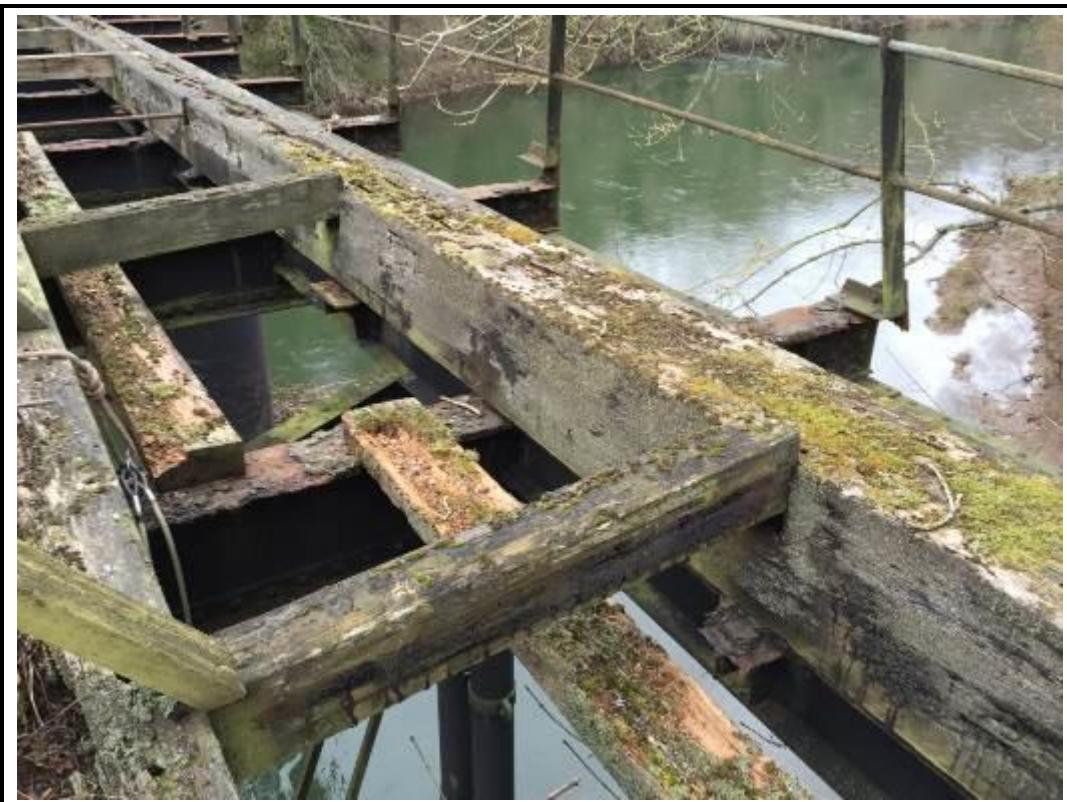
Photo 25. View of displaced cross timbers.

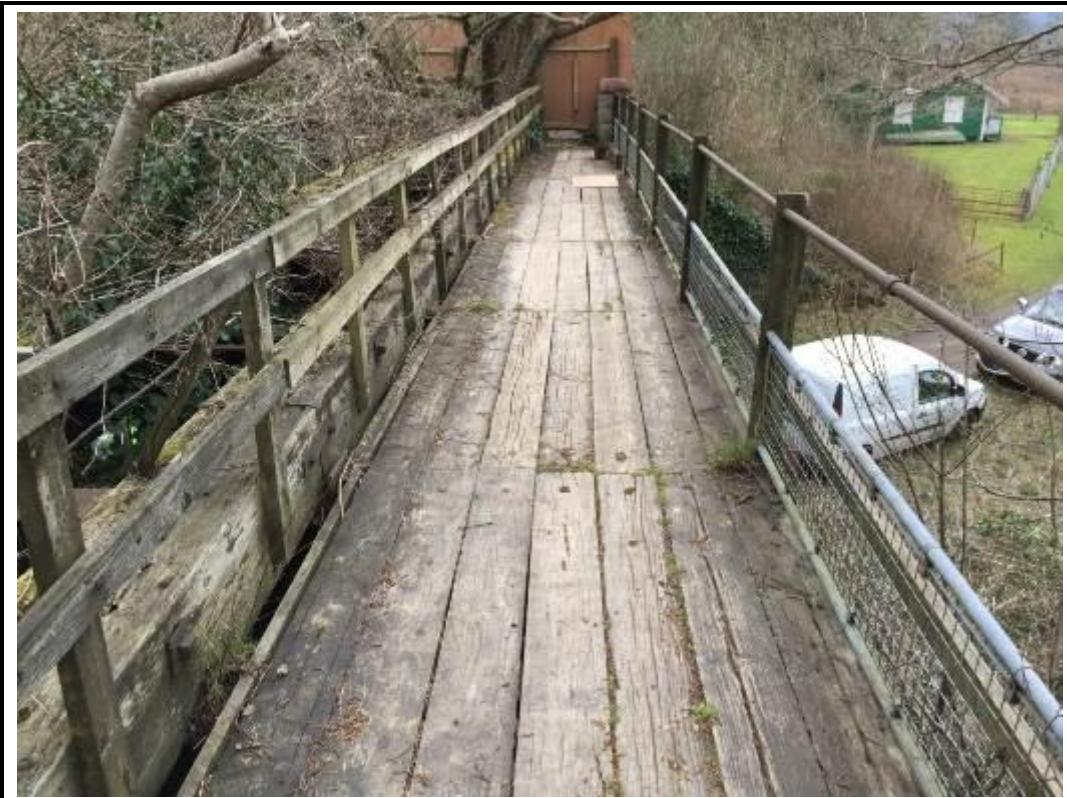
The timber walkway planks are in poor condition ([Photo 26](#)). There are several areas of plywood repairs ([Photo 27](#)) that cover collapsed timbers beneath ([Photo 28](#)). There are 4no missing or removed planks due to being rotten and no longer secured to the top flange of the transverse beams ([Photo 29 + 30](#)). The worst affected areas are at the high and low mileage ends. **These missing planks should be repaired before the walkway is re-opened.**

Photo 26. View of timber walkway planks.

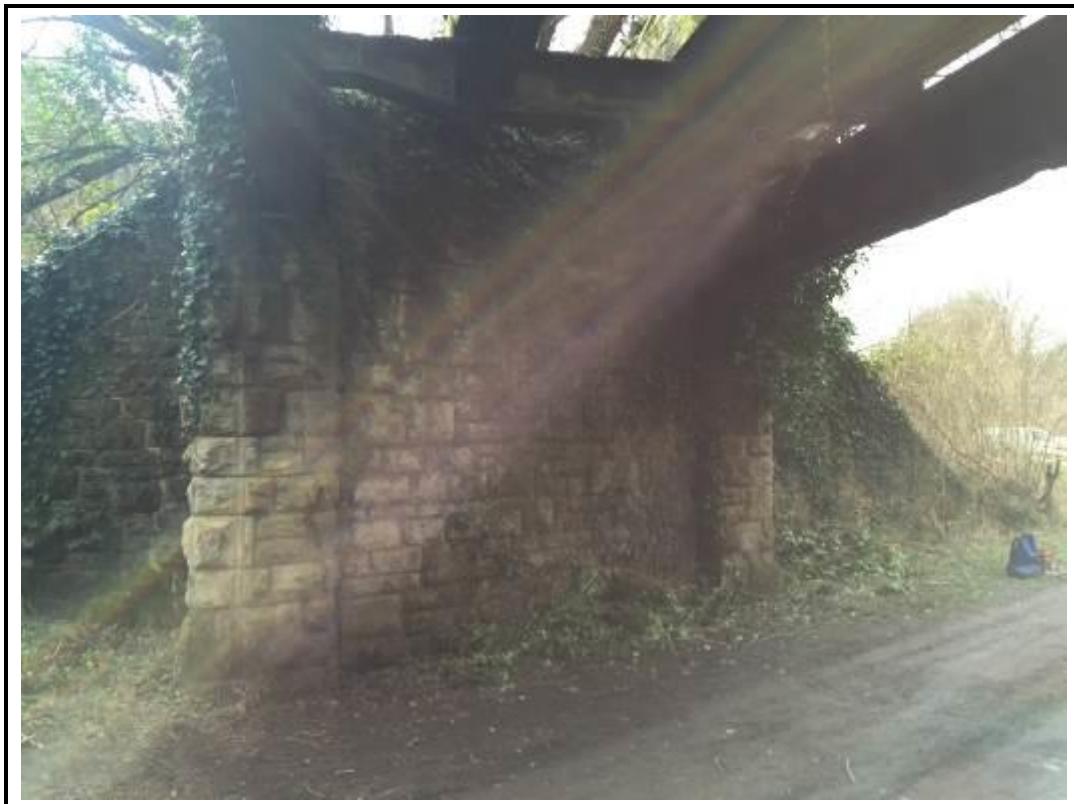
Low Mileage ([Photo 31](#))

Photo 31. View of Low Mileage abutment.

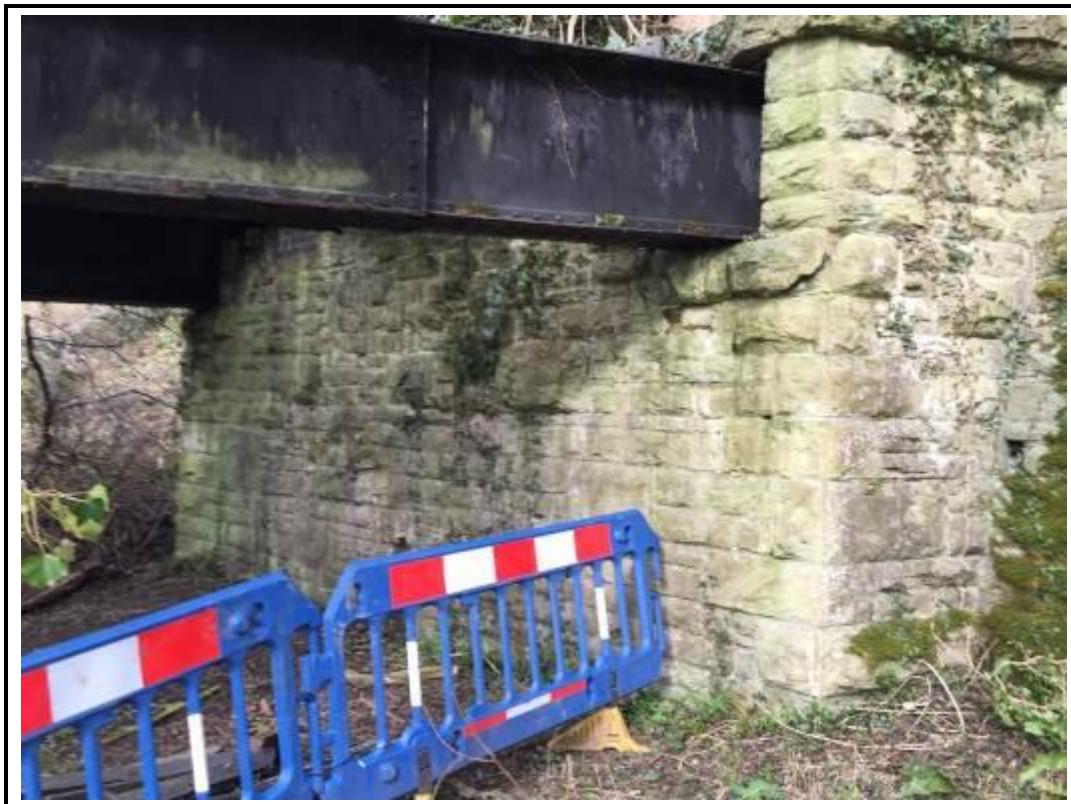
High Mileage ([Photo 37](#))

Photo 37. View of high mileage abutment.

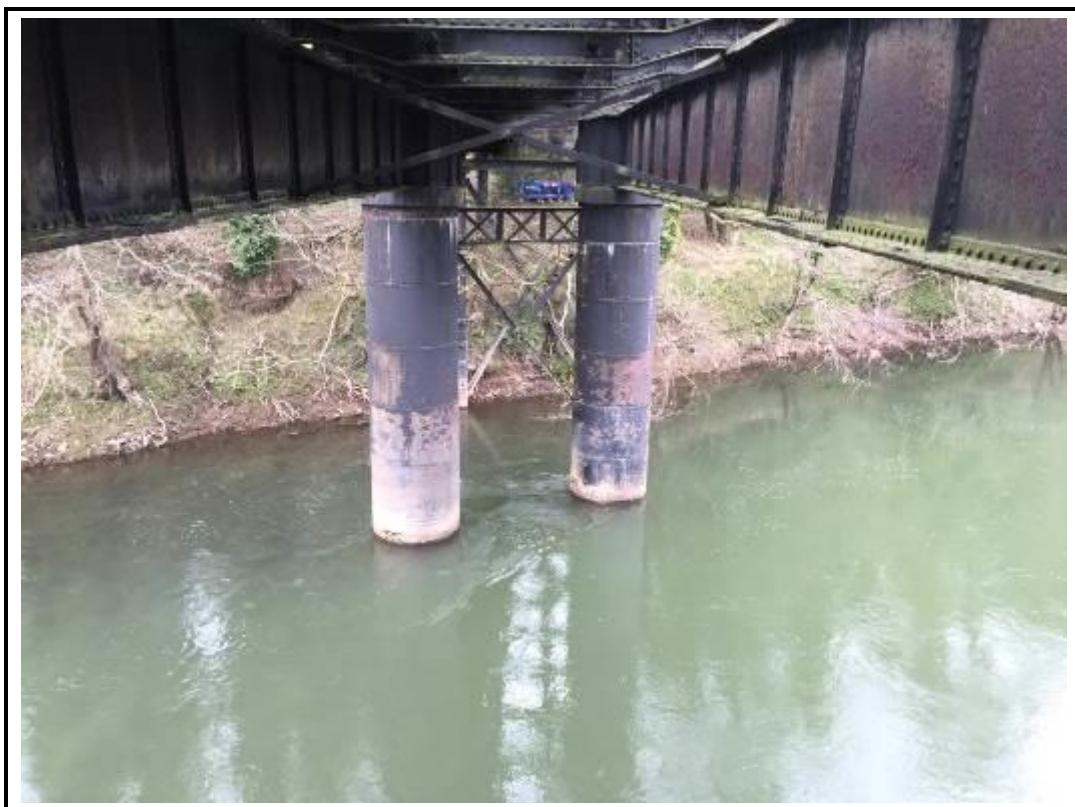
The main span is supported by pier 4 and 5 each consisting of 2no caissons, each approximately 1.5m diameter ([Photo 41](#)). The top 1m to the base of the main girders are hollow. This is filled with debris and has saplings growing from within ([Photo 42](#)).

Photo 41. View of main span pier construction.

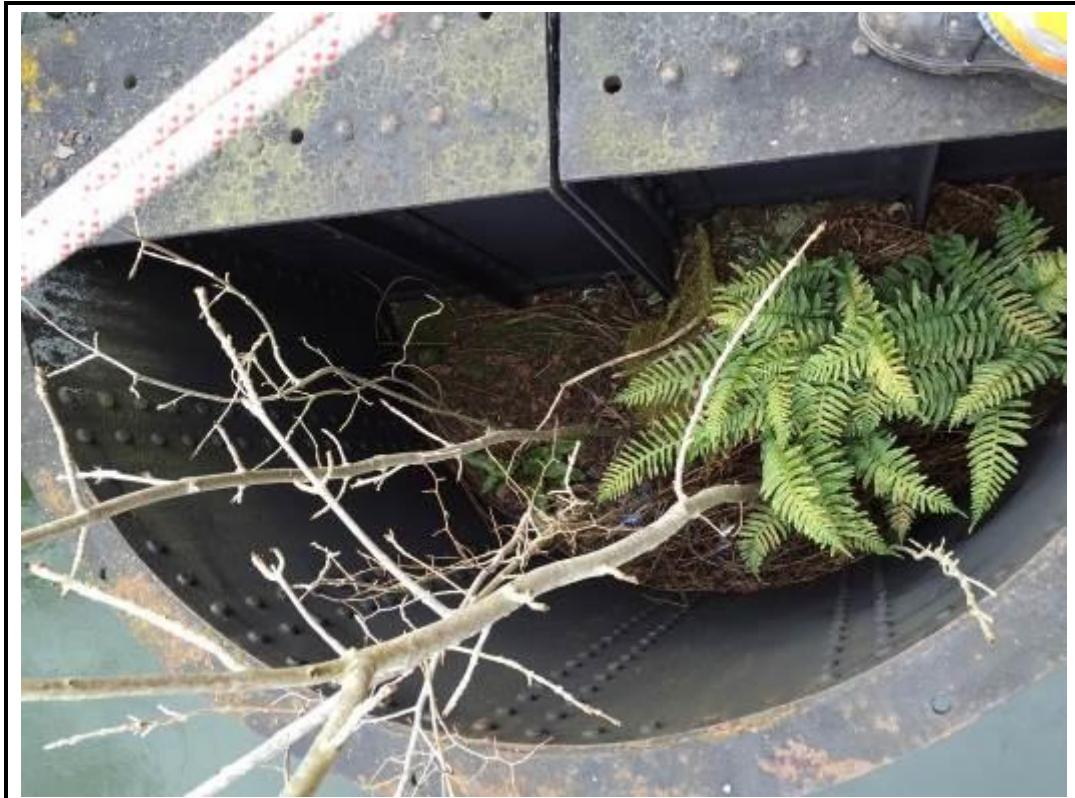
Photo 42. View of typical vegetation growth within caissons.

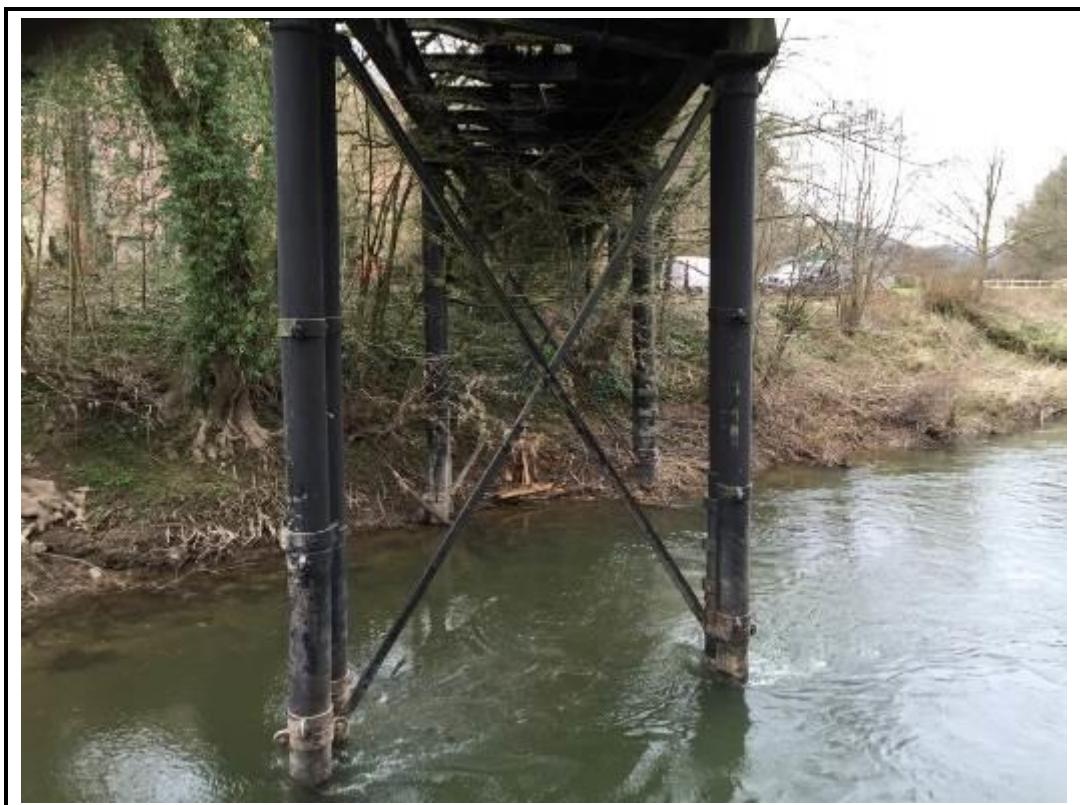
The remaining piers are in a fair condition. They consist of 4no columns each with a steel box sat between two columns and the main girders ([Photo 47](#)).

Photo 47. View of secondary pier construction.

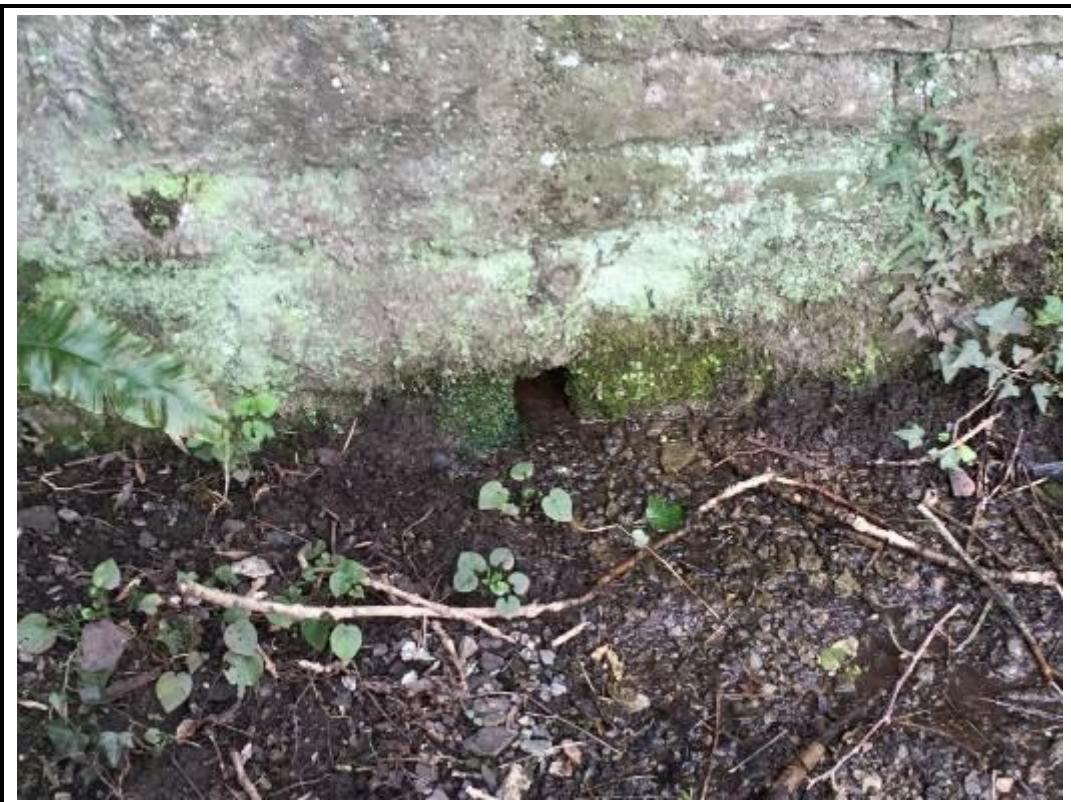
Photo 51. View of weep hole in high mileage abutment.

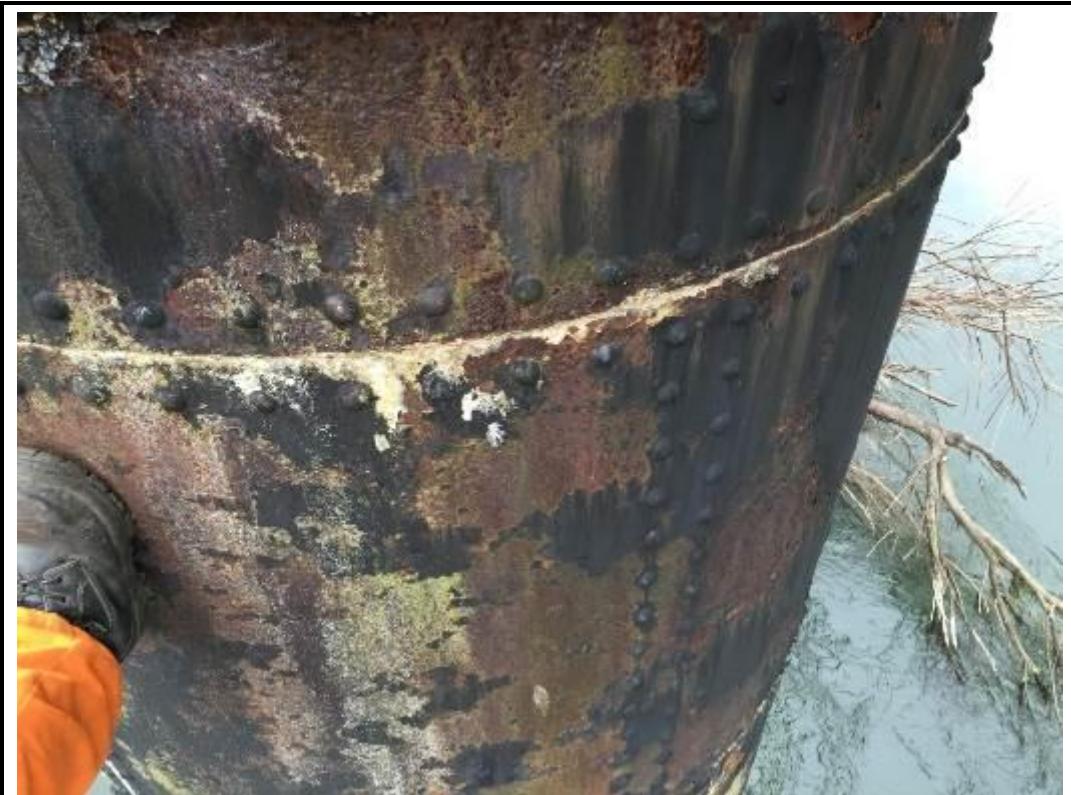
Photo 52. View of typical paint loss to piers 4 and 5.
