PRINCIPAL INSPECTION

Lydbrook Rail Bridge B976

21st – 24th March 2016

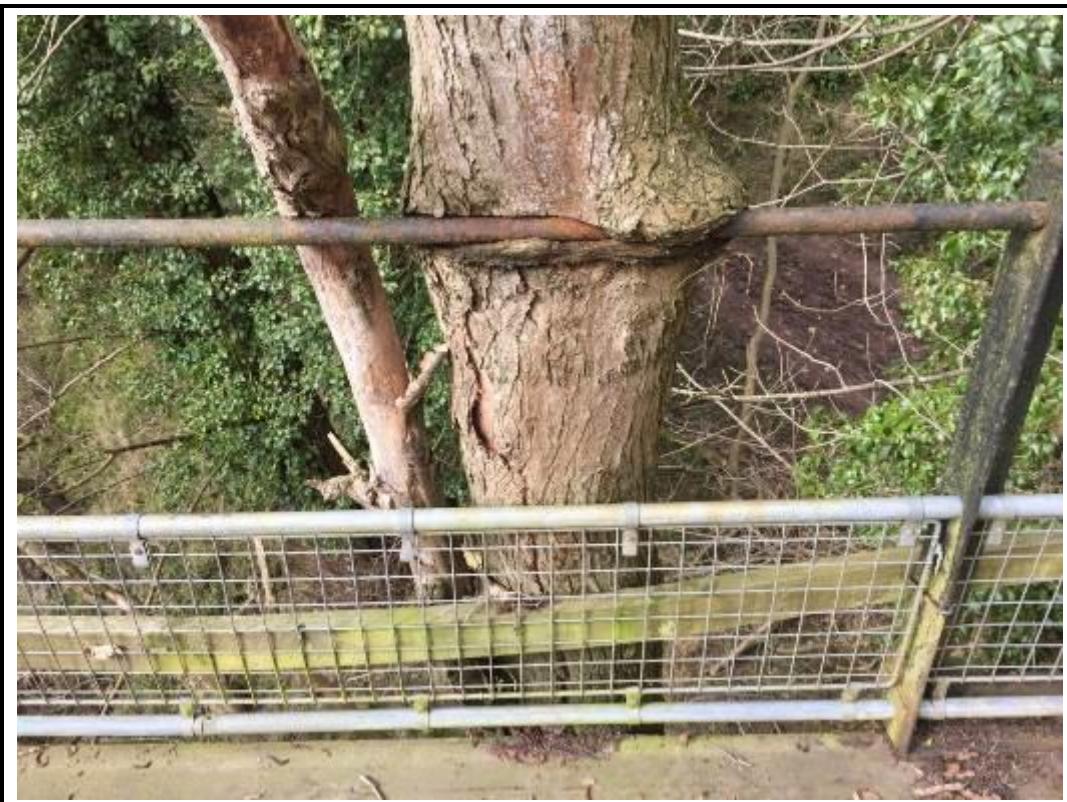
Adjacent to pier 6 a tree is growing around the handrail ([Photo 59](#)).

Photo 59. View of tree growth affecting downside handrail.

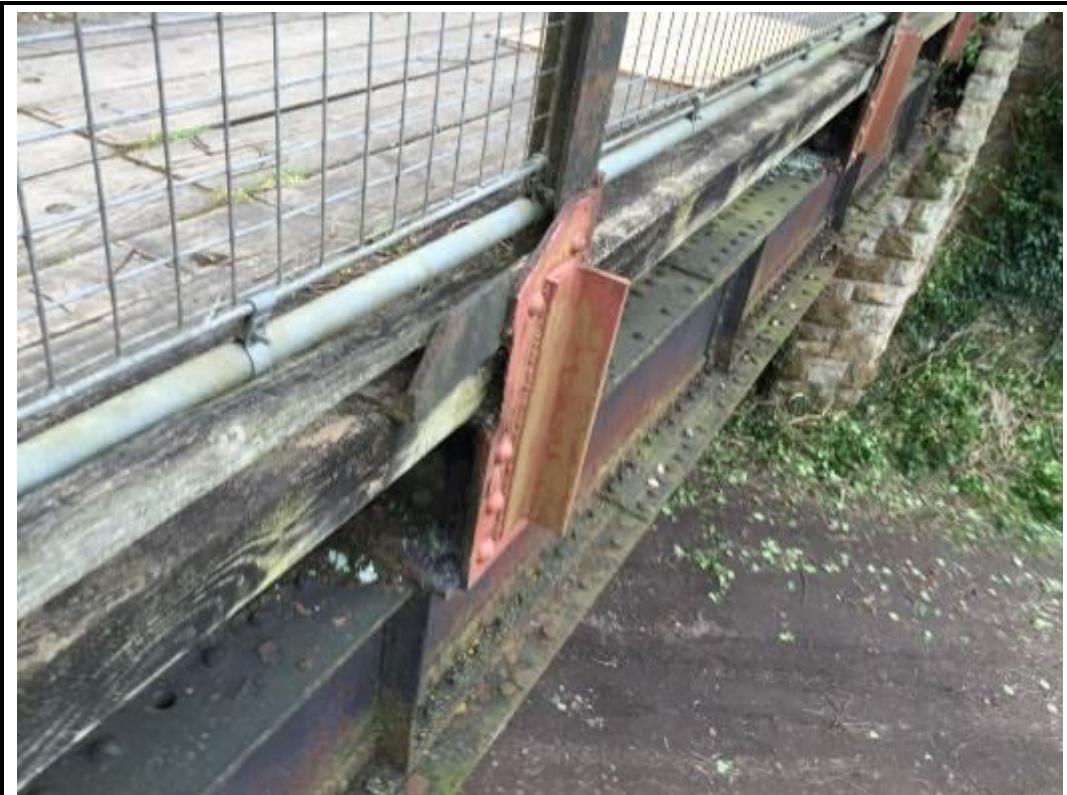
Secondary bracing has been put in place at every upright to stop the handrail collapsing in the same manner as the upside ([Photo 60](#)).

Photo 60. View of added bracing to downside handrail uprights.

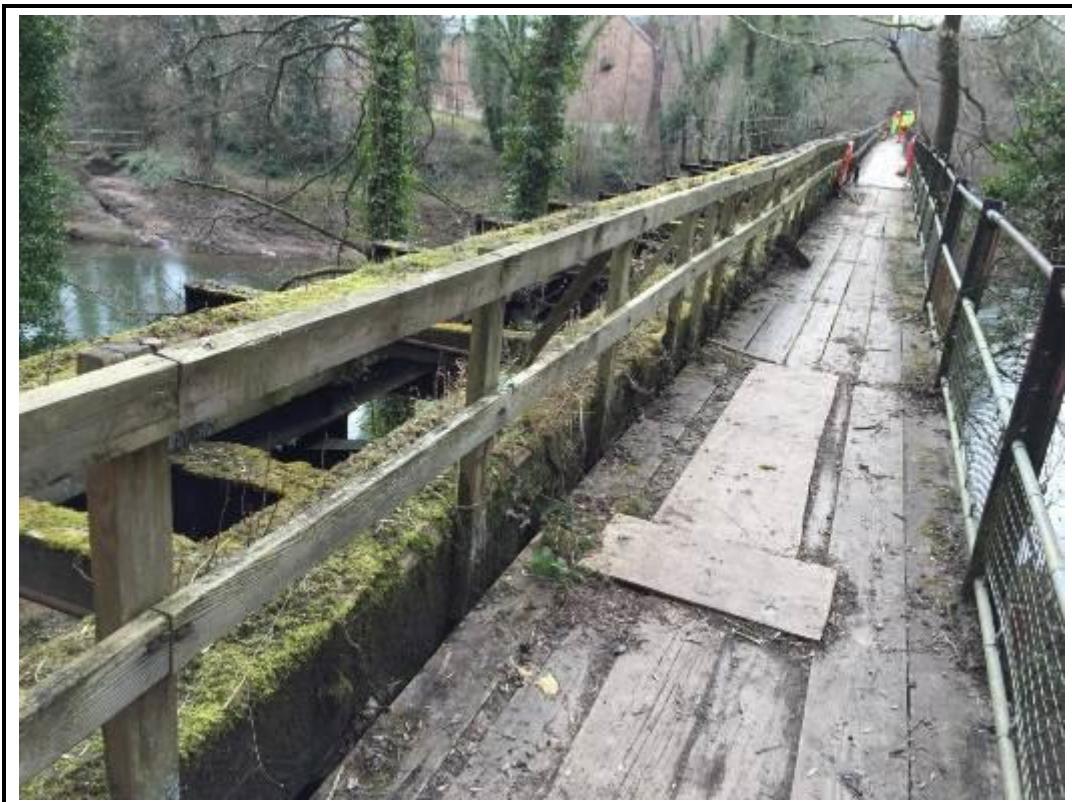
The walkway upside safety fence is constructed from timber and attached to the rotten downside timber baulk ([Photo 61](#)). The majority of the fence timbers are rotten throughout and splits are present around the lower fixing bolts ([Photo 62](#)).

Photo 61. View of upside walkway handrail.

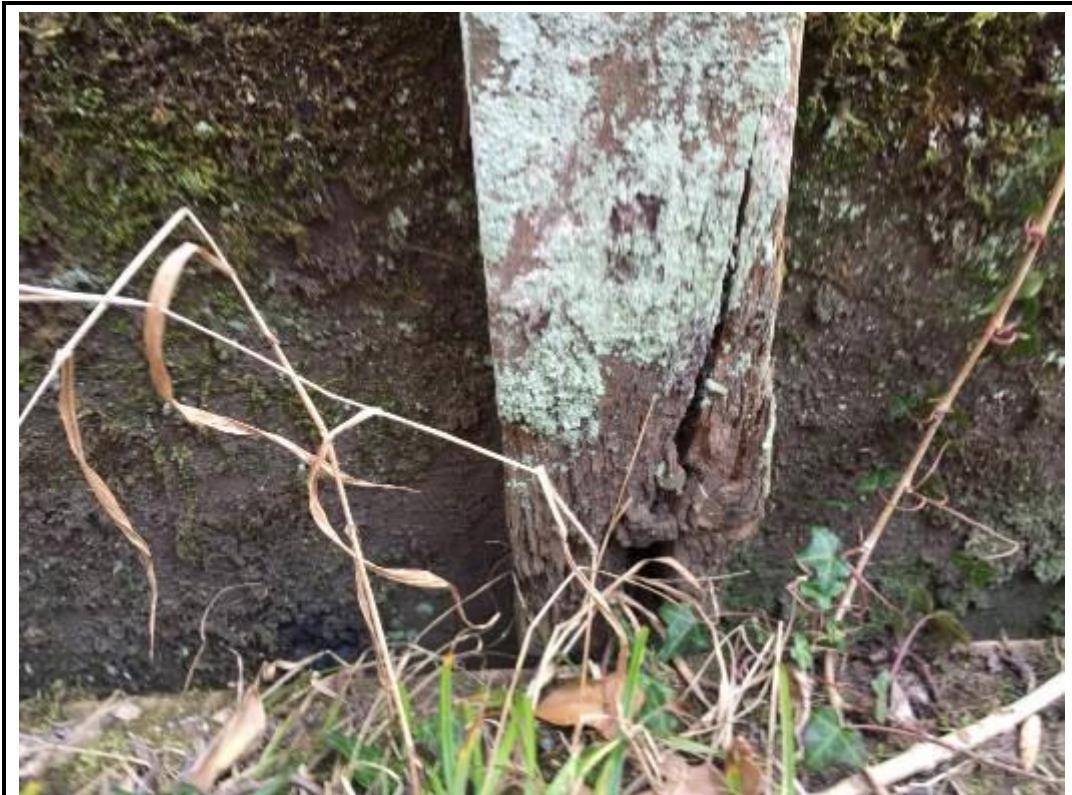
Photo 62. View of typical splitting to base of timber handrail.

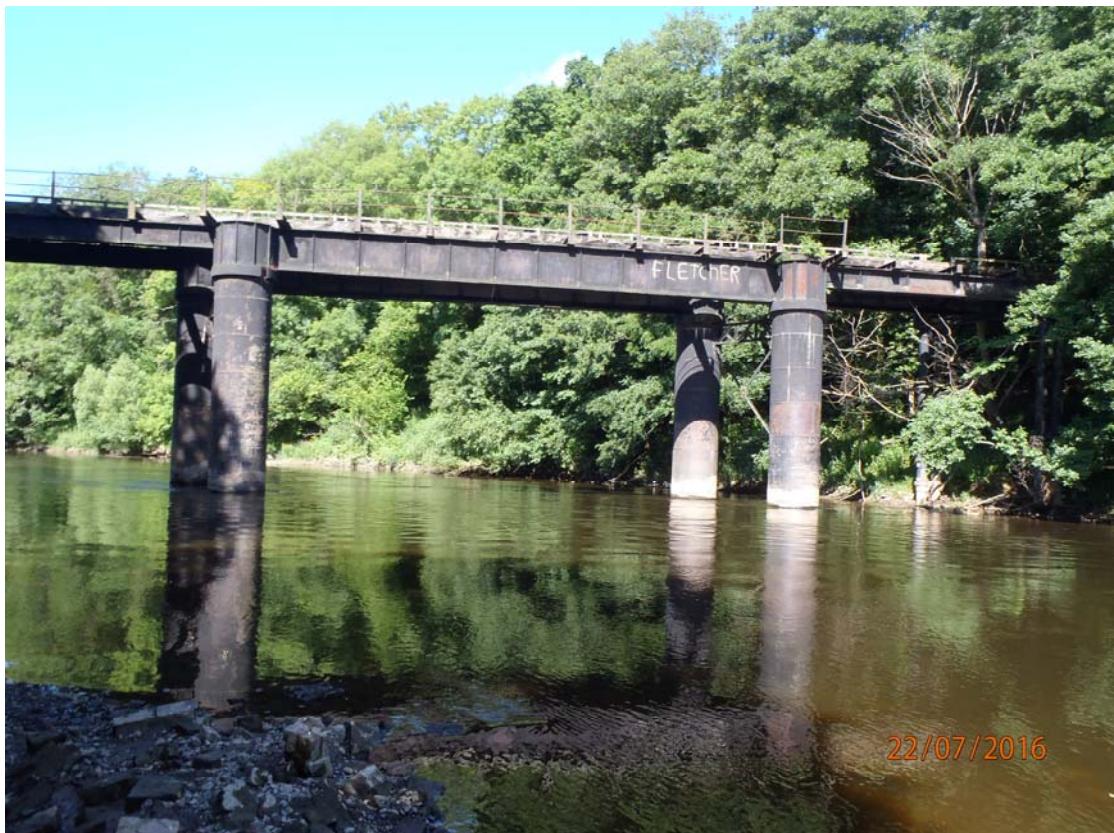
Photo 1 – View of East (Upstream) Elevation

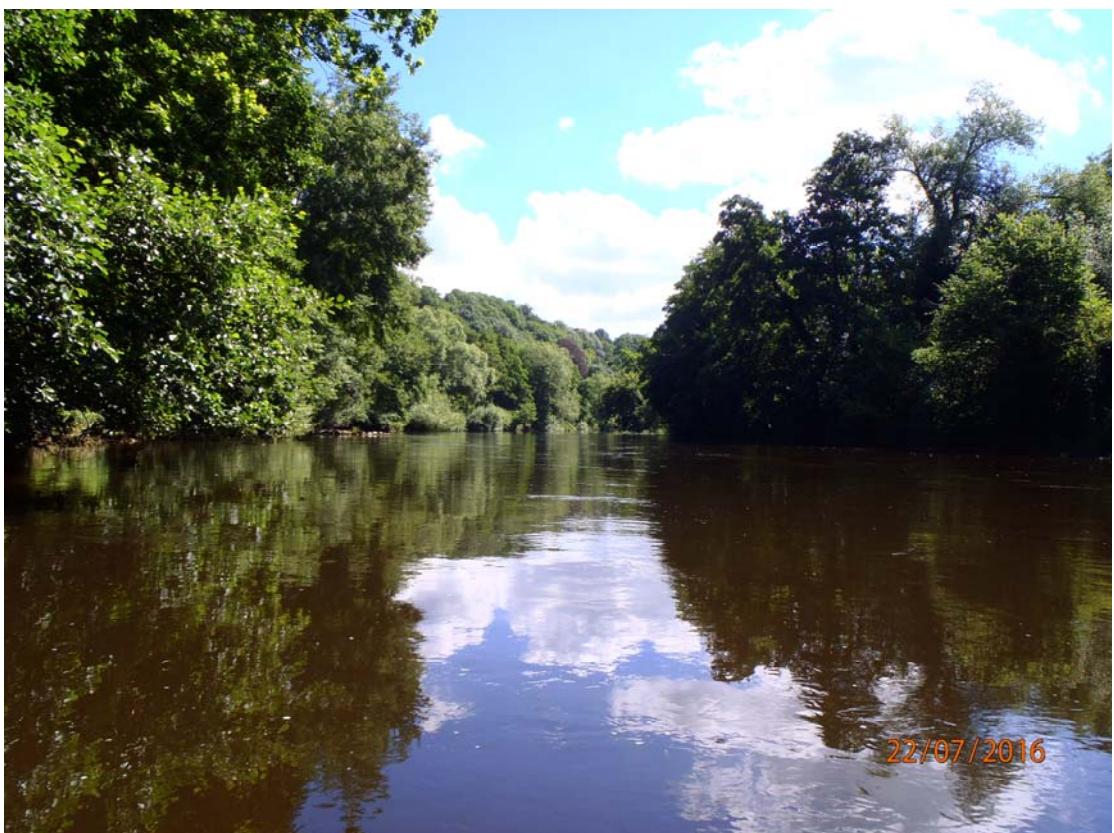
Photo 2 – View to Upstream

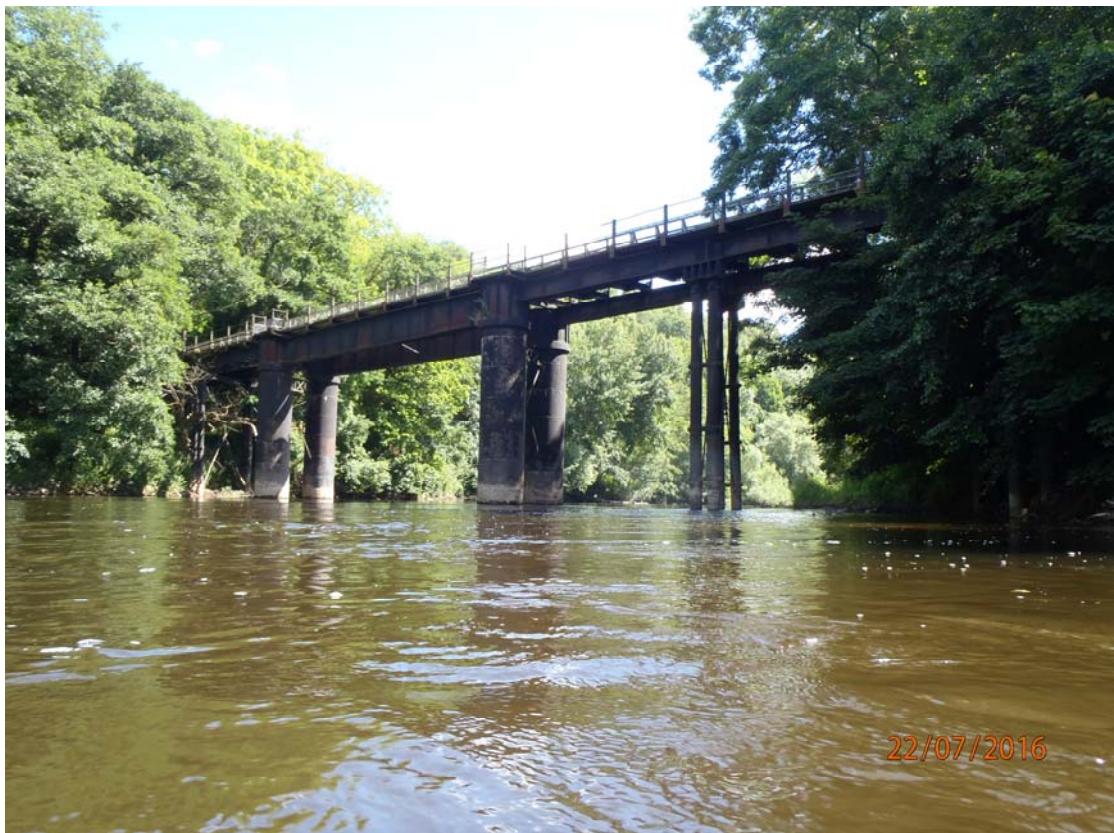
Photo 3 – View of West (Downstream) Elevation

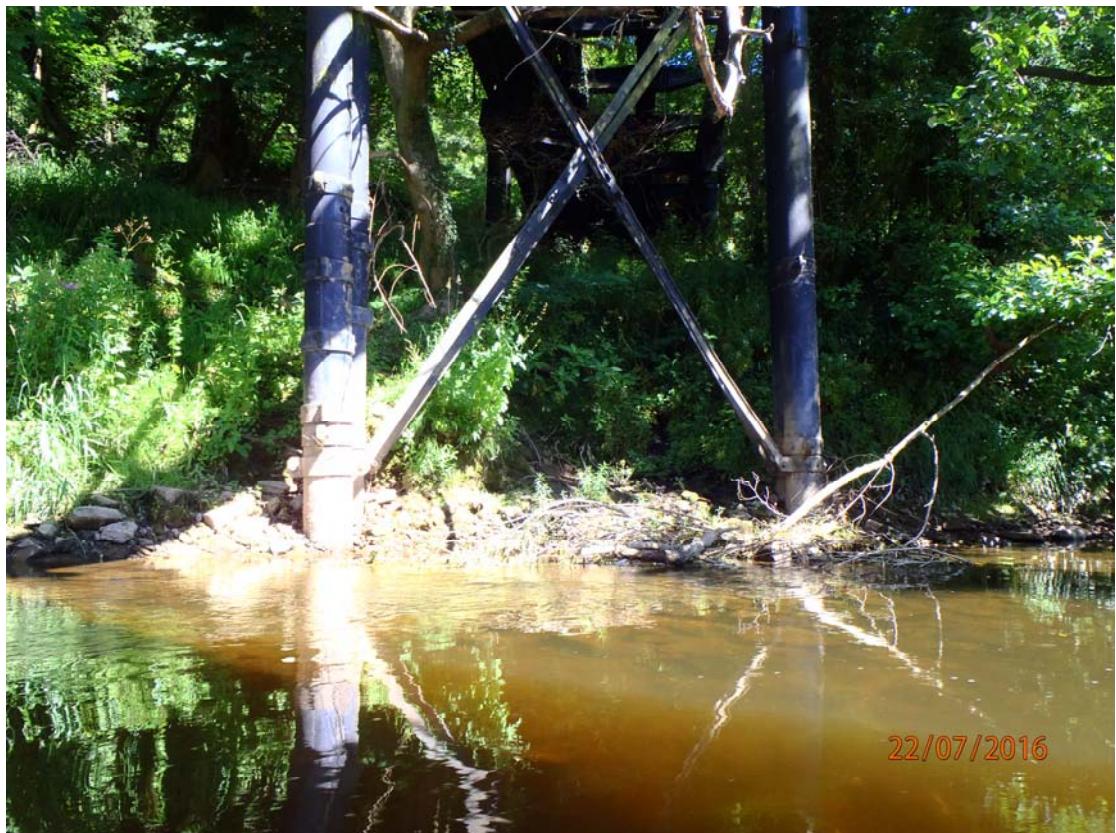
The 4no 400mm \varnothing cylinders stand on the edge of the watercourse and were found to be in fair condition with only minor paint loss and surface corrosion noted to the parts at and around water level - All connections were found to be tight ([Photo 5](#))

Photo 5 – View of Pier 2 Cylinders

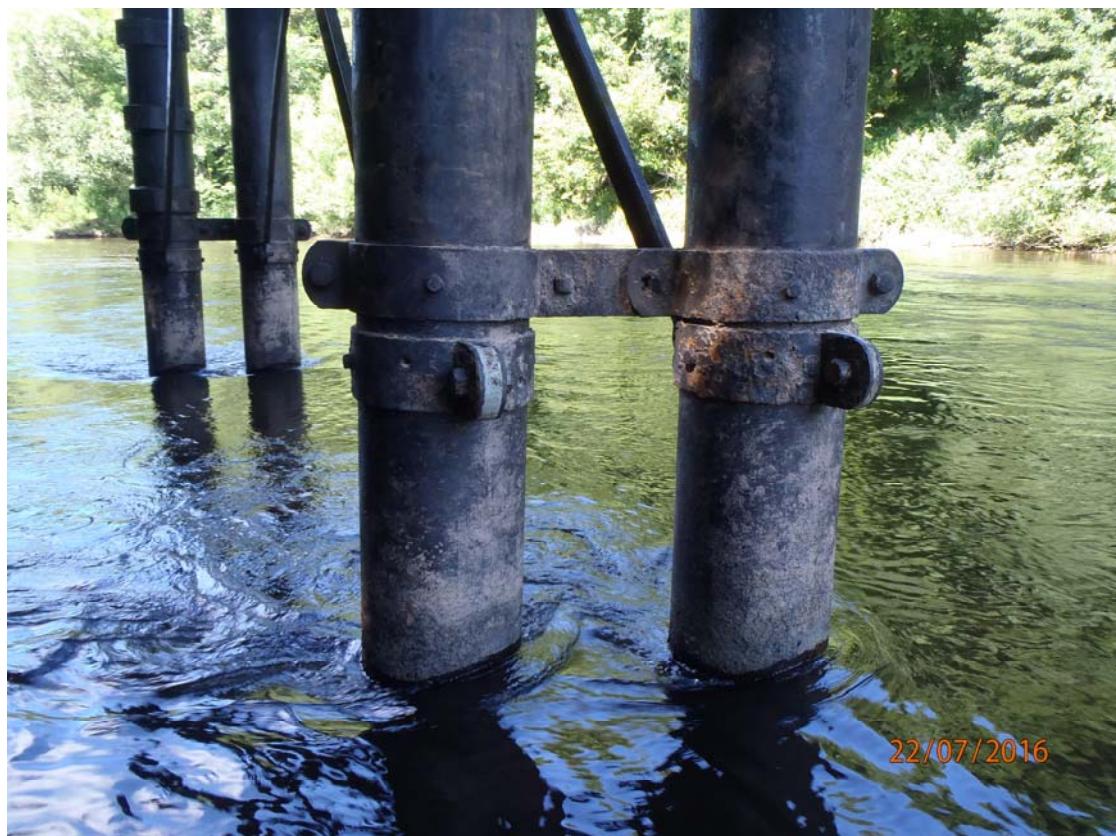
The metalwork to each of the 4no cylinders was found to be fair with occasional paint loss and surface corrosion to less than 1mm around the waterline. All connections were found to be tight ([Photo 6](#)).

Photo 6 – View of Pier 3 Cylinders

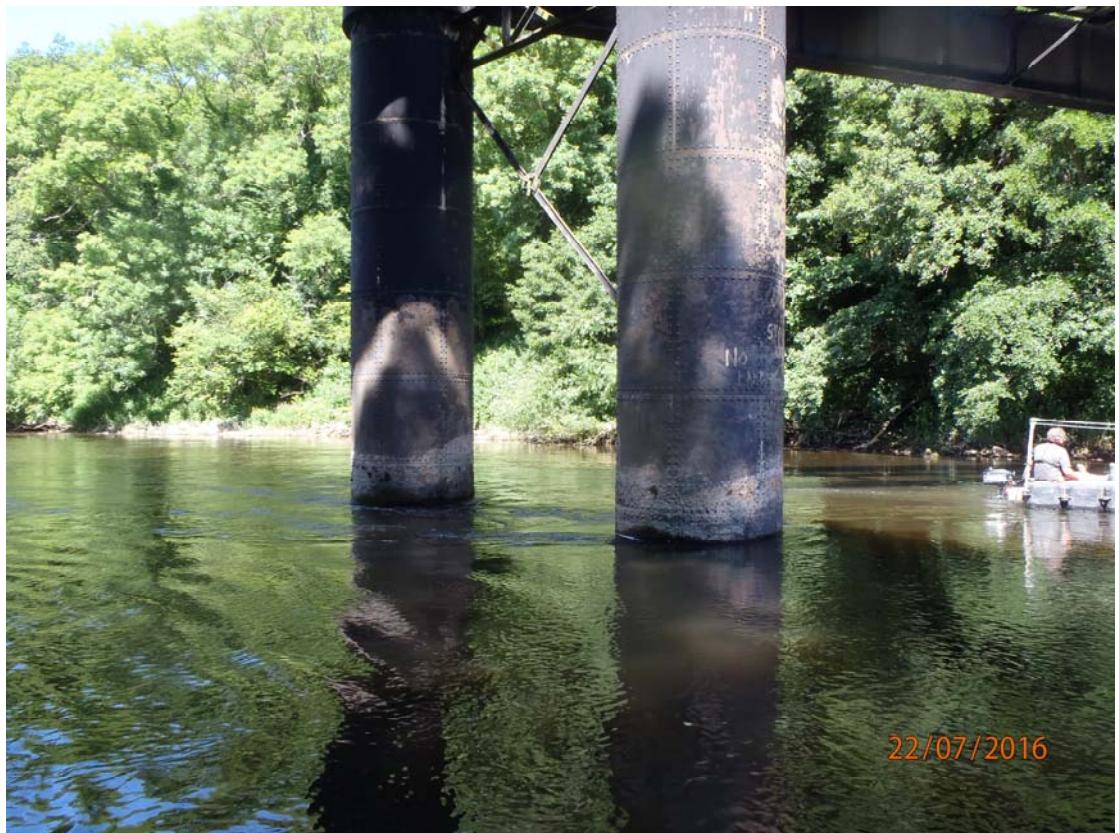
Photo 7 – View of Pier 4 Cylinders

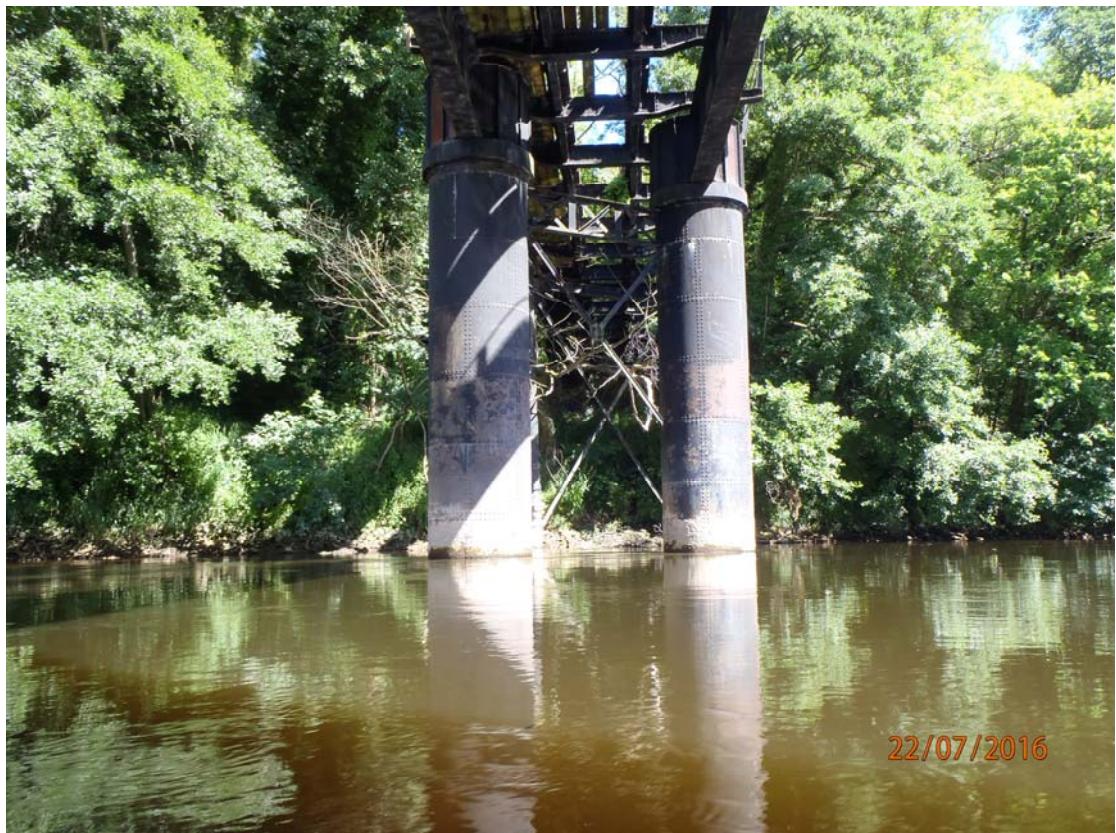
All four 2000mm \varnothing cylinders were found to be fair with paint loss and lamination blistering/ pitting occurring from bed level to 500mm above normal water level; corrosion was found to be up to 3mm in depth and covered a total of approximately 3m², concentrated at the upstream face of the upstream cylinders ([Photos 8 to 11](#)).

Photo 9 – View of Pier 5 Cylinders
